Tbilisi Mall paint scopes

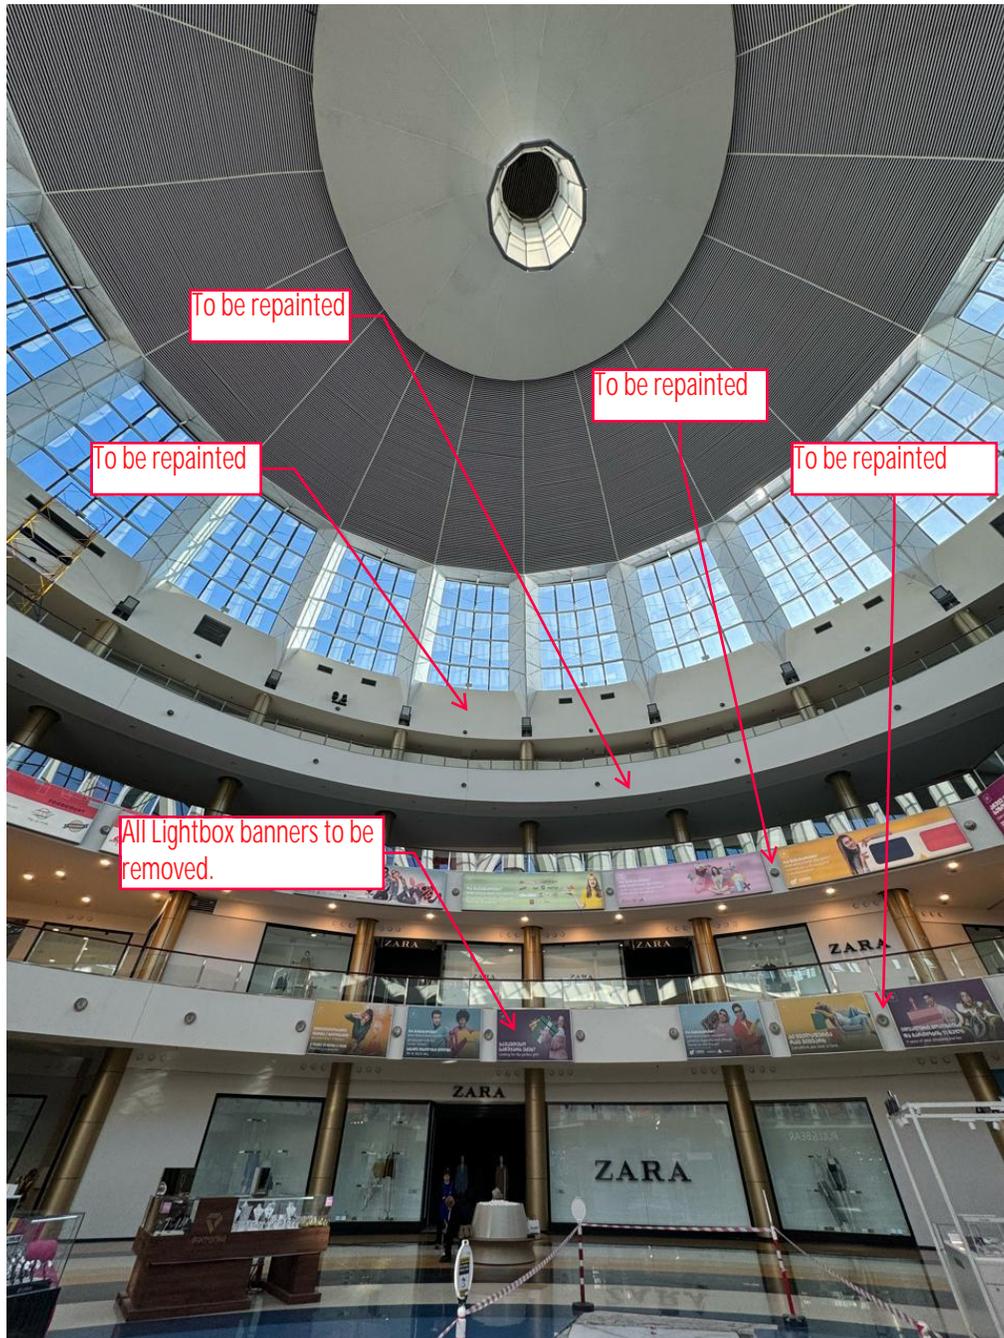
Photo #1 – Lightbox banners to be removed, and foreheads to be repainted.

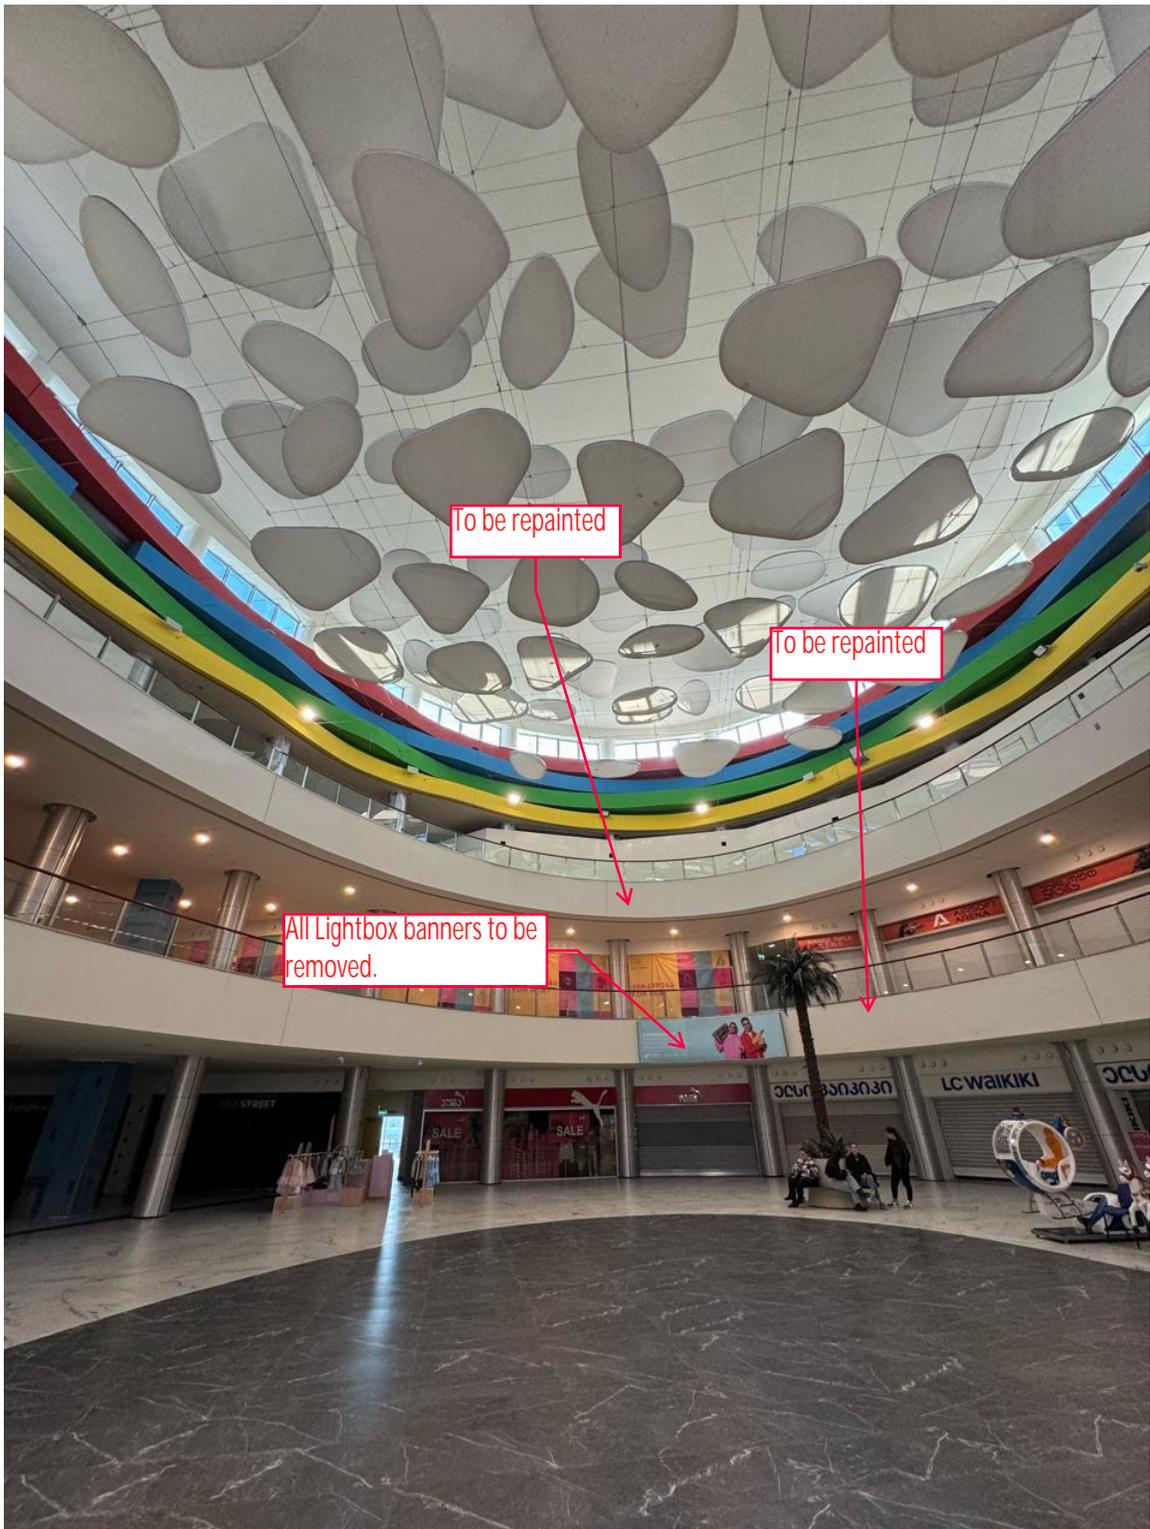
Photo #2 – Lightbox banners to be removed, and foreheads to be repainted.

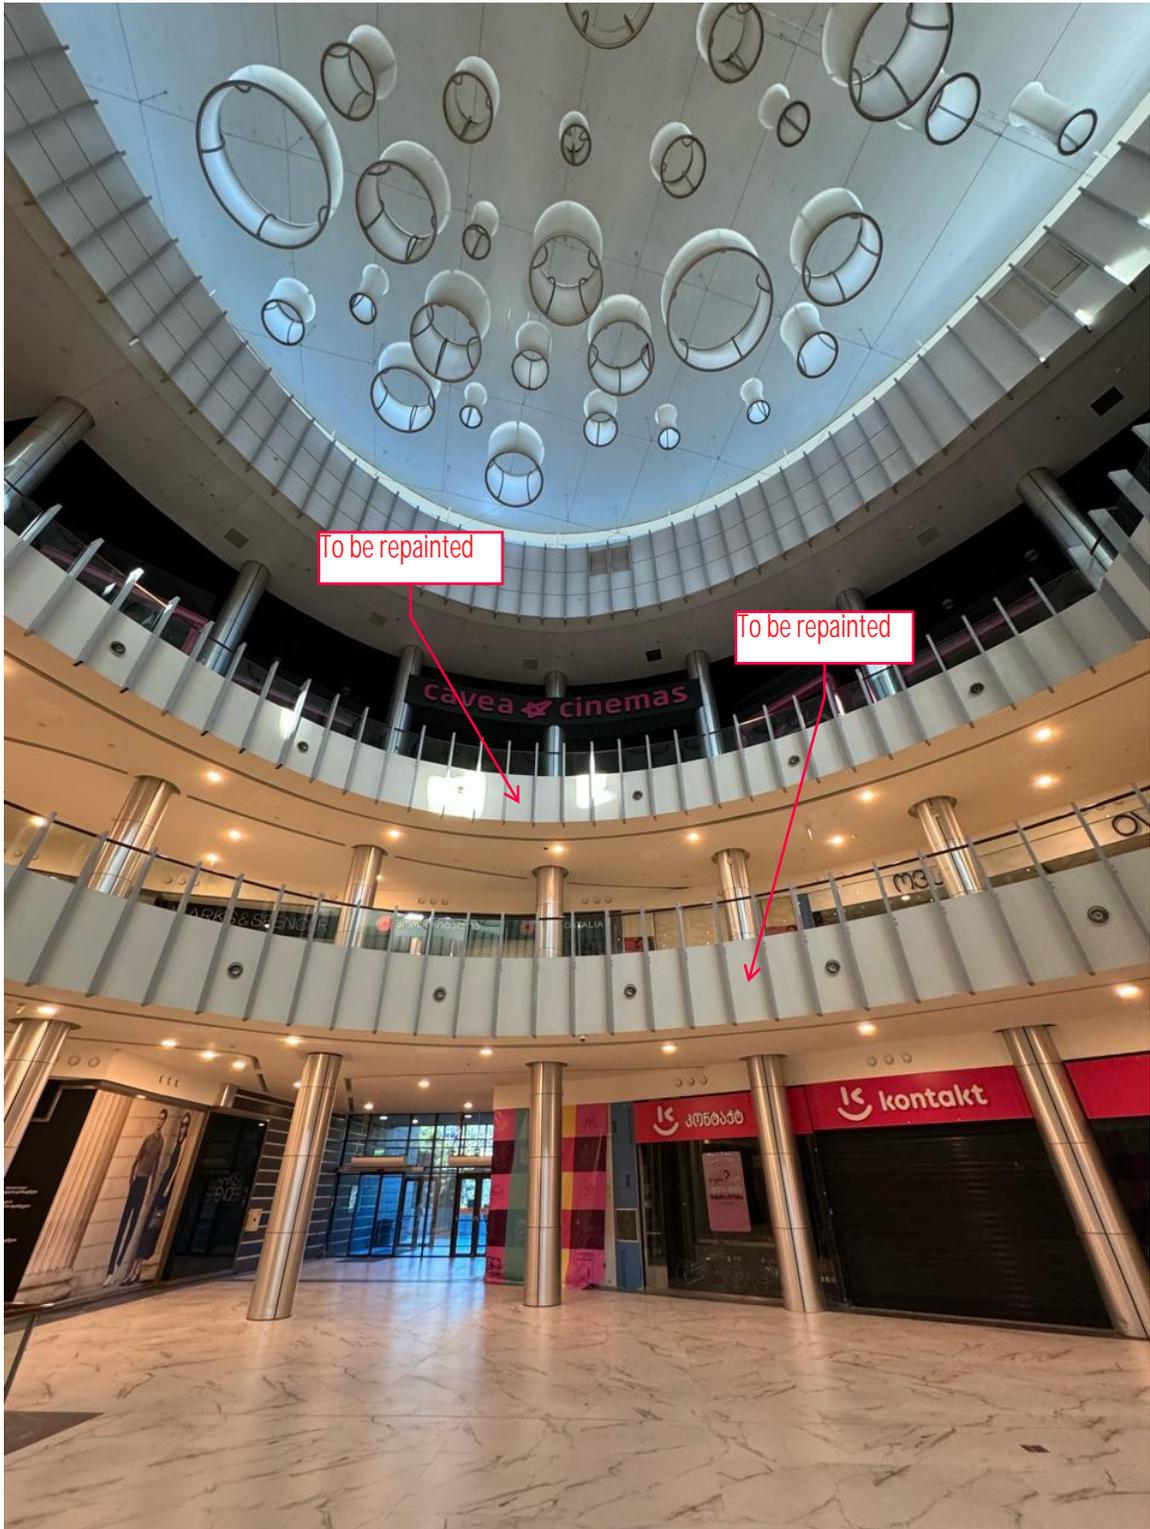
Photo #3 – Lightbox banners to be removed, and foreheads to be repainted.

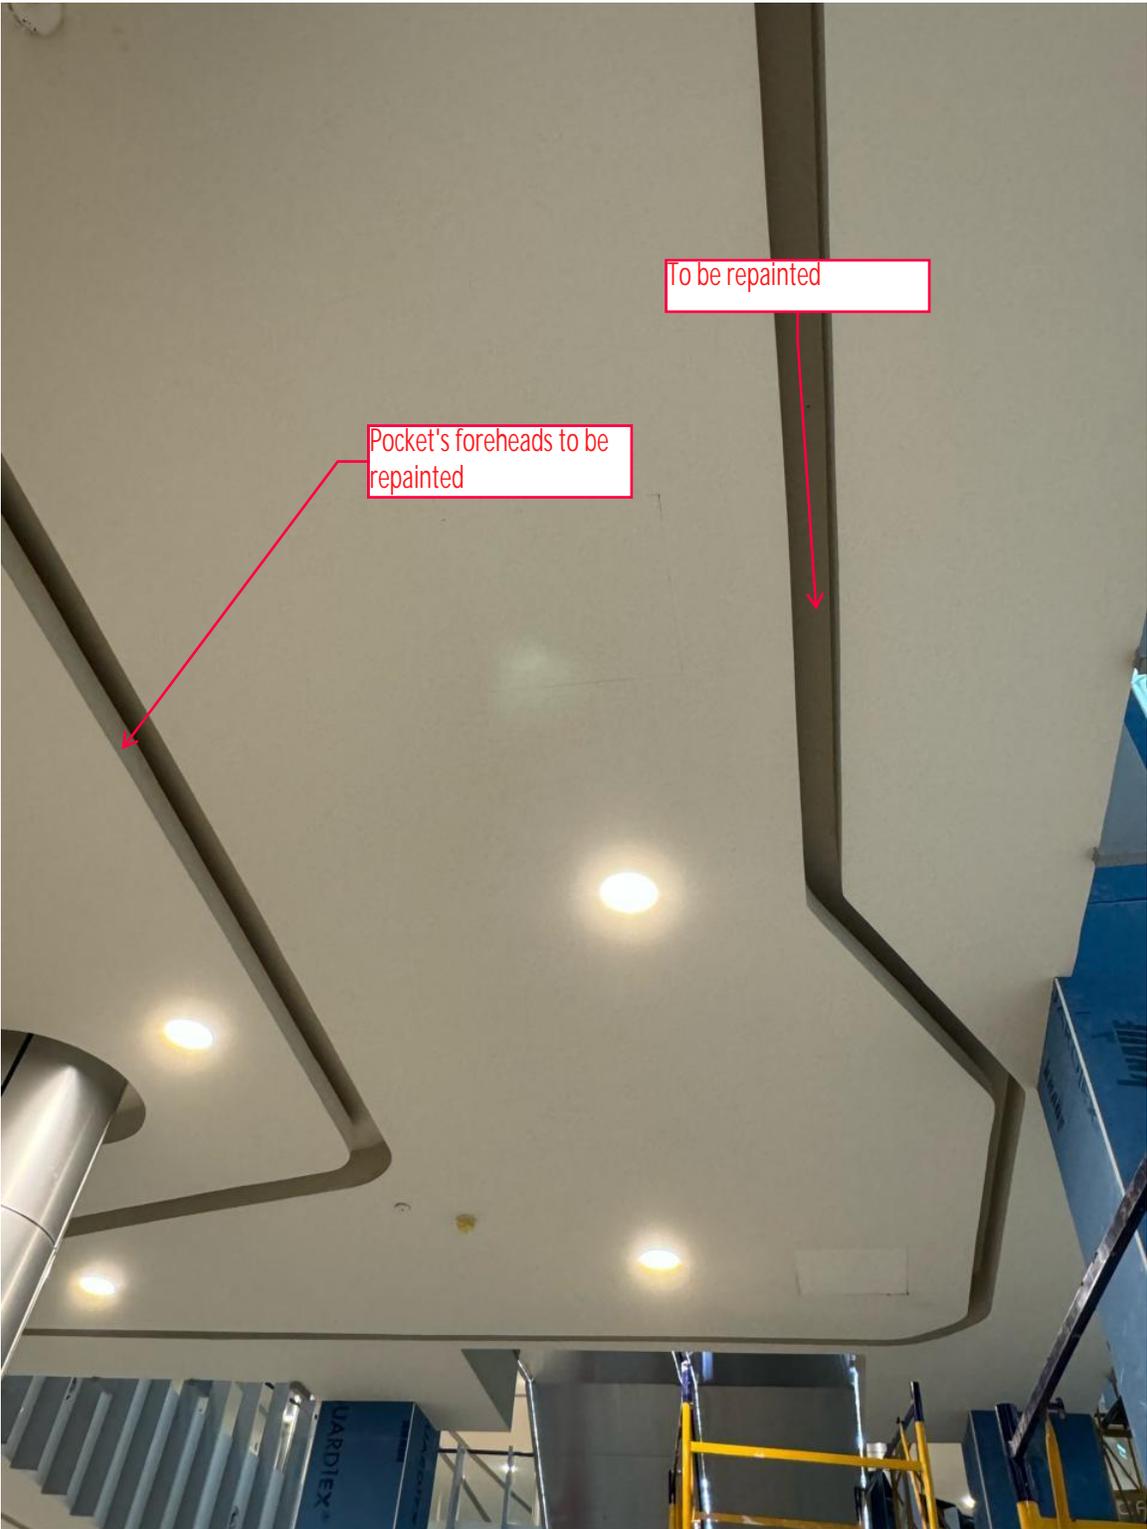
Photo #4 – Pockets to be repainted.

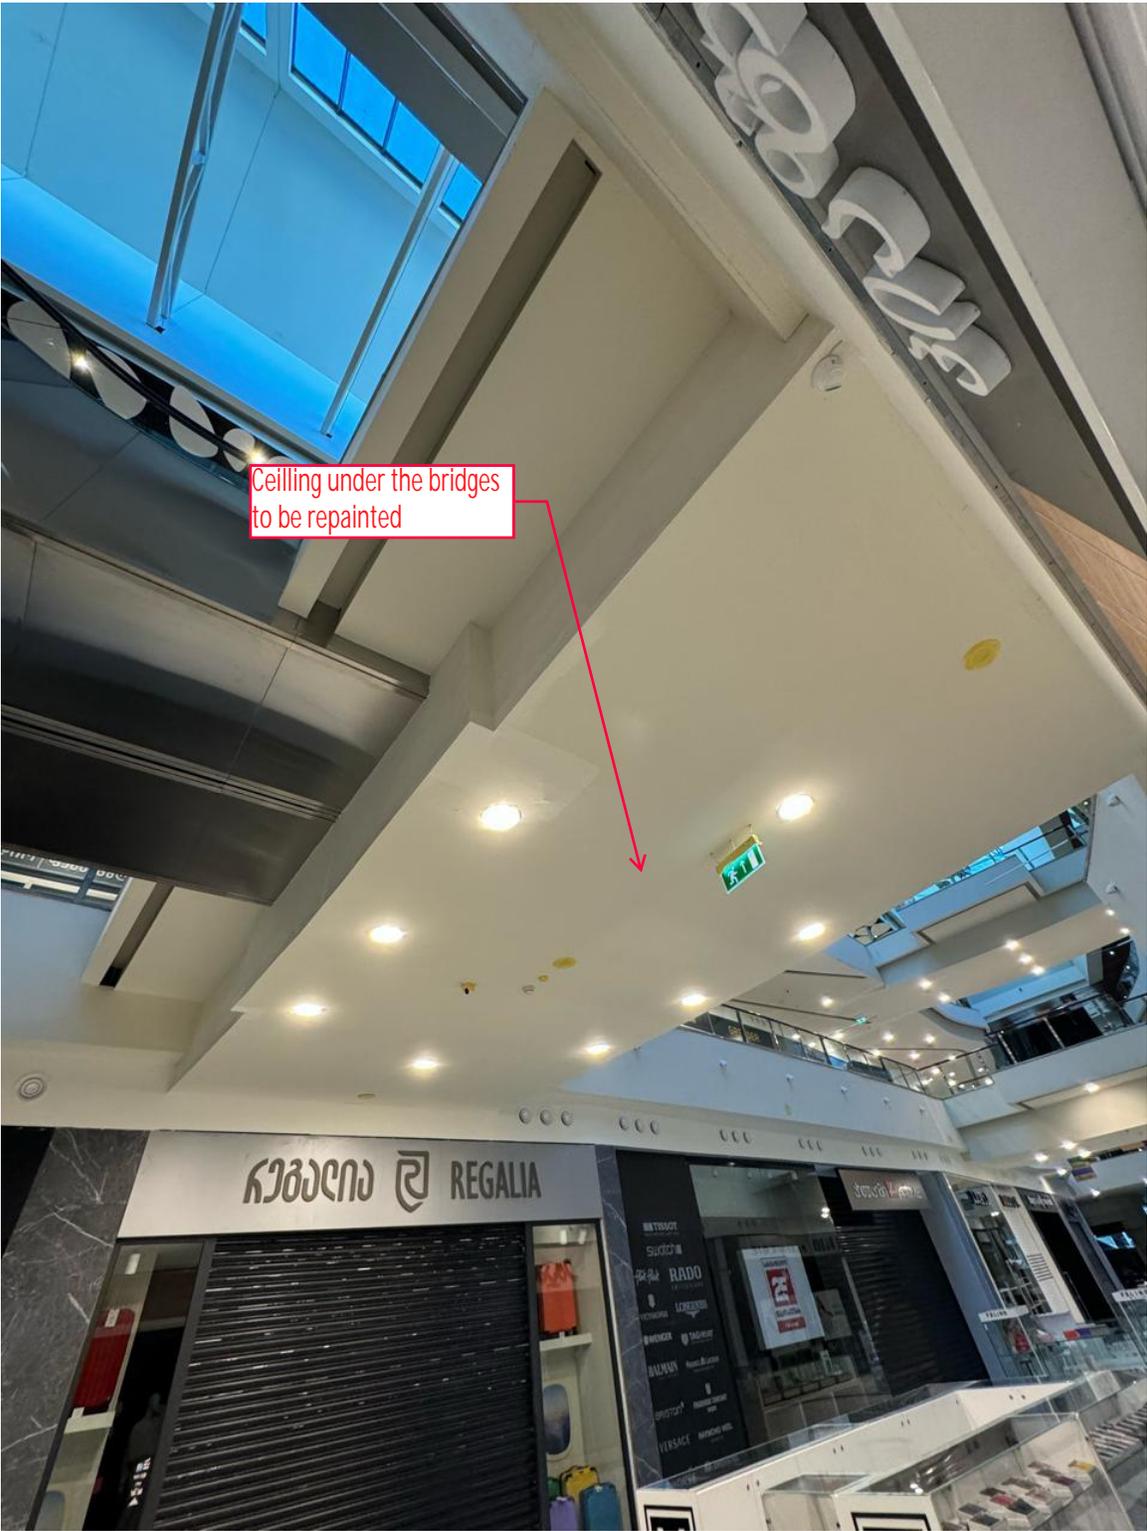
Photo #5 – Ceiling under the bridges to be repainted.

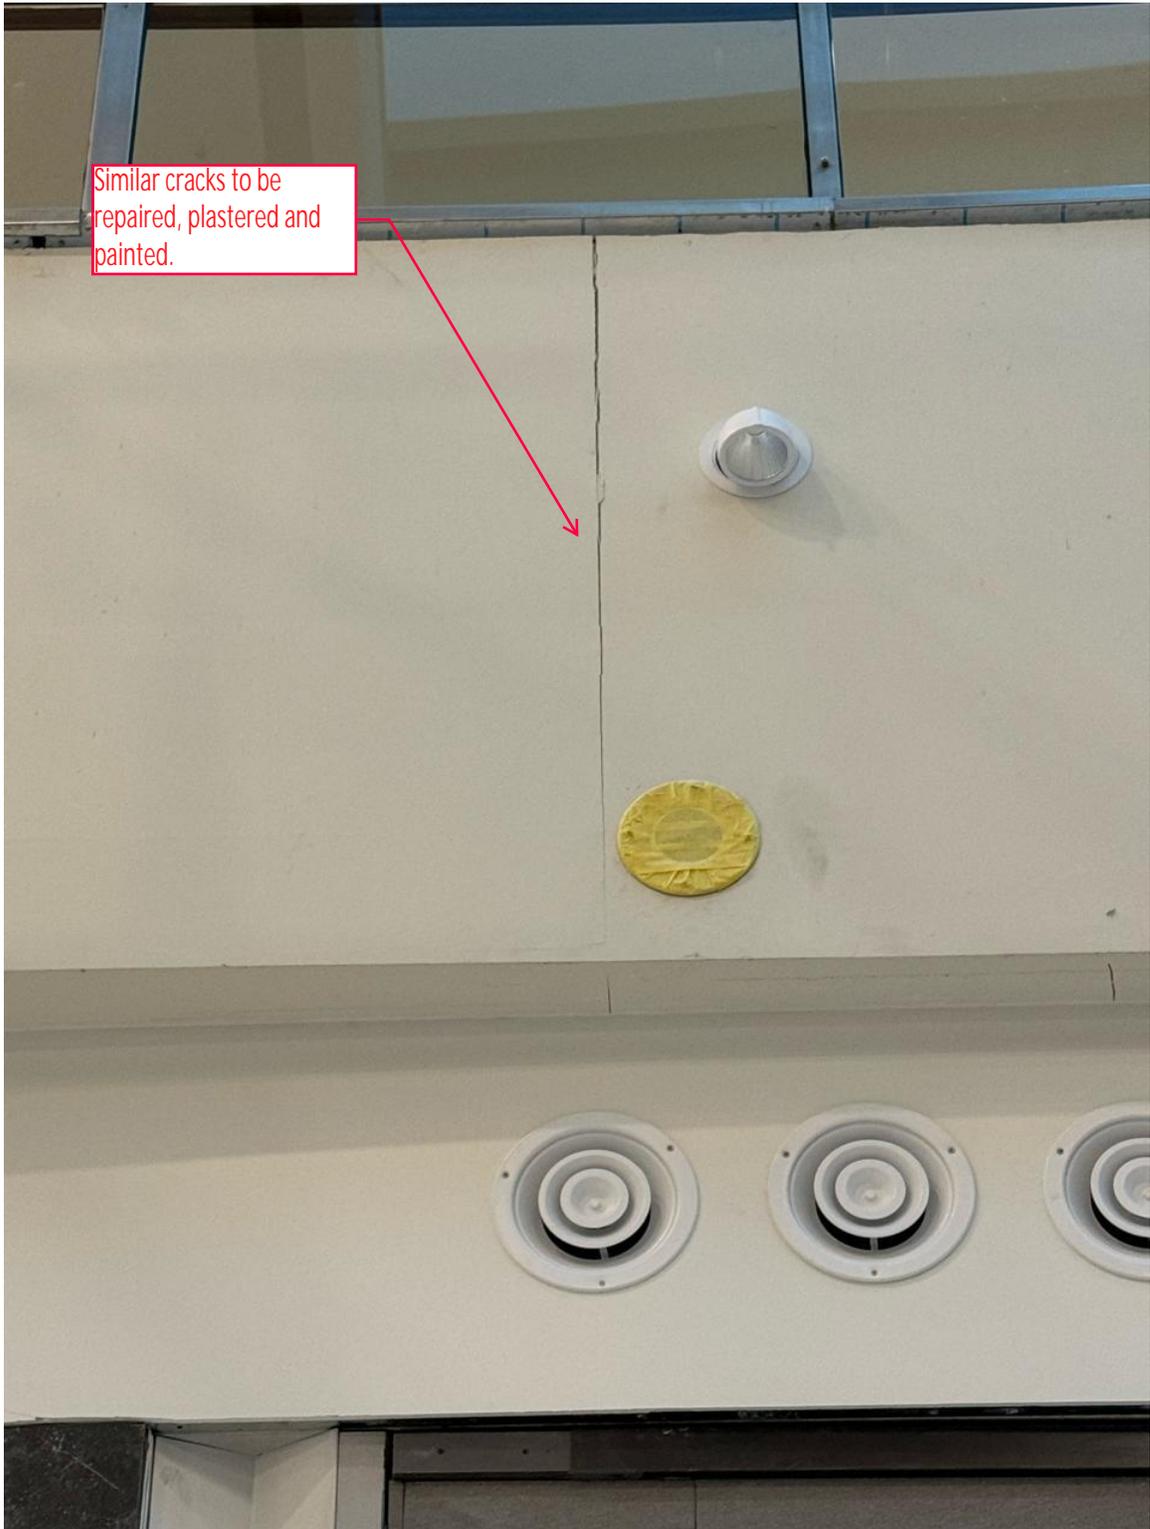
Photo #6 – Cracks to be repaired and painted.

Similar cracks to be repaired, plastered and painted.

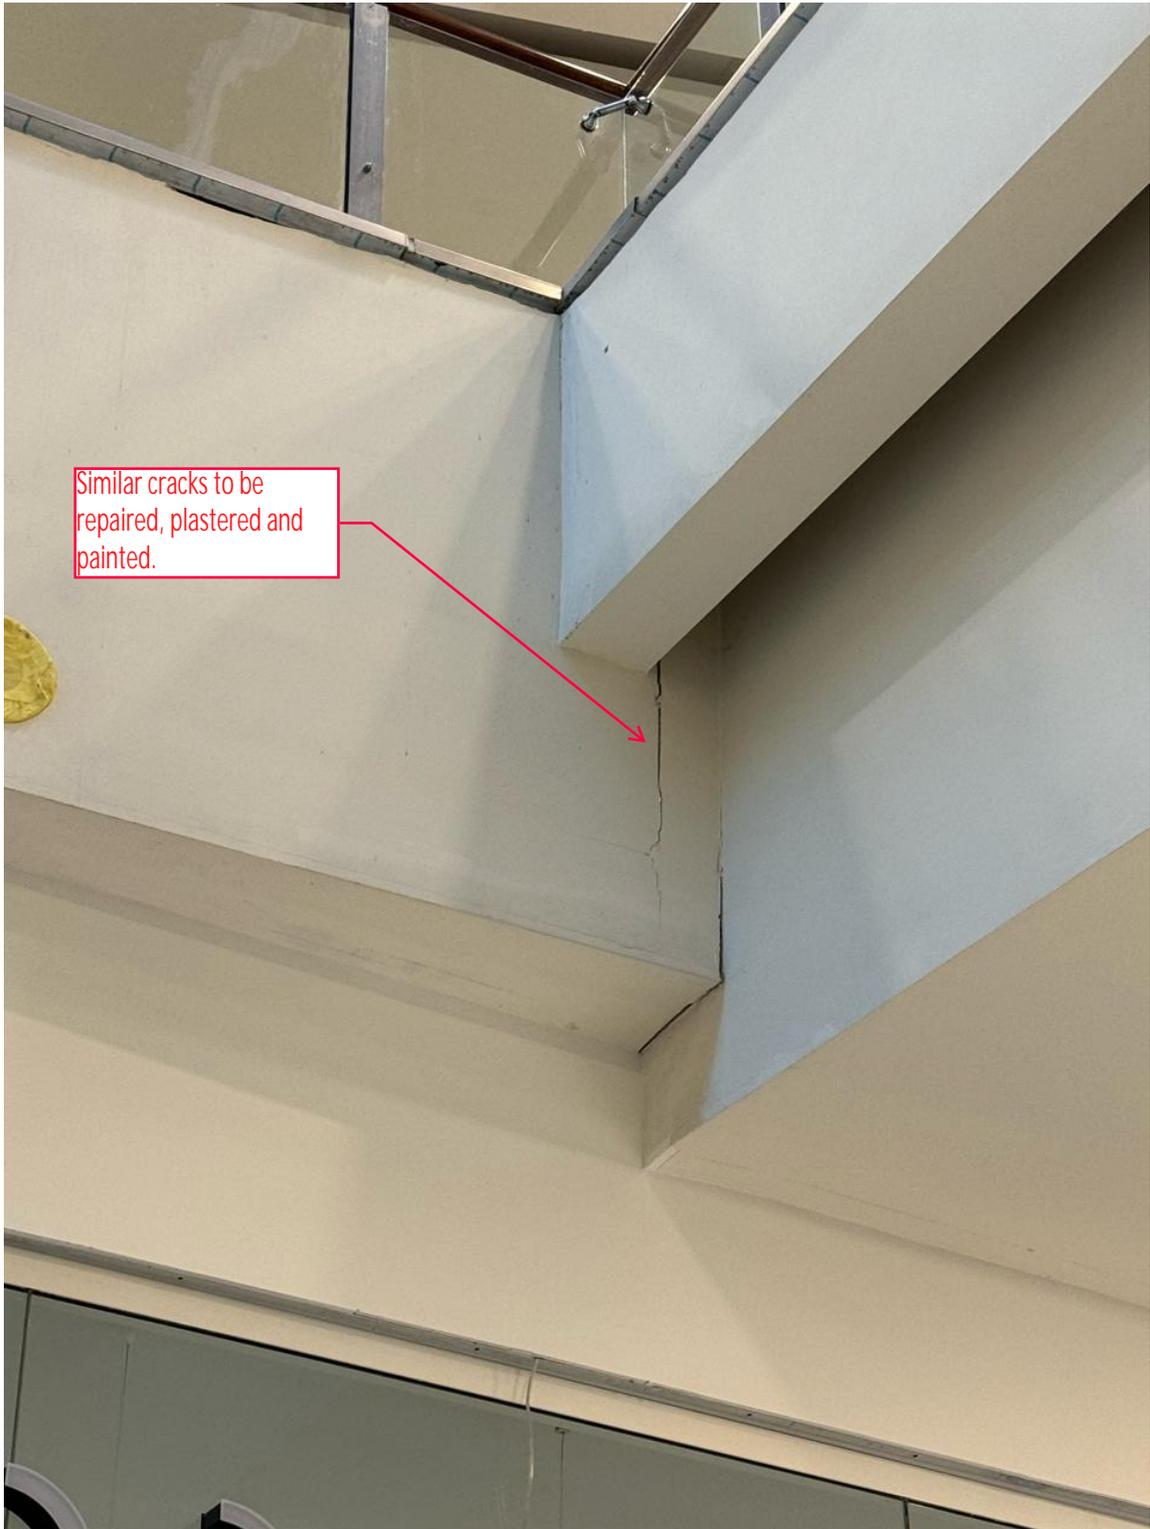
Photo #7 – Cracks to be repaired and painted.

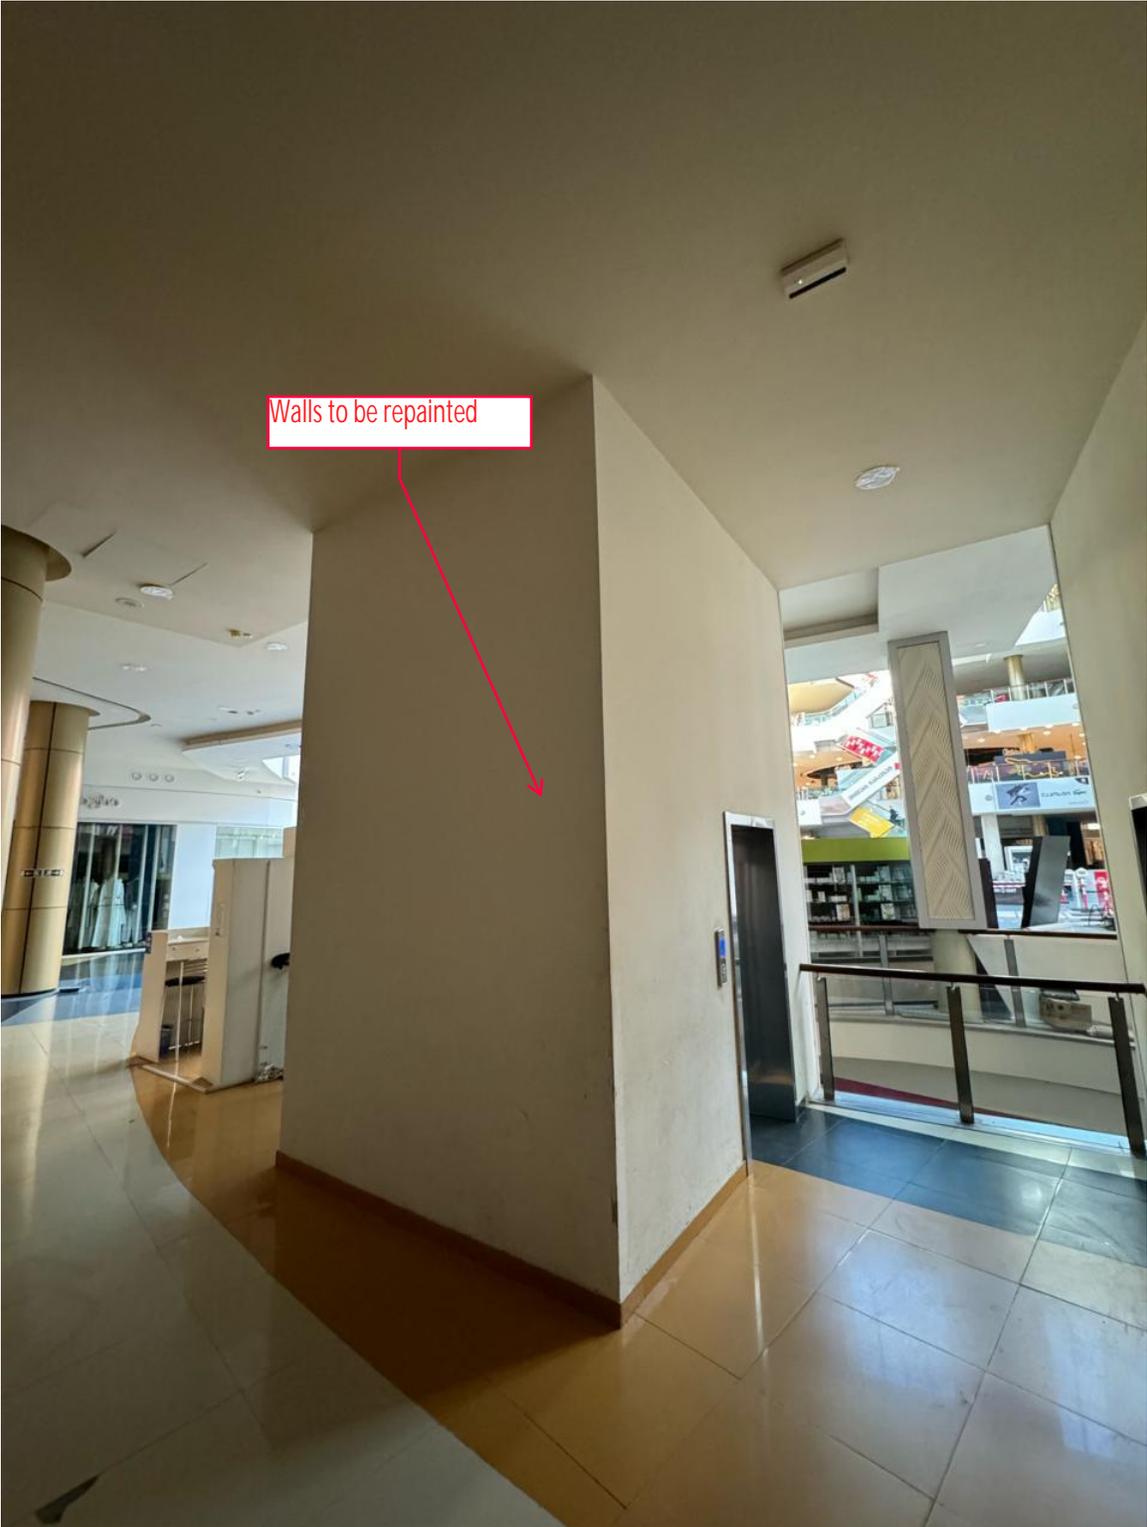
Photo #8 – Walls at the glass elevator entrances to be repainted (Corners to be repaired).

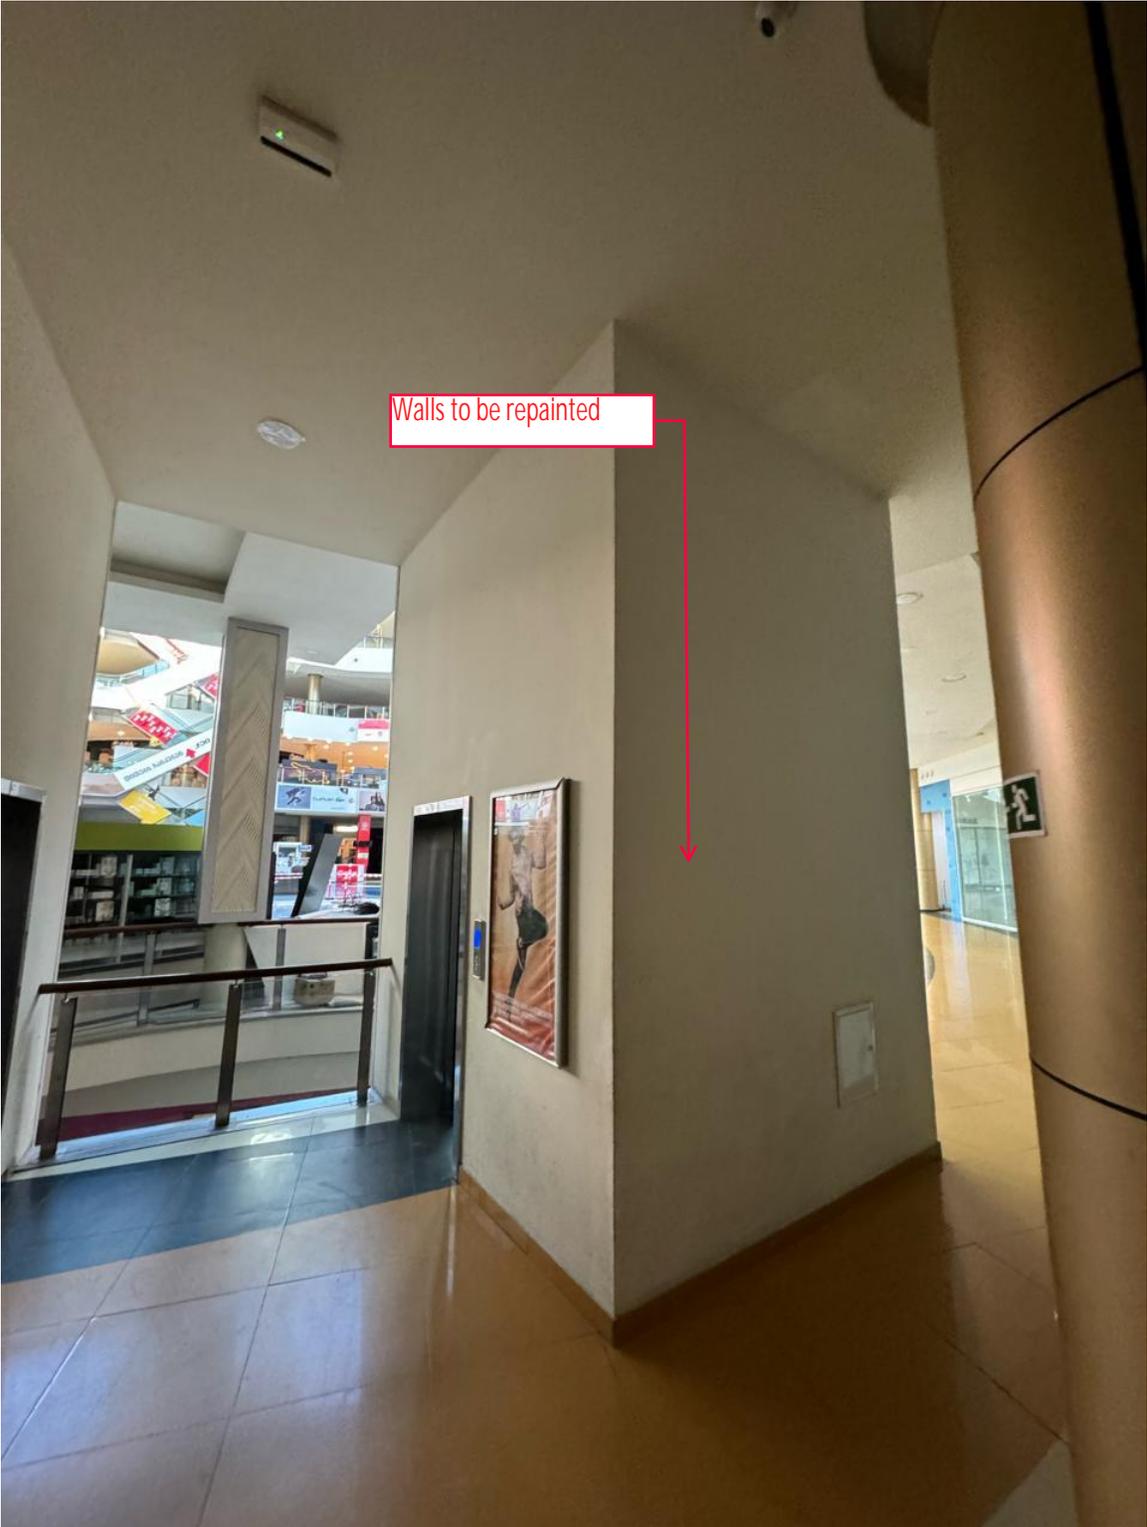
Photo #9 – Walls at the glass elevator entrances to be repainted (Corners to be repaired).

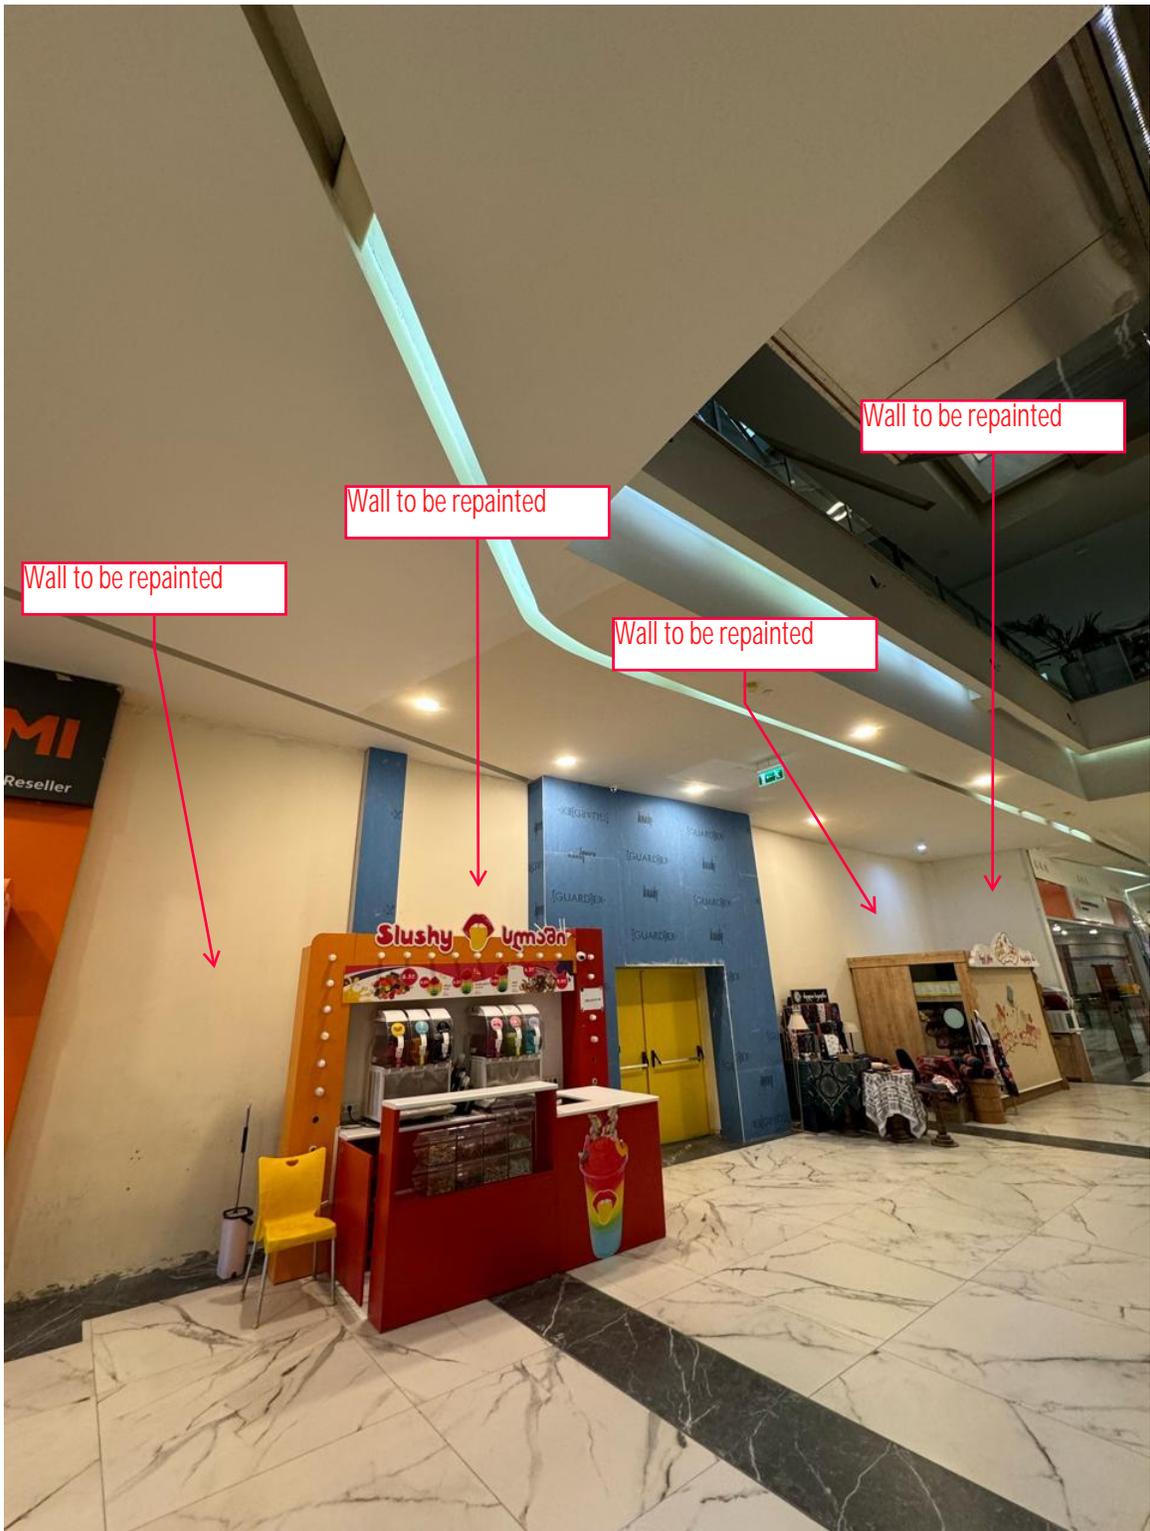
Photo #10 – Walls in front of the Carrefour to be repainted.

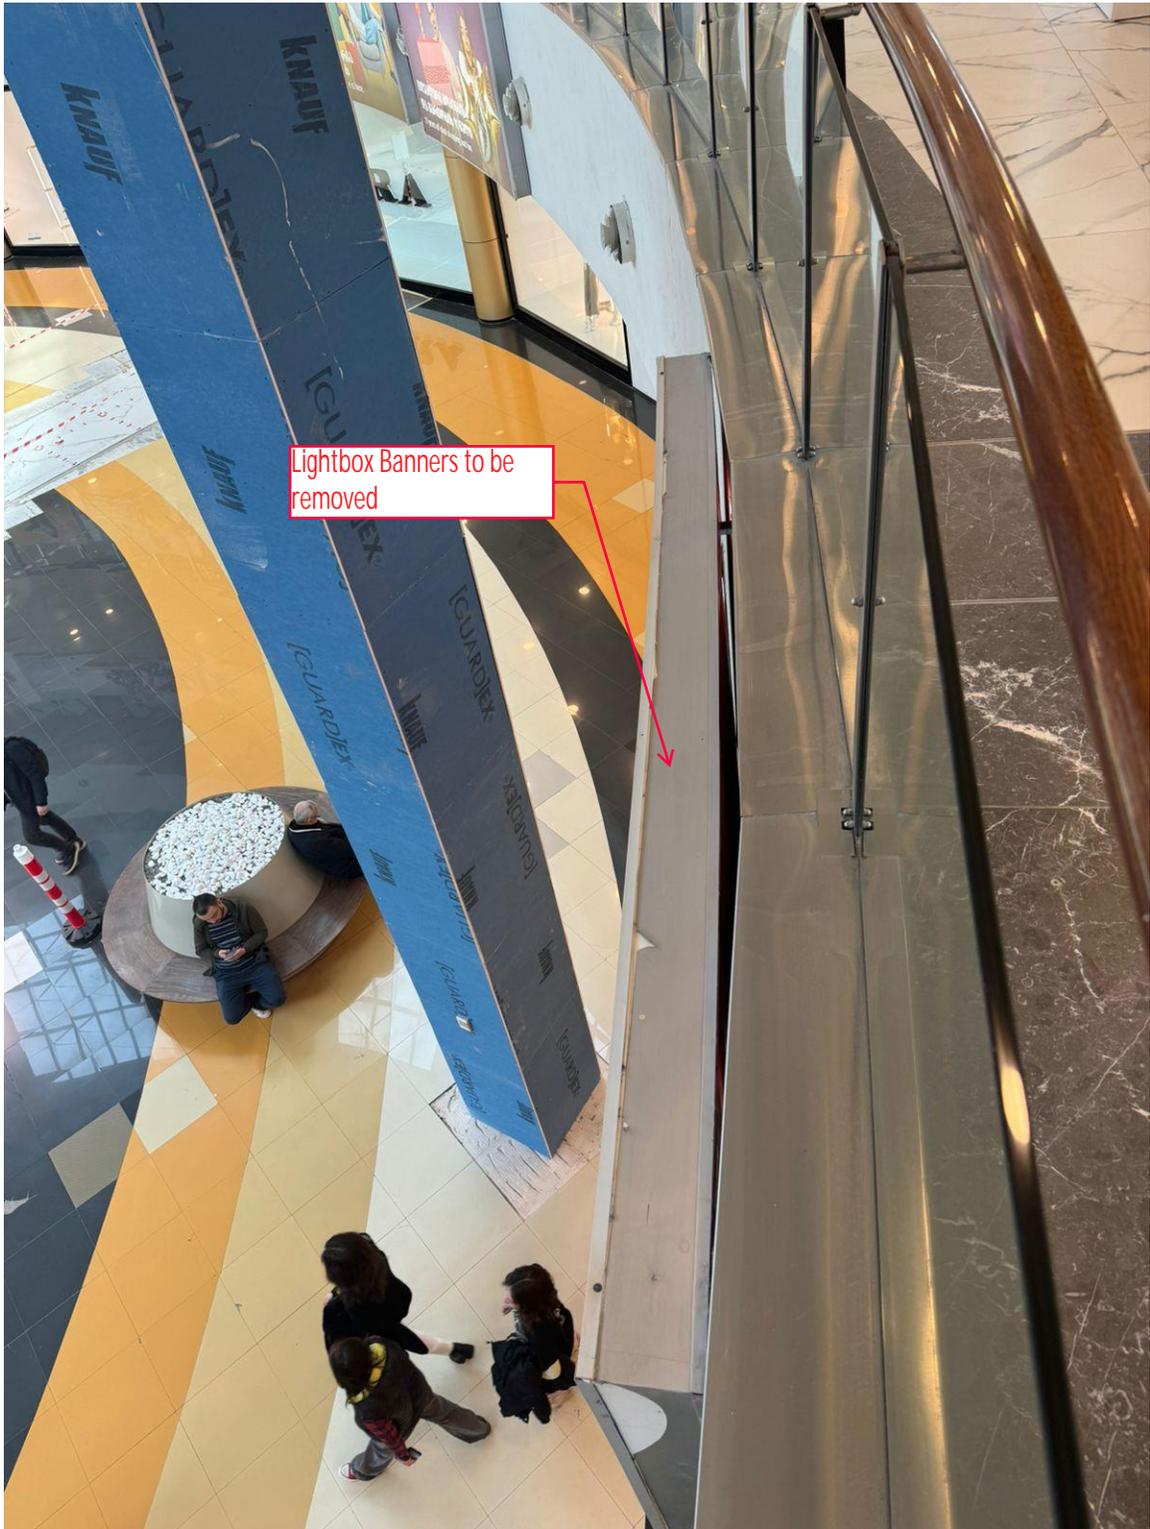
Photo #11 – Lightbox banners to be removed, placed in the Tbilisi Mall warehouse.

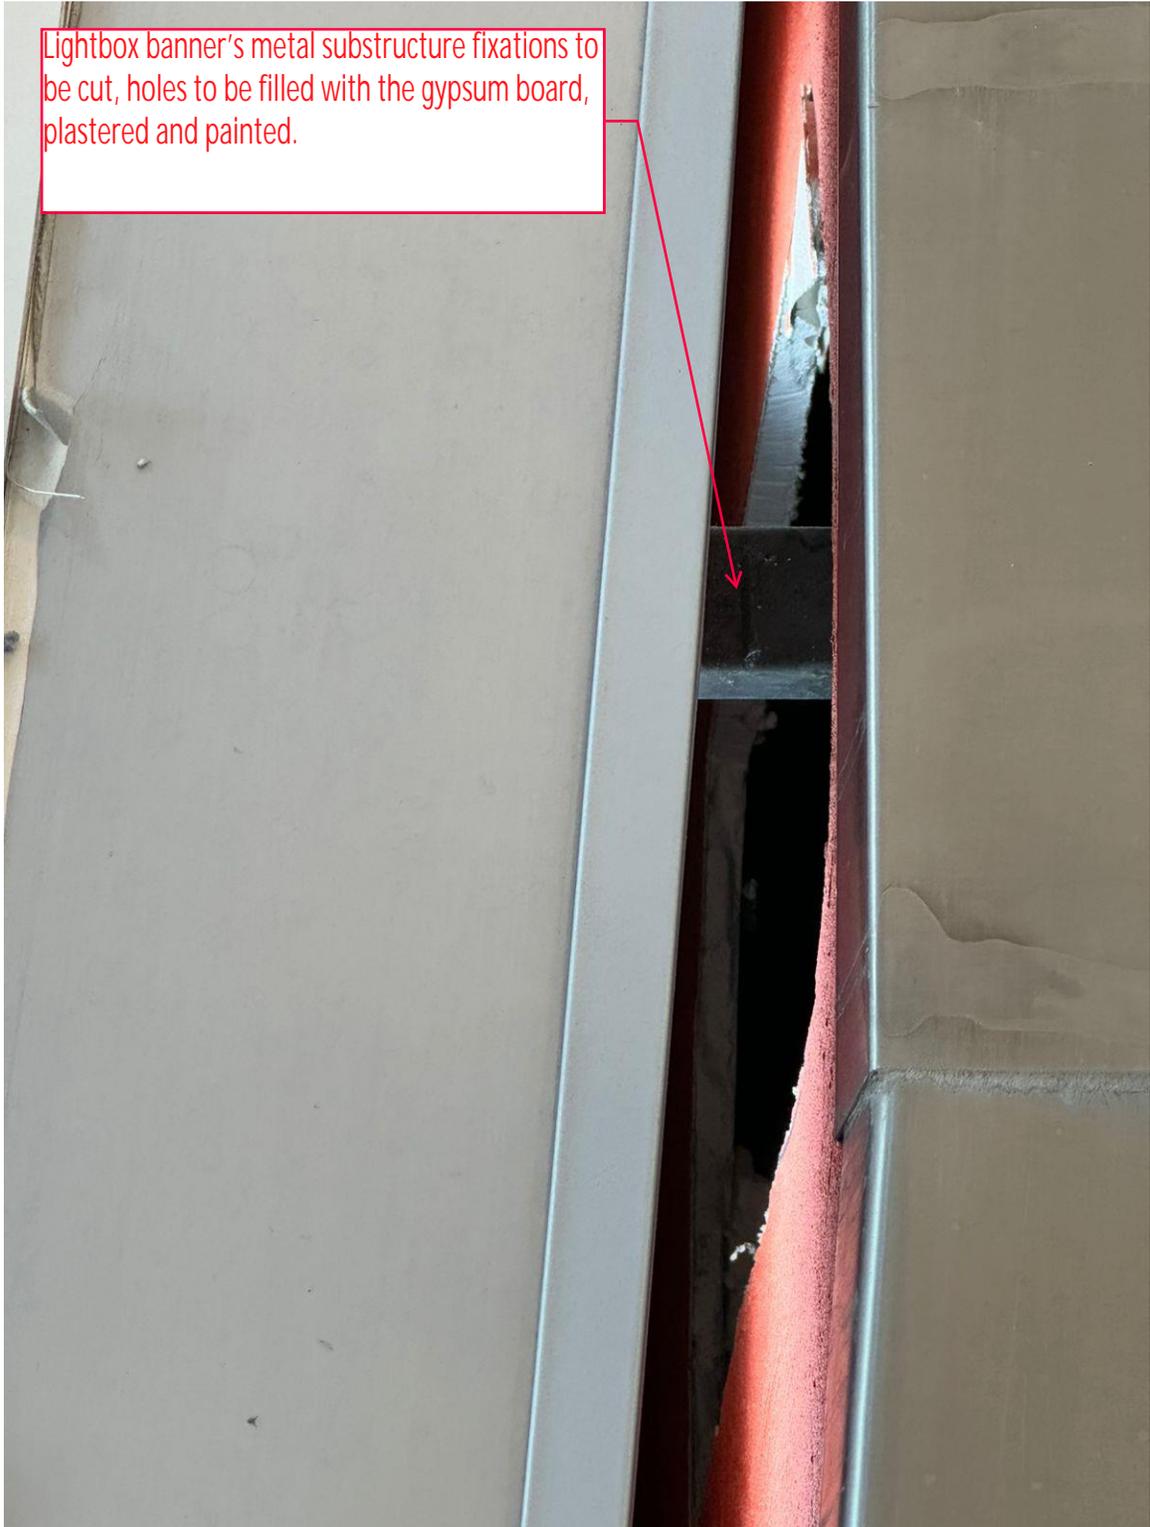
Photo #12 – Lightbox banner’s metal substructure fixations to be cut, holes to be filled with the gypsum board, plastered and painted.

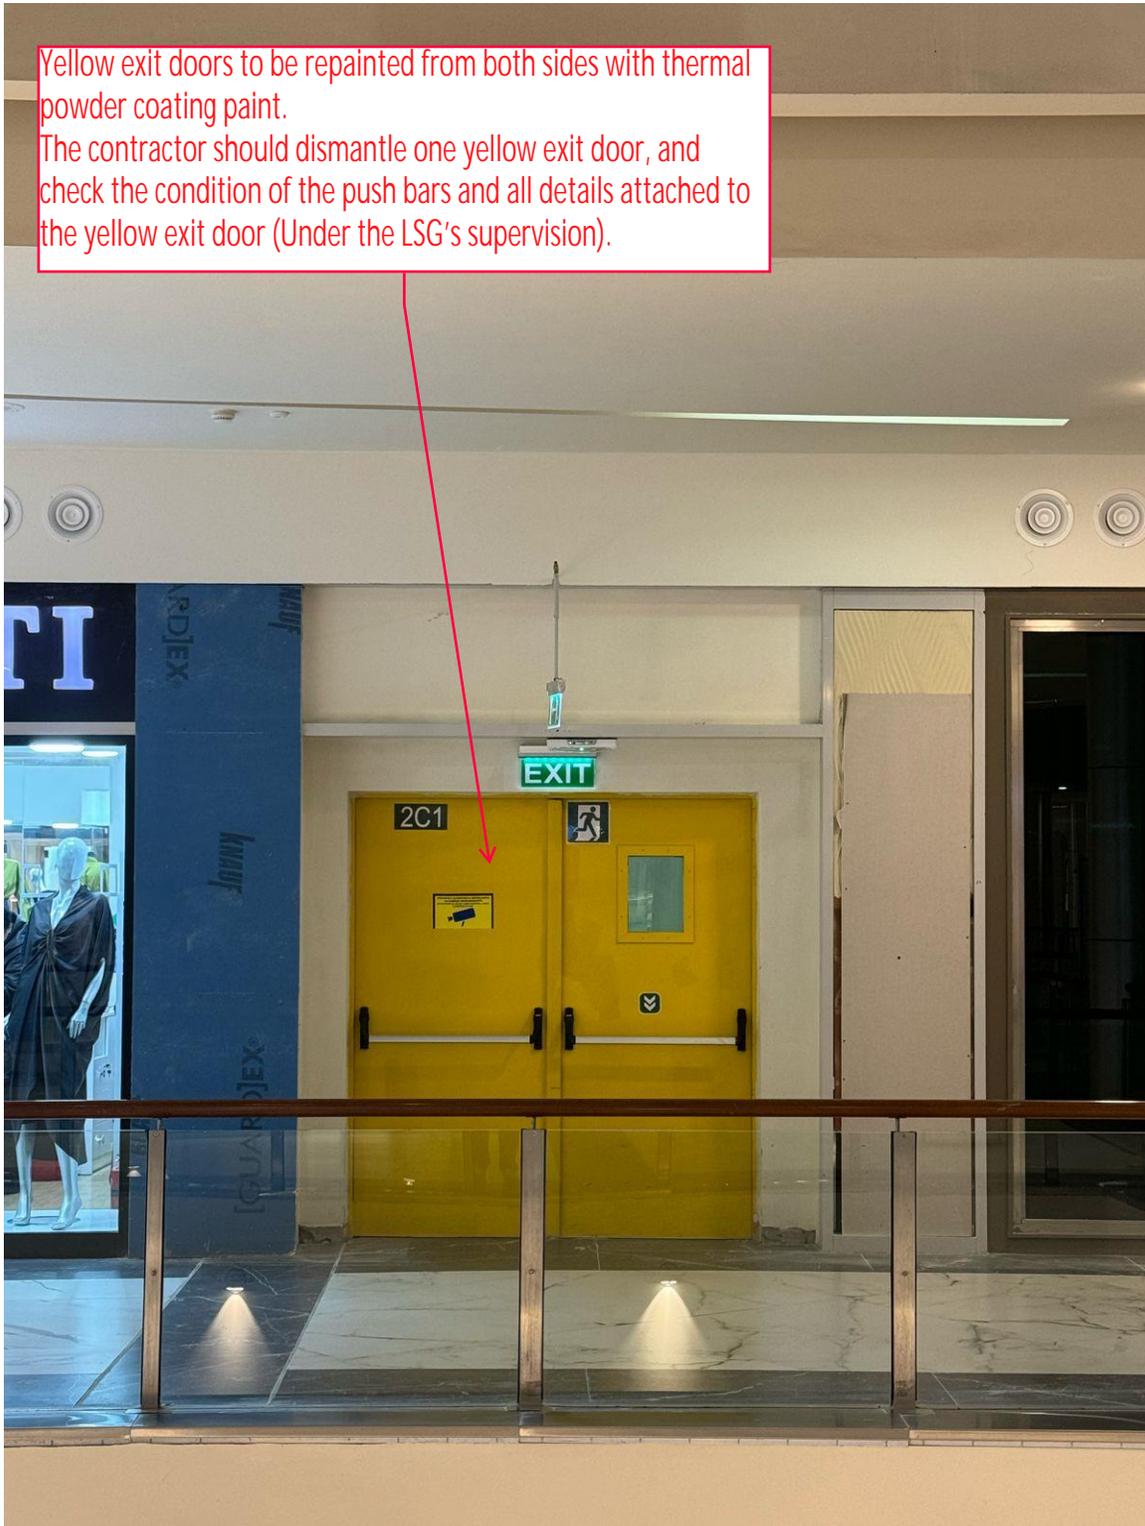
Photo #13 – Yellow exit doors to be repainted from both sides with thermal powder coating paint.

The contractor should dismantle one yellow exit door, and check the condition of the push bars and all details attached to the yellow exit door (Under the LSG's supervision).
