Georgian Water and Power LLC

The results of the visual inspection of water reservoirs located near Chatmi mountain in city Rustavi

## Notice to Client #1

**Tbilisi, 03 October 2024**

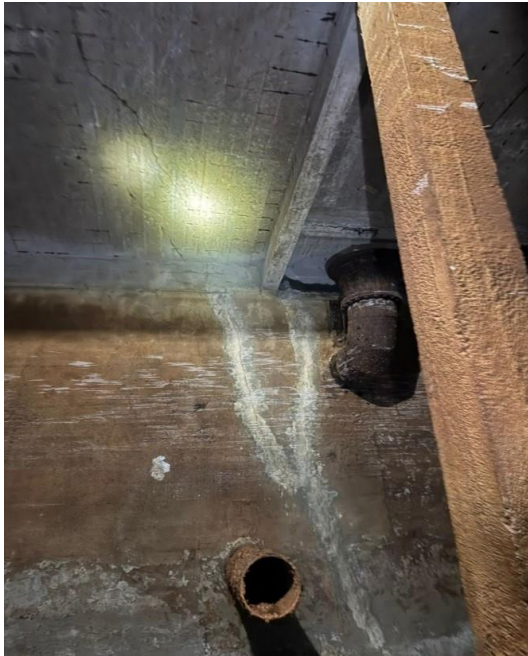
1. Cracks has been observed on the walls, beam, roof slab and bottom of the reservoir. The main reason of the water reservoir damages is uneven foundation settlements caused by water infiltration into the soil (Photo 3-2, Photo 3-3 and Photo 3-4).
2. The waterproofing layer is damaged on the inner side of the water reservoir (Photo 3-2)
3. The main drainage pit of the drainage system located behind the water reservoir is damaged and not operational (Photo 3-5).

*Photo 3-2 Cracks on the walls and roof slab of water reservoir No. 1*

1. Cleaning and treatment of the stripped reinforcement bars of reservoir structures with anti-corrosion material.
2. Treatment of cracks on reservoir walls and invert should be carried out according to the degree of damage and opening width.
3. After the treatment of the cracks, the layer of reinforced mortar should be arranged on the water reservoir invert.
4. A new insulating layer should be arranged on the invert and walls with a waterproofing material, applicable for drinking water reservoirs.
5. To improve the damaged drainage system of water reservoir No.1, it is necessary to replace the damaged well.

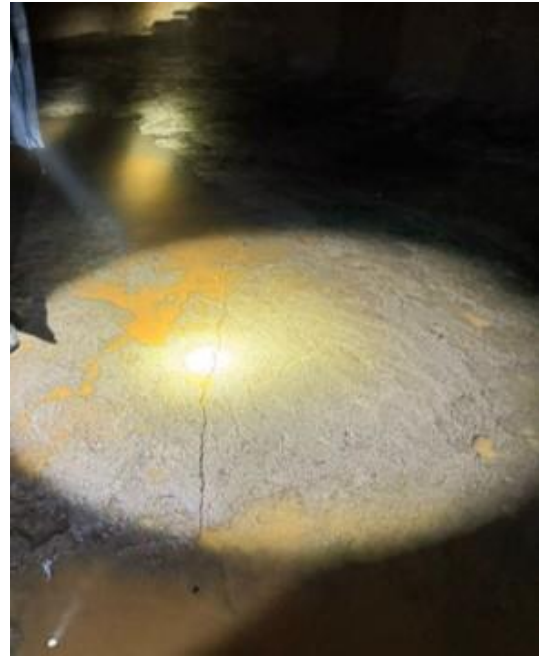
*Photo 3-3 Crack on the bottom of the water reservoir No. 1*

1. Due to the water infiltration into the foundation soils, there are uneven settlements of the reservoir foundation. In order to prevent deformations caused by possible subsequent washing of the base soil, grouting works under slab and under foundation,

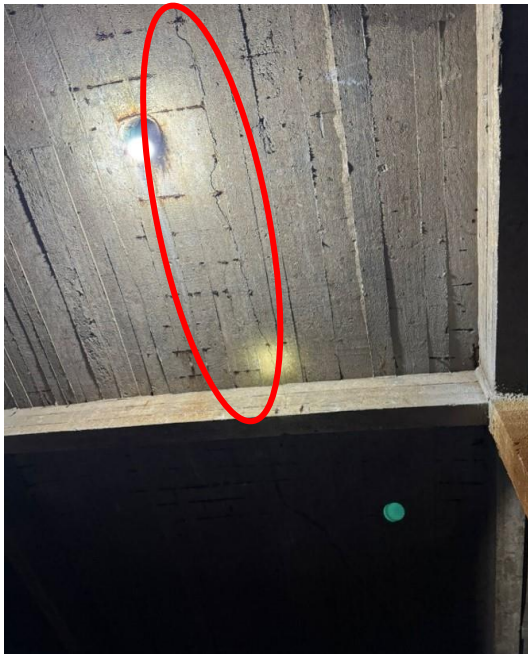
*Photo 3-4 Crack on the beam of the water reservoir No. 1*

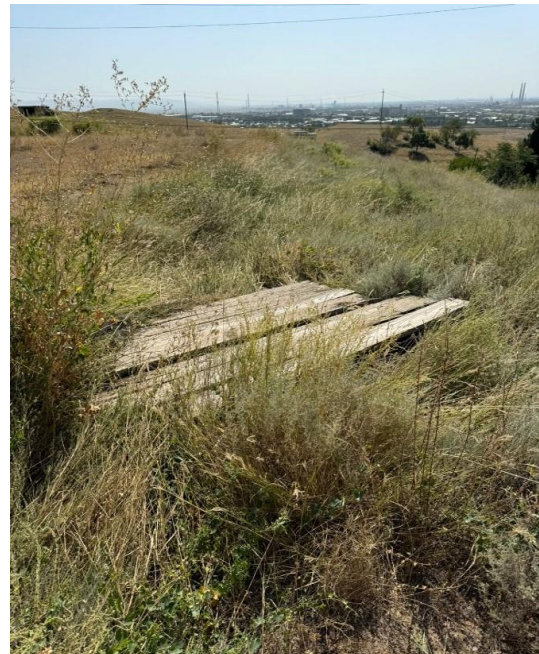
*Photo 3-5 Damaged drainage well*

- should be carried out. Prior to plan grouting works, it is necessary to identify reservoir foundation conditions (physical-mechanical characteristics of the foundation soils).
2. To exclude external factors damaging the reservoir, it is necessary to ensure the guaranteed smooth operation of the drainage system.
  3. Remedial works described in short-term approaches to be performed.

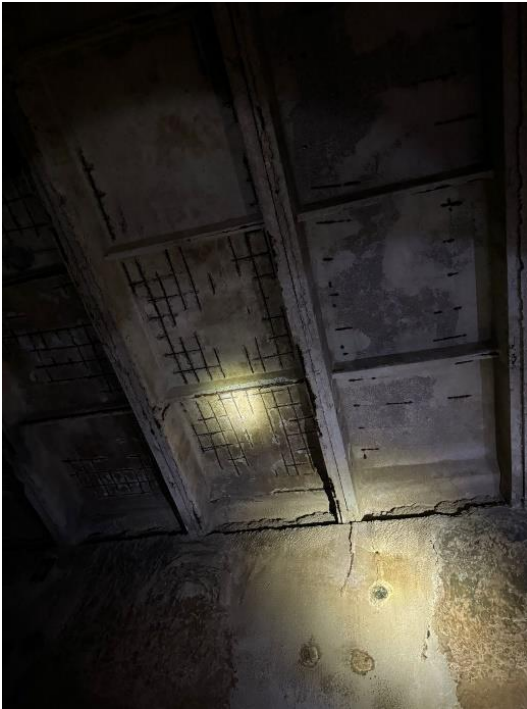
1. On the precast roofing slabs the stripped off reinforcement bars are seen (Photo 3-7).
2. Cracks are observed on the walls and invert of the water reservoir (Photo 3-8).
3. The waterproofing layer is damaged on the inner side of the water reservoir (Photo 3-9).
4. According to the local engineers information, the Ø300 mm drain pipe of the reservoir is damaged and not operational (Photo 3-10).

Photo 3-7 Damaged roofing tile of water reservoir No. 2

1. Cleaning and treatment of the stripped reinforcement bars of reservoir structures with anti-corrosion material.
2. Treatment of cracks on reservoir walls and invert should be carried out according to the degree of damage and opening width.
3. After the treatment of the cracks, the layer of reinforced mortan should be arranged on the water reservoir invert.
4. A new insulating layer should be arranged on the invert and walls with a waterproofing material, applicable for drinking water reservoirs.
5. The damaged Ø300 mm drain pipe of the reservoir should be replaced.

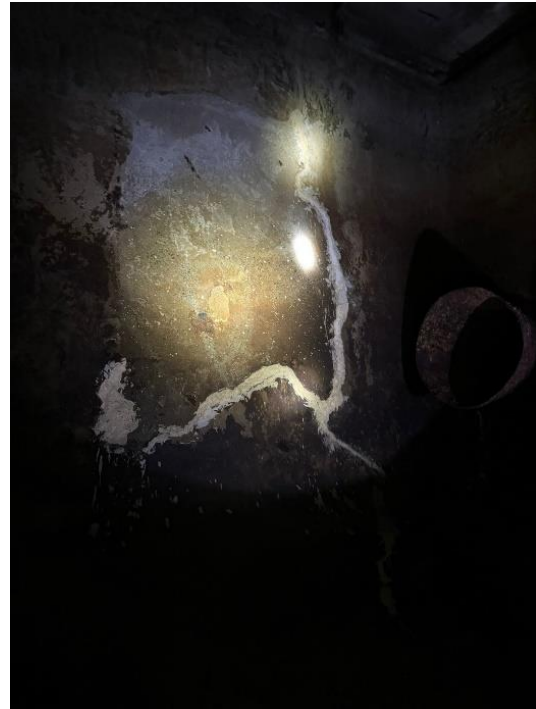
Photo 3-8 Cracks on the walls of water reservoir No. 2

1. Due to the water infiltration into the foundation, there are uneven settlements of the reservoir foundation. To prevent deformations caused by possible subsequent washing of the base soil, grouting works under slab and foundation, should be carried out.

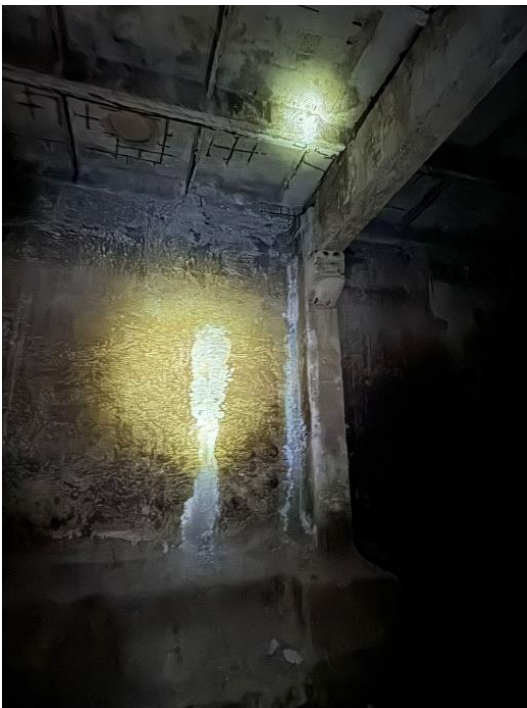
Photo 3-9 Damaged waterproofing layer of the water reservoir No. 2

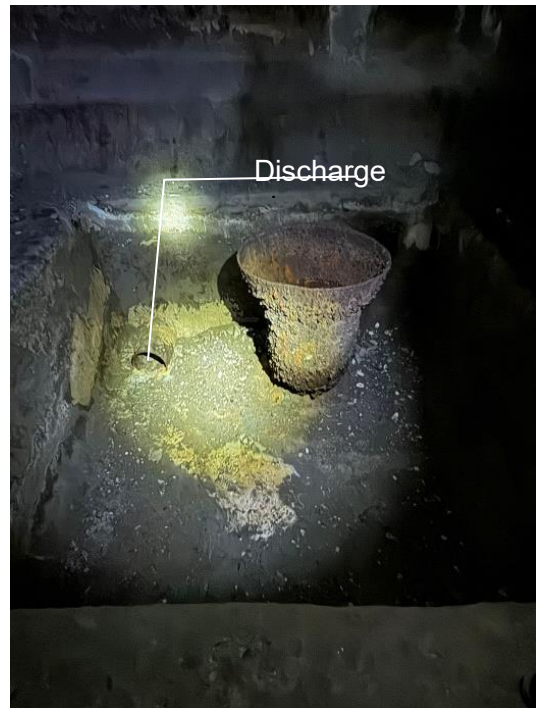
Photo 3-10 Damaged drain pipe of the water reservoir No. 2
