Inspection of the technical condition of the Tbilisi Mall facade
Contract No. 01/12-2025 dated 02.12.2025

01/12-2025-TR		
		Sheet	No. doc	Signed	Date			
Director		Savchenko			01.2026	Inspection of the technical condition of the Tbilisi Mall facade		
Engineer		Shuranov			01.2026			
							Stage	Page
								Pages
								2 75

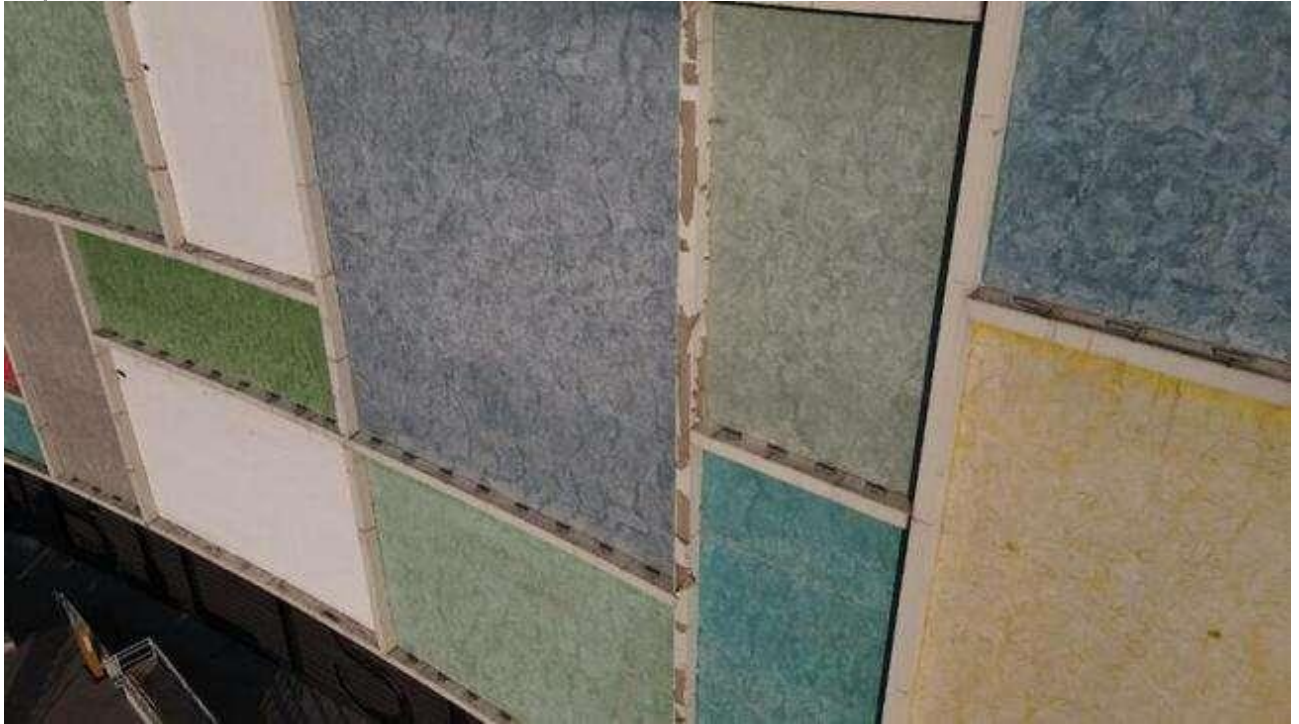
Figure 5.1.9. General view of the facade. Damage to the finishing layer of the impostes

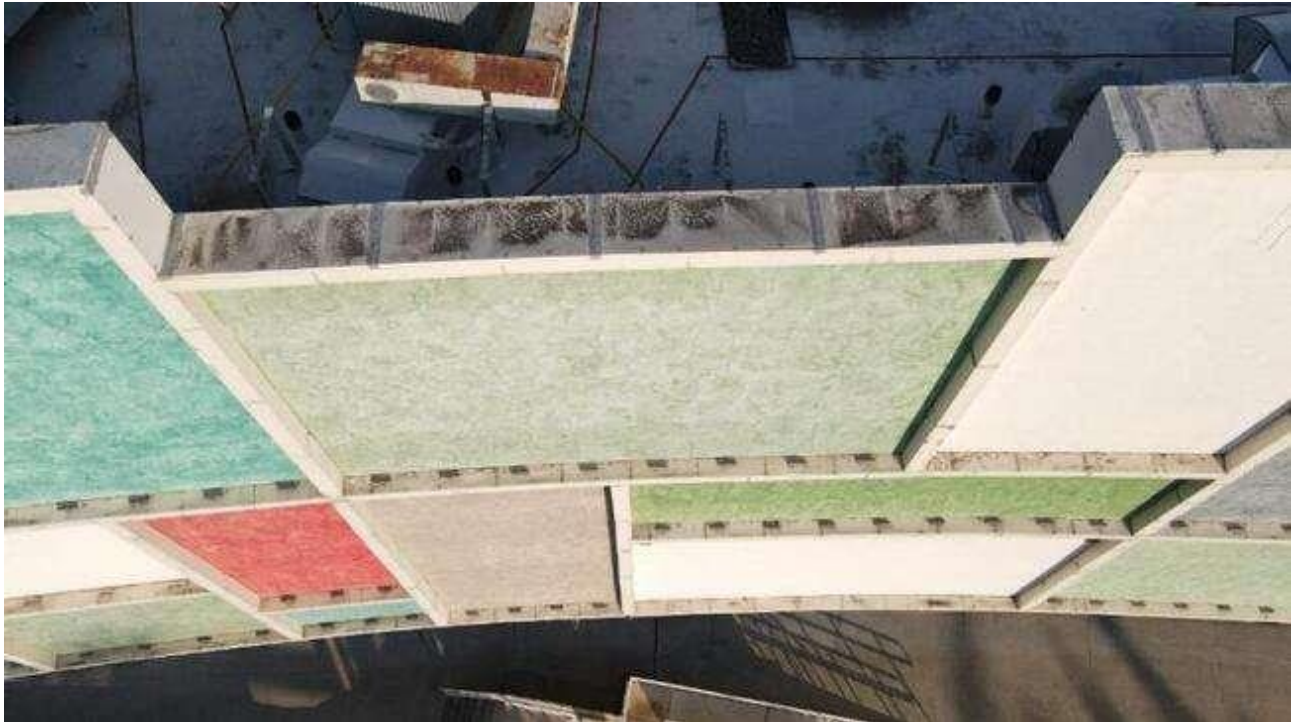
Figure 5.1.10. Drip molding along the upper edge of the facade. The joints of the drip molding are treated with sealant

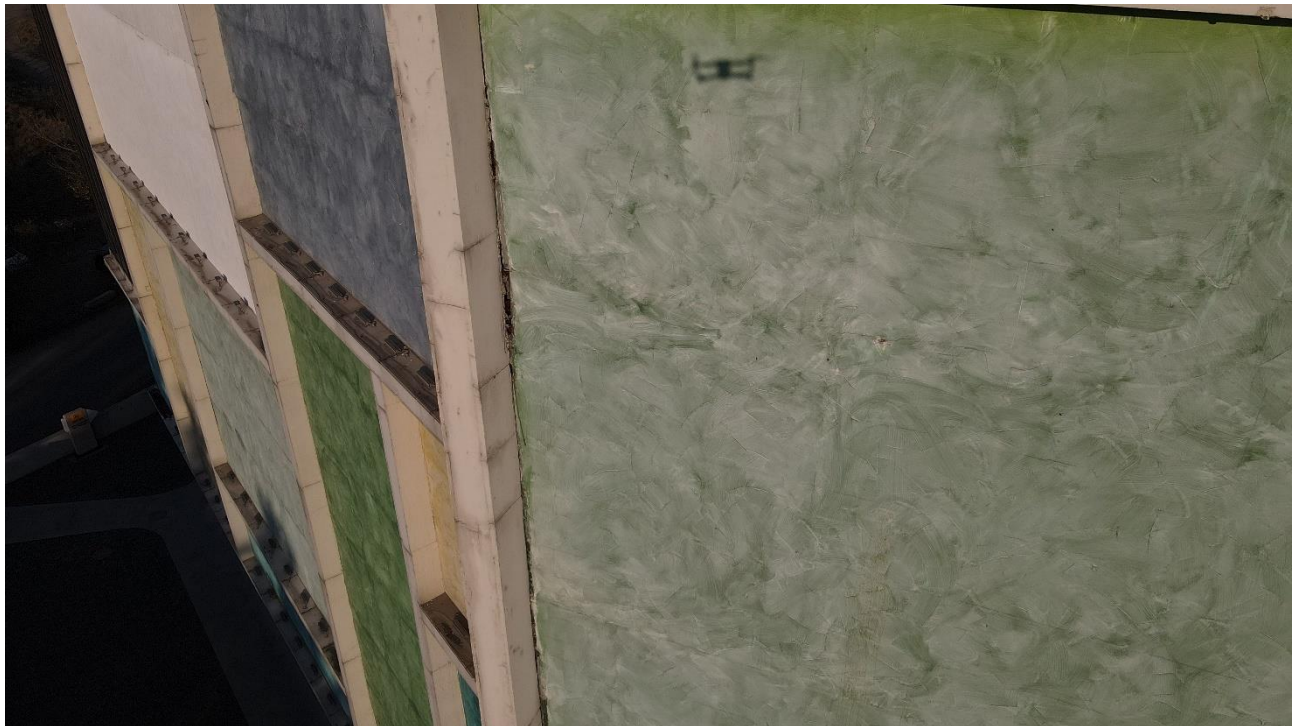
Figure 5.1.12. Damage to the junction between wall insulation and vertical jamb

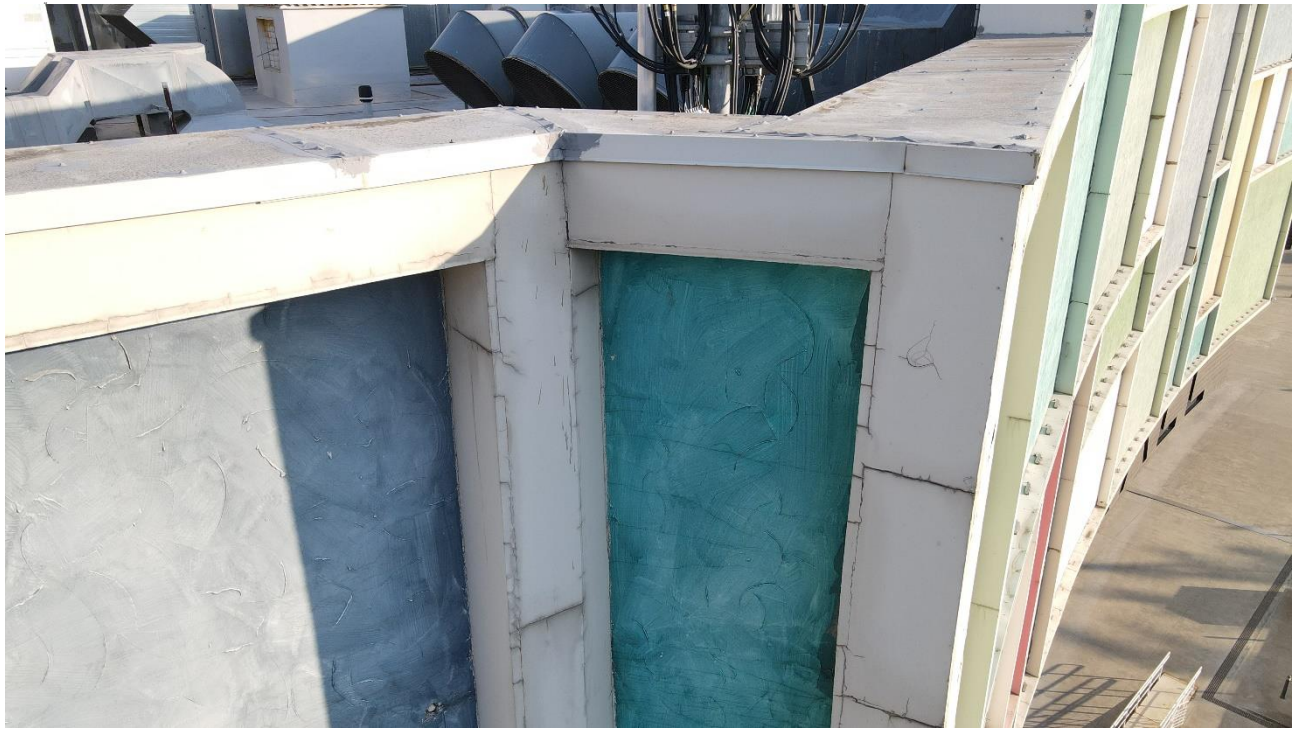
- Numerous (covering more than 10% to 40%) minor defects in the form of destruction of the finishing layer of the facade pilasters. This widespread defect is located on the side of maximum wind loads on the north side. Reinforced facade glass mesh is not used in the construction of the pilaster finish.

Figure 5.1.1 2. Cracks in the finishing layer of vertical imposts

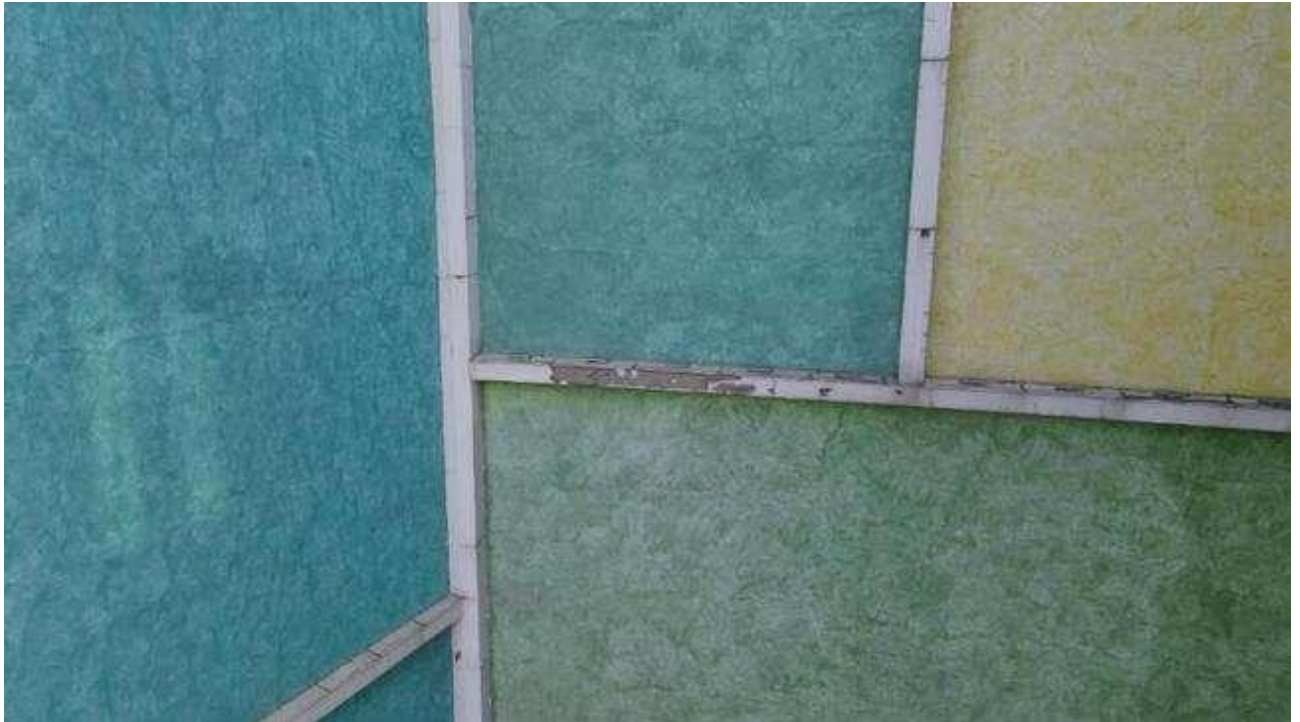
Figure 5.1.13. Damage to the finishing layer of imposts

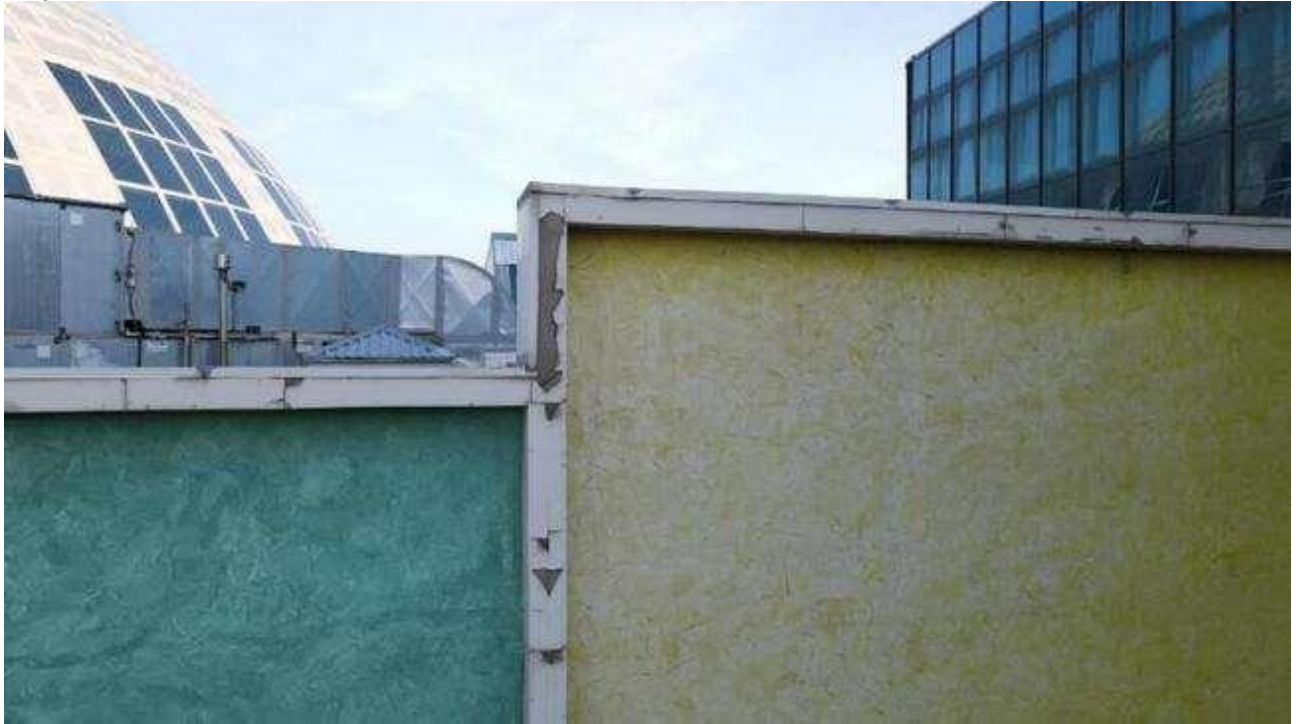
Figure 5.1.14. Damage to the finishing layer of imposts

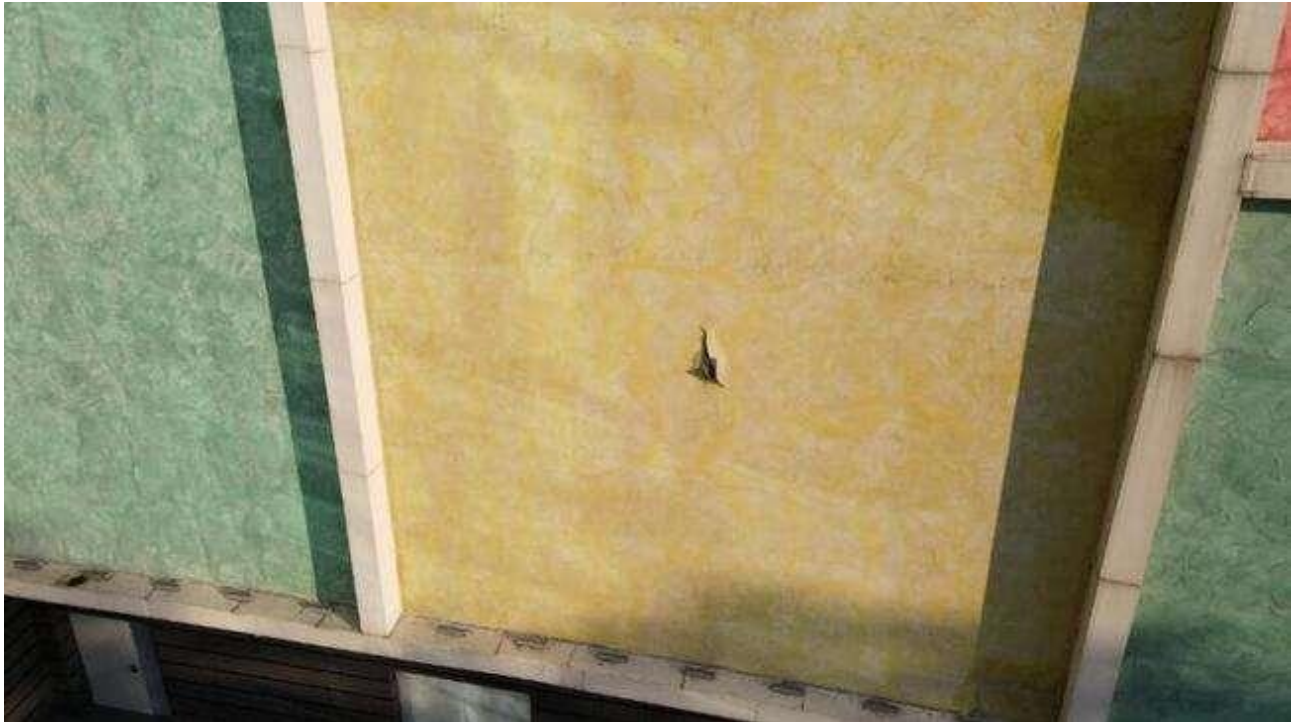
Figure 5.1.15. Localized damage to the PPS insulation layer

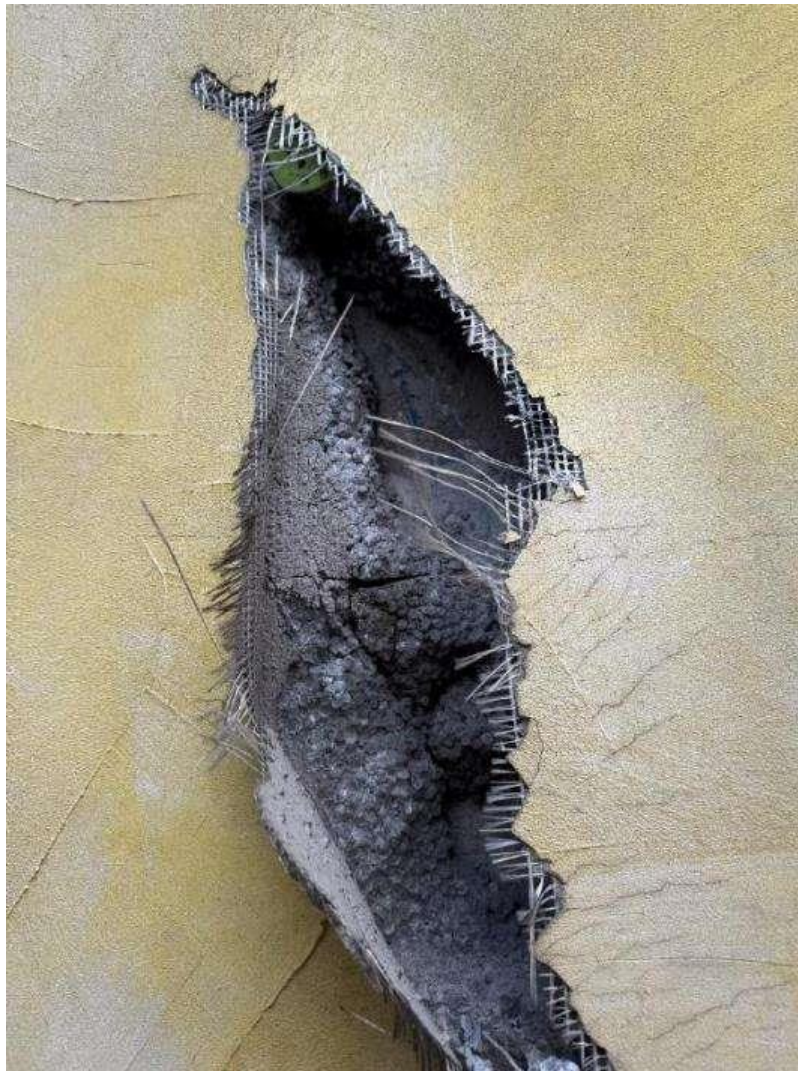
Figure 5.1.16. Localized damage to the PPS insulation layer

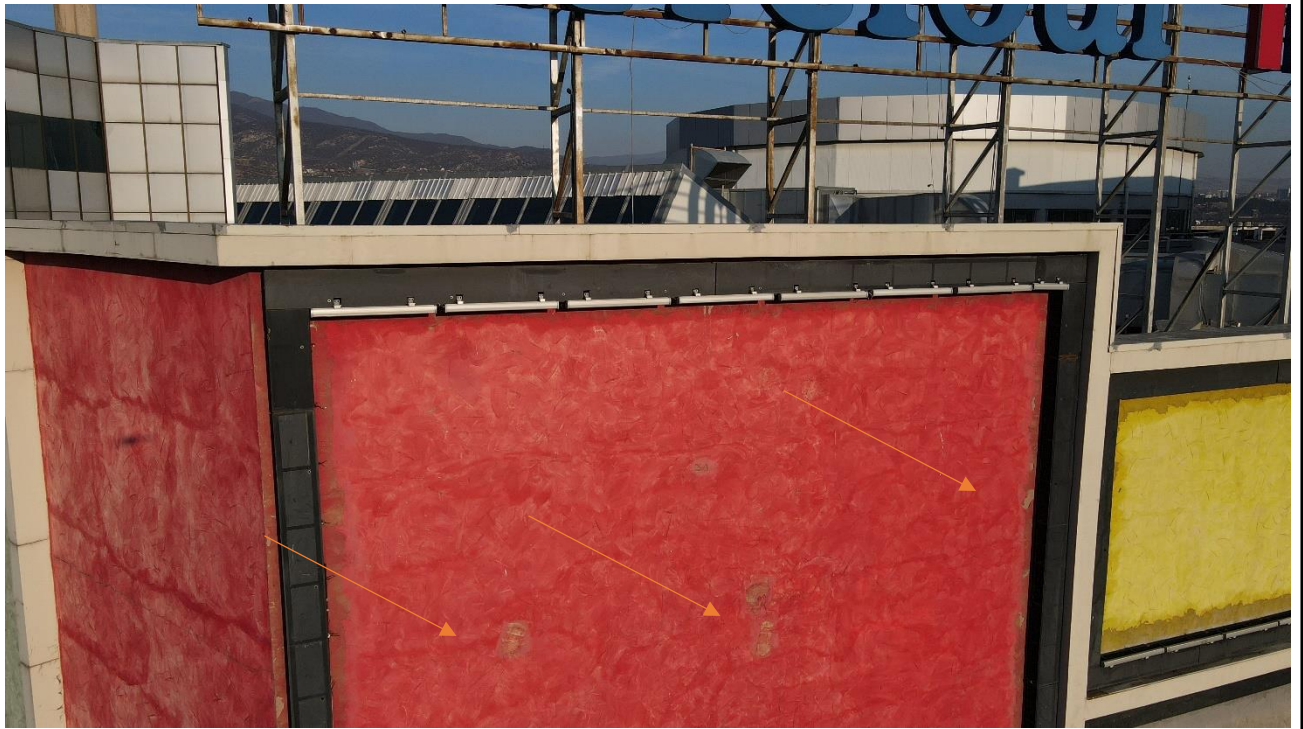
Figure 5.1.18. Space for a banner. Areas of facade damage

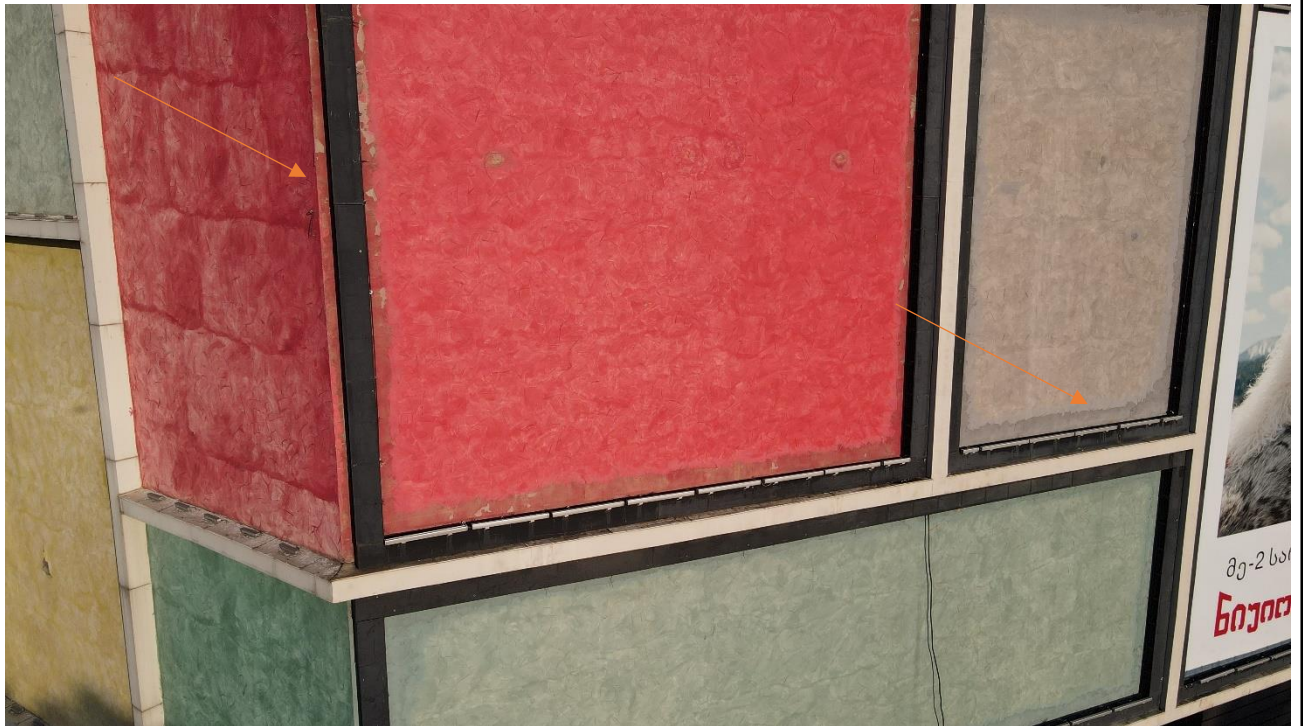
Figure 5.1.19. Space for a banner. Areas of facade damage

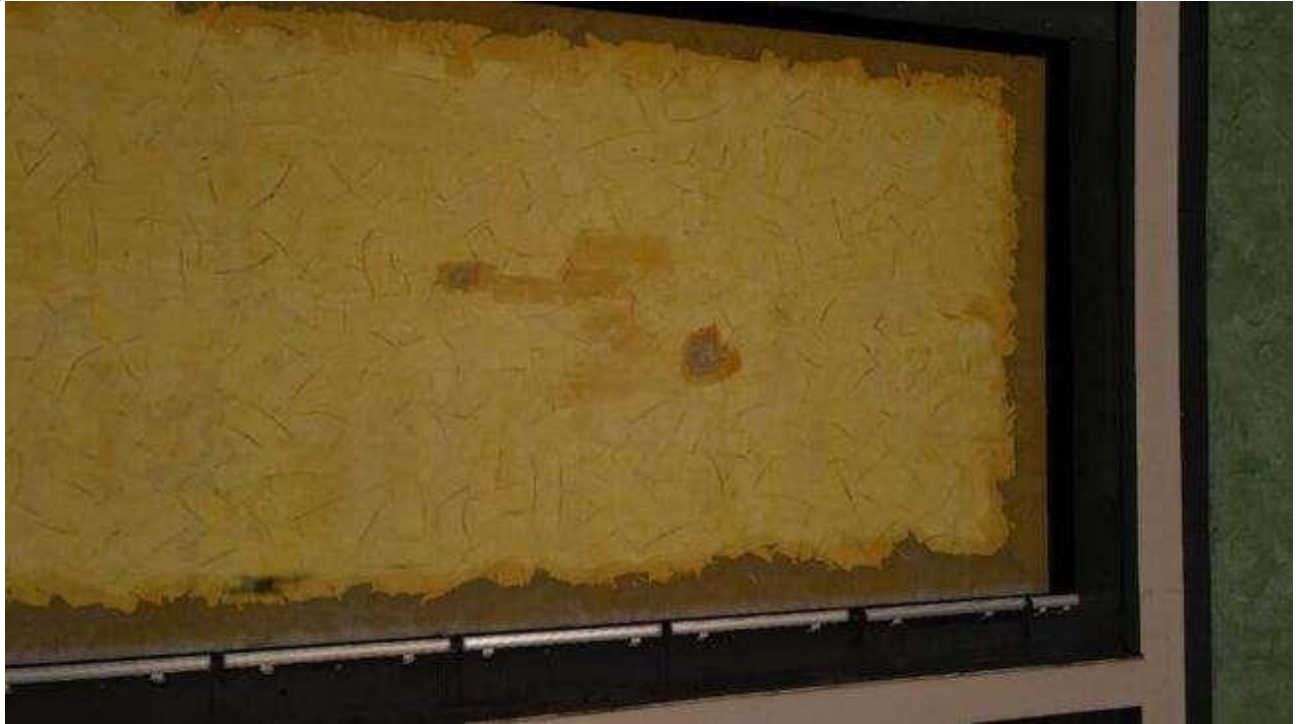
Figure 5.1.20. Space for a banner. Areas of facade damage

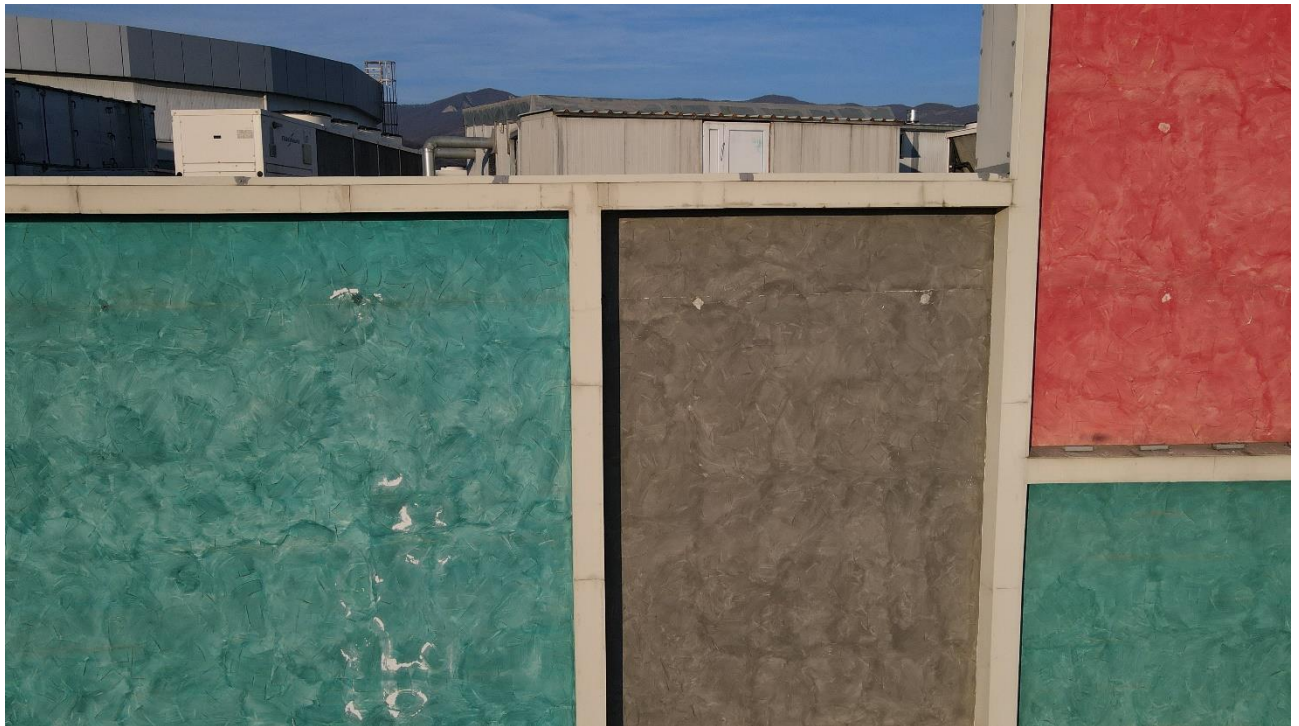
Figure 5.1.23. Areas of damage to the finishing layer

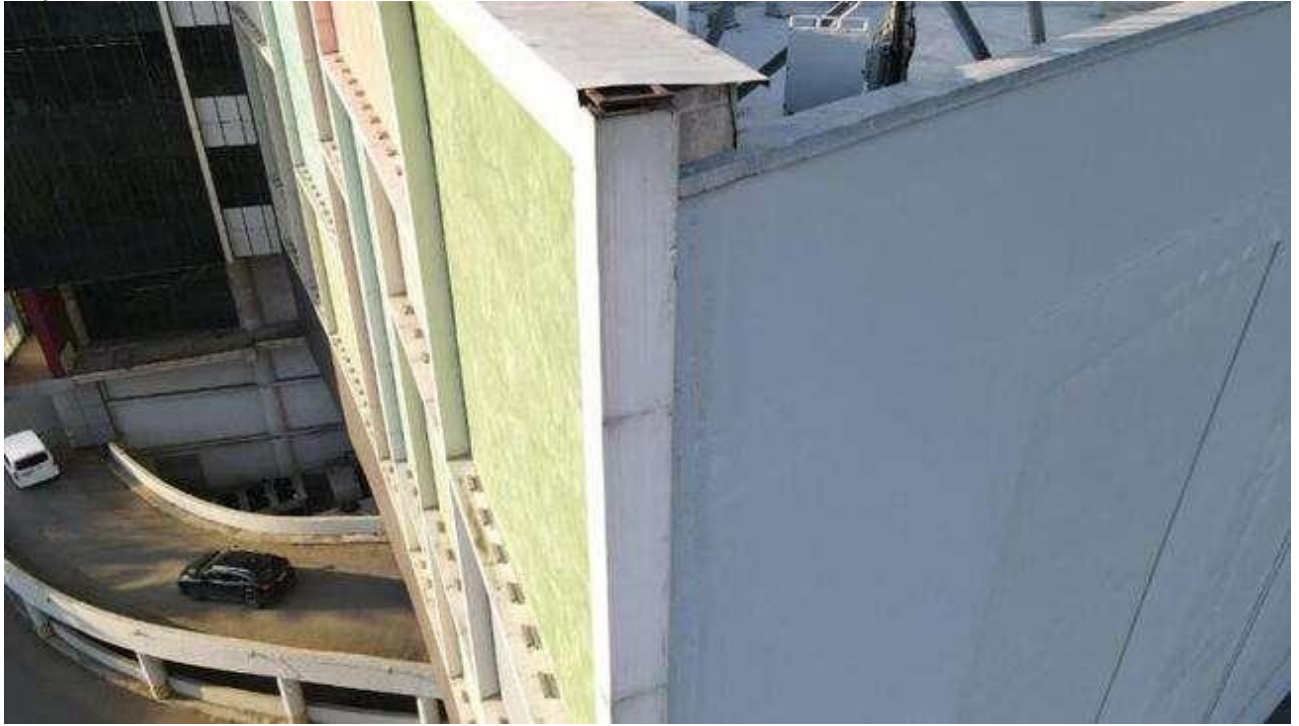
Figure 5.1.24. Facade junction along axis 1/C. Insufficient parapet overhang

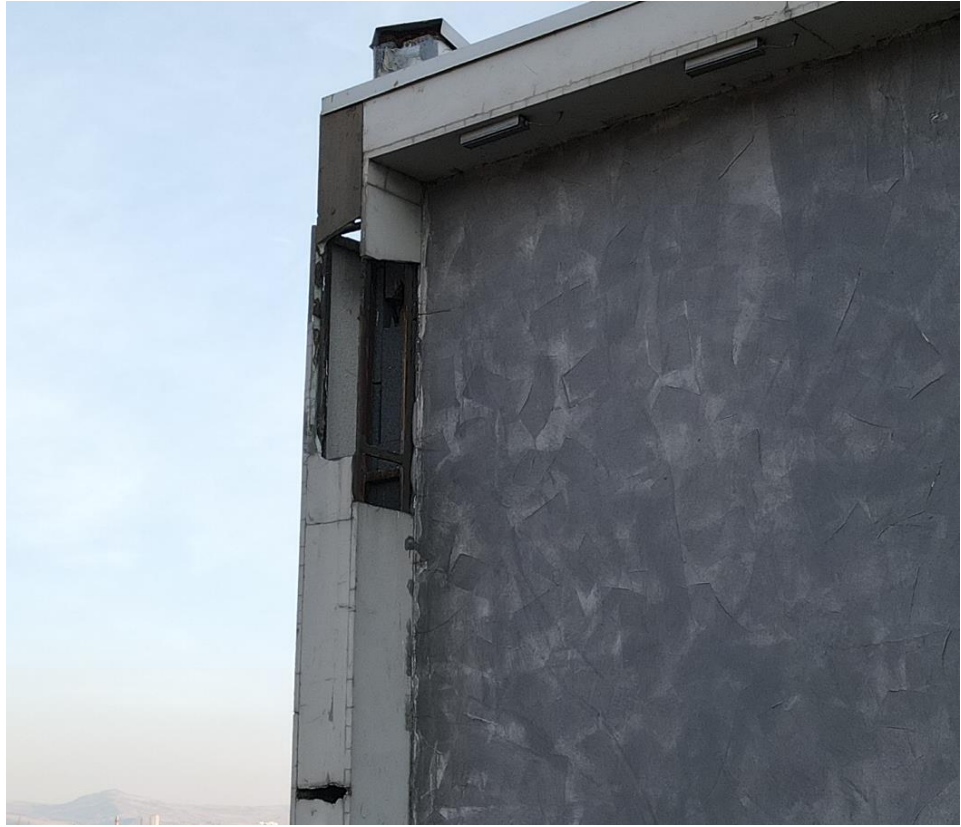
Figure 5.1.25. Destruction of vertical impost. Corrosion of steel impost frame along axis 6/C

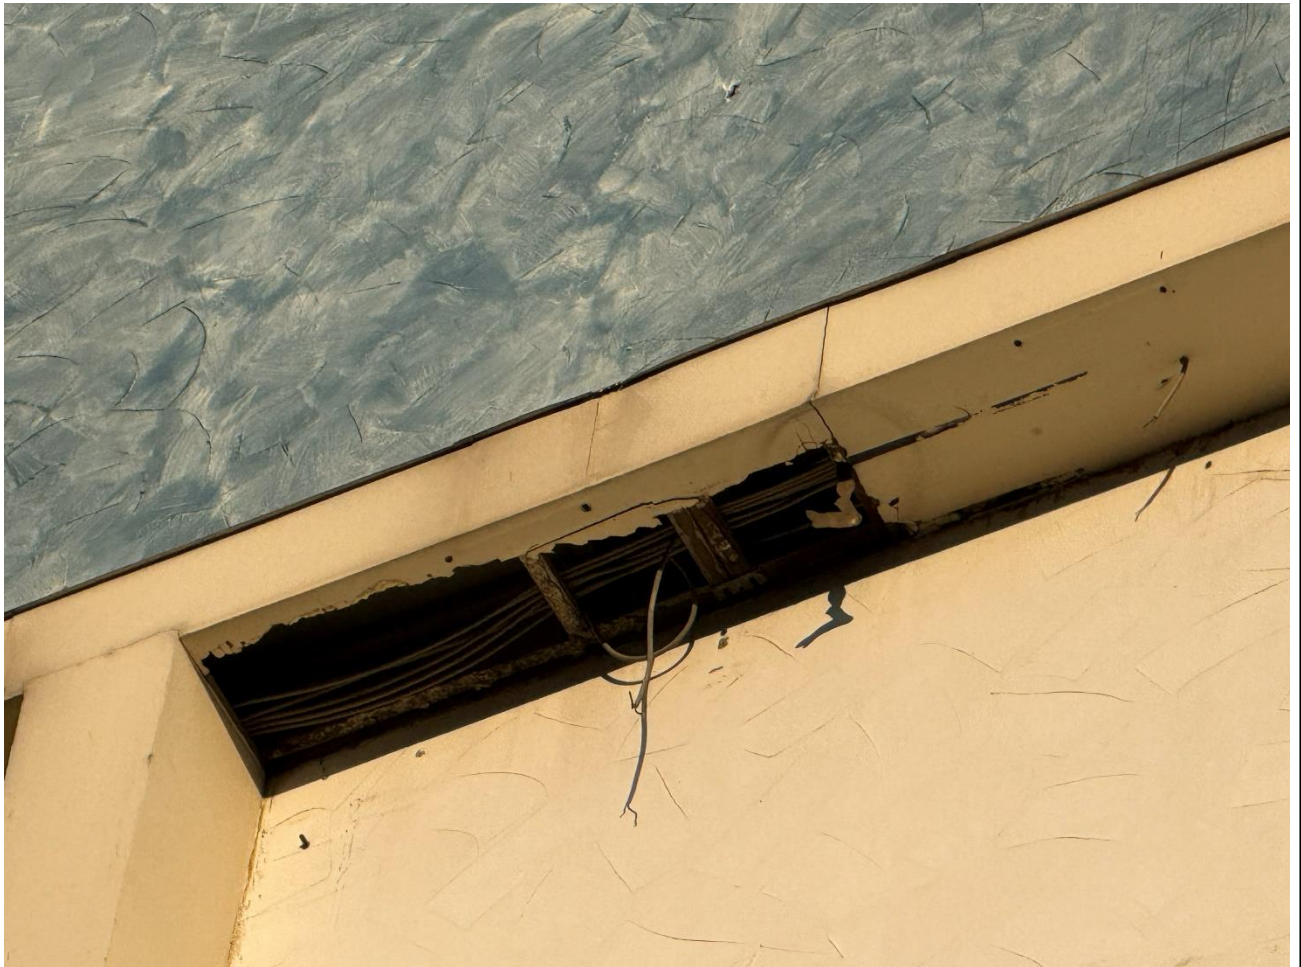
- Massive (more than 40%) minor defects in the form of surface corrosion of the metal frame of the pilasters. This defect is caused by partial destruction of the protective and finishing layer of metal;

Figure 5.1.26. Destruction of the horizontal impost. Corrosion of the steel frame of the impost

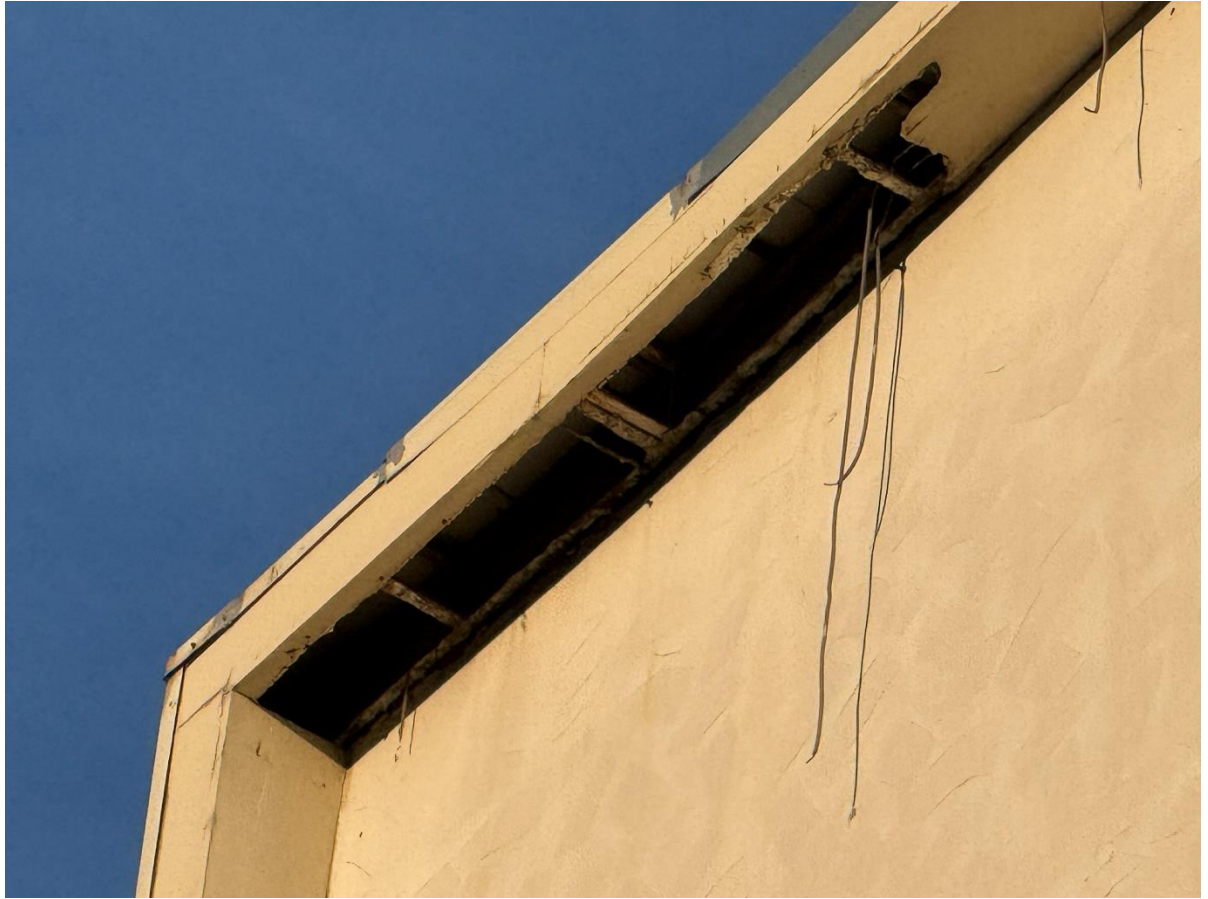
Figure 5.1.27. Destruction of the horizontal impost. Corrosion of the steel frame of the impost

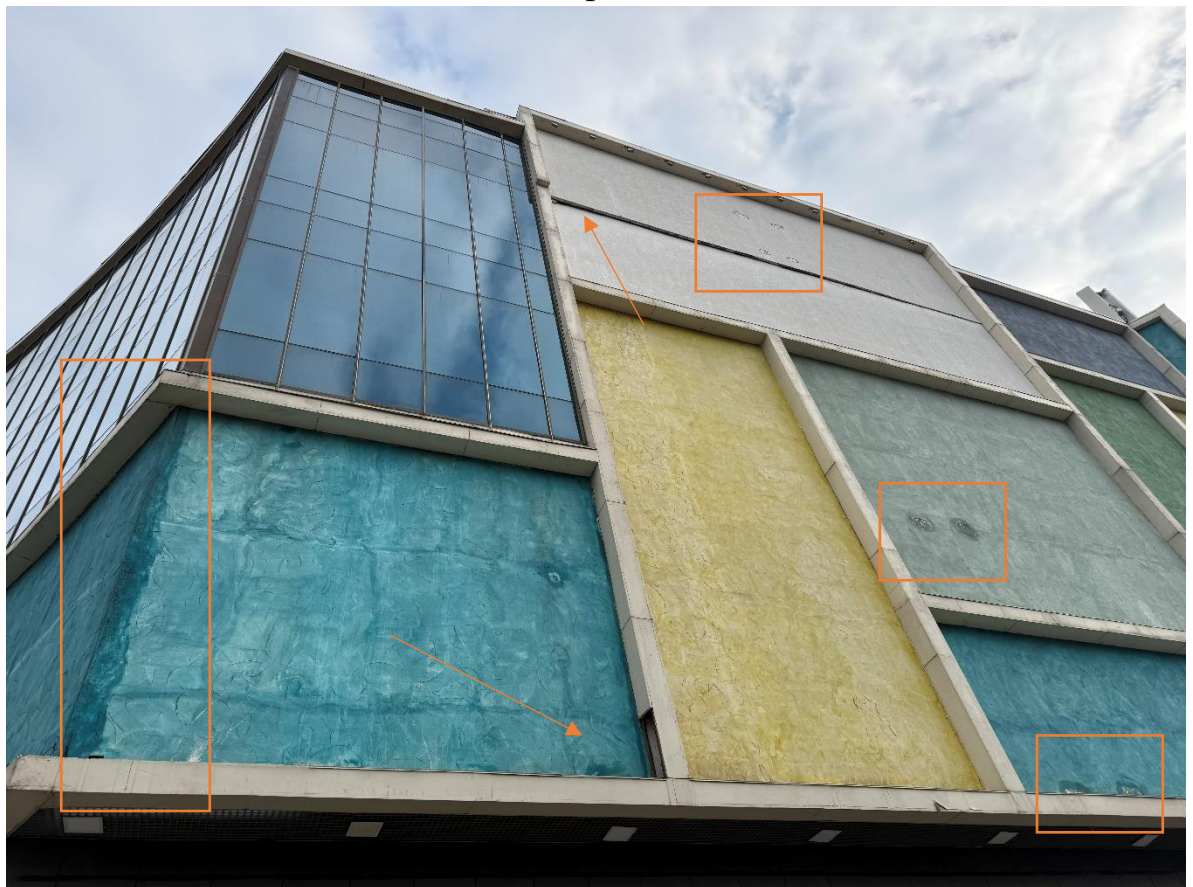
Figure 5.1.28. Areas of facade damage. Unsatisfactory facade construction (insulation delamination). Damage to the impost.

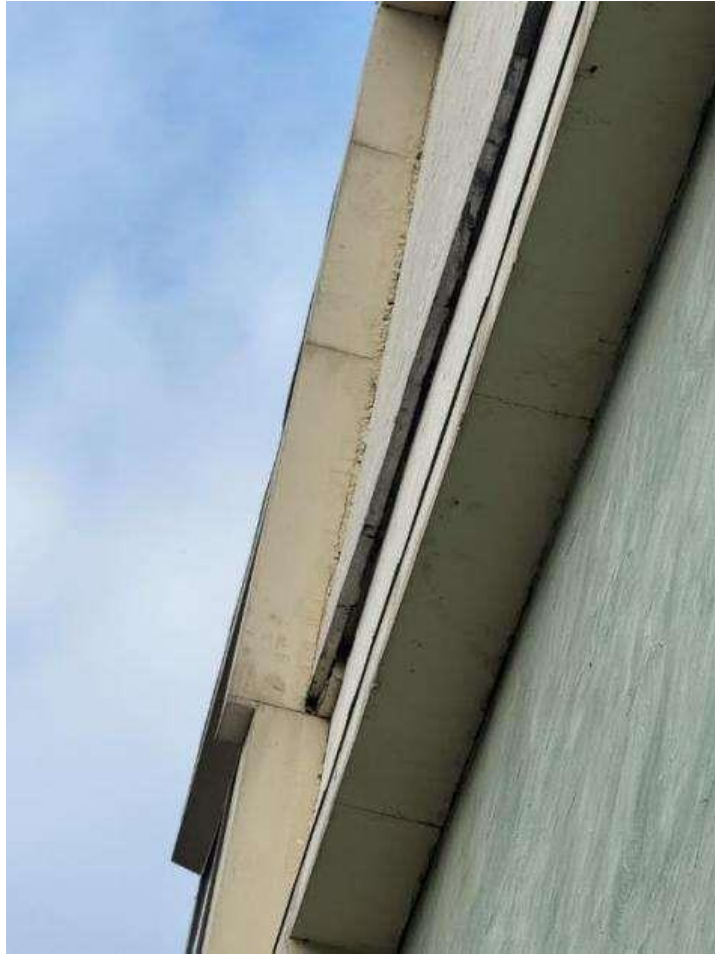
- isolated (up to 10%) significant defects in the form of detachment of the insulating layer from the wall and the formation of stress cracks; this defect is located in A-B/1 and 5-6/A. This defect arose due to the unevenness of the bonding base (exceeding Table 1) and insufficient mechanical fastening.

Figure 5.1.29. Lack of insulation layer adhesion along axis 5-6/A

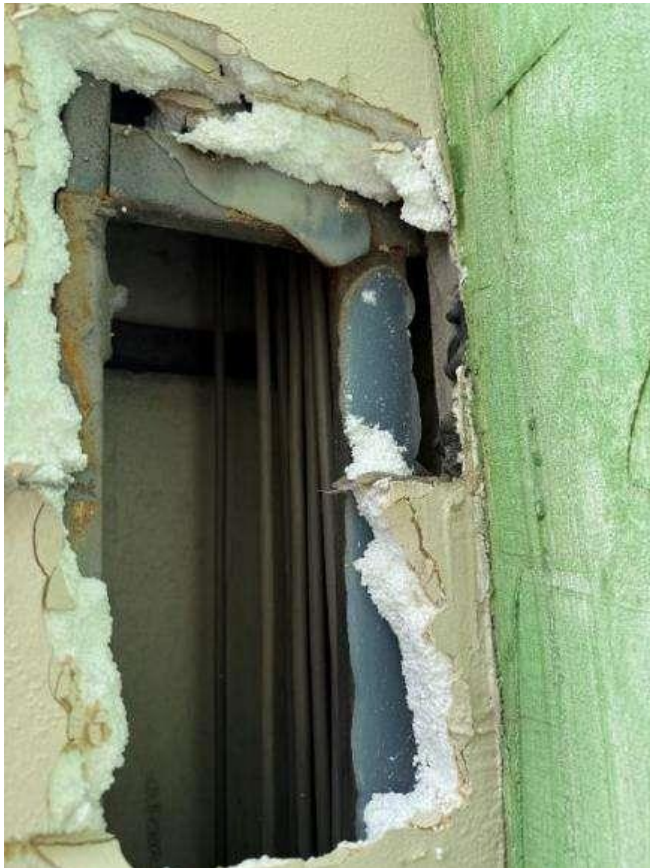
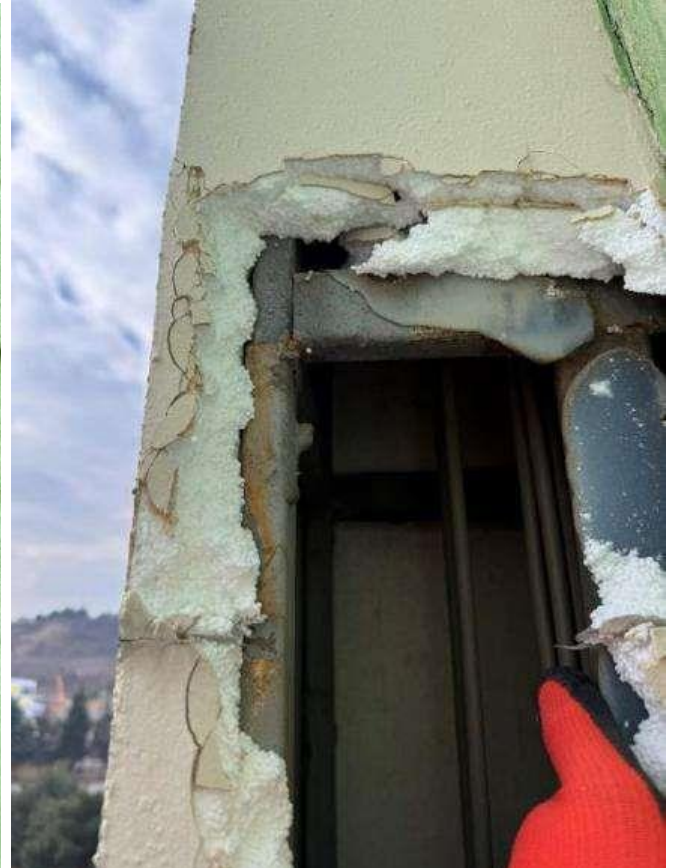
- isolated (up to 10%) significant defects in the form of cracks and breaks in the pilaster cladding (expanded polystyrene panels). This defect is caused by poor-quality fastenings (adhesive), without the use of mechanical fastenings and facade glass mesh;

Figure 5.1.32. Opening of the vertical impost. Areas of adhesive bonding (non-continuous). This method of fastening is not standardized; similar solutions must also be mechanically fastened due to the small contact area

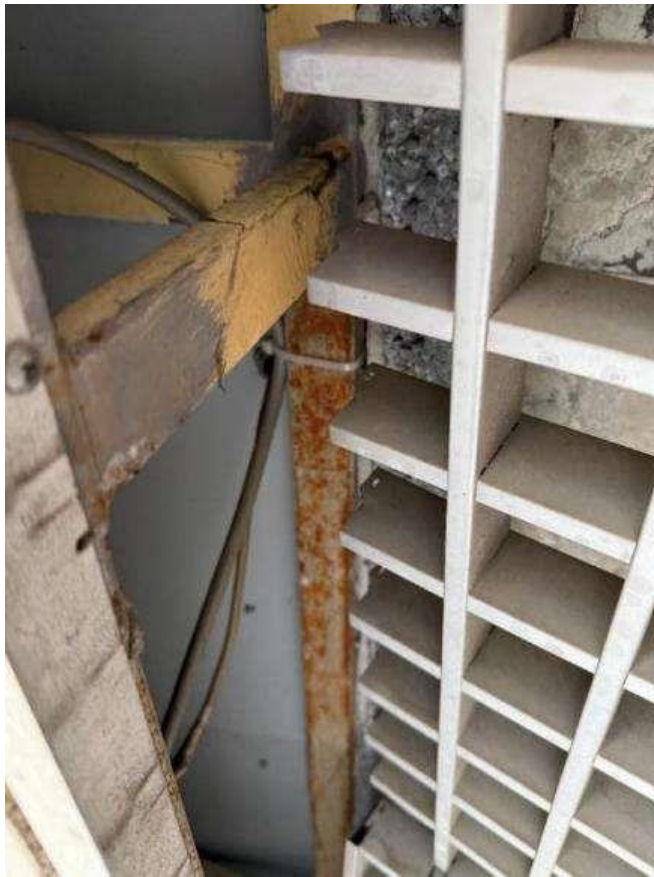
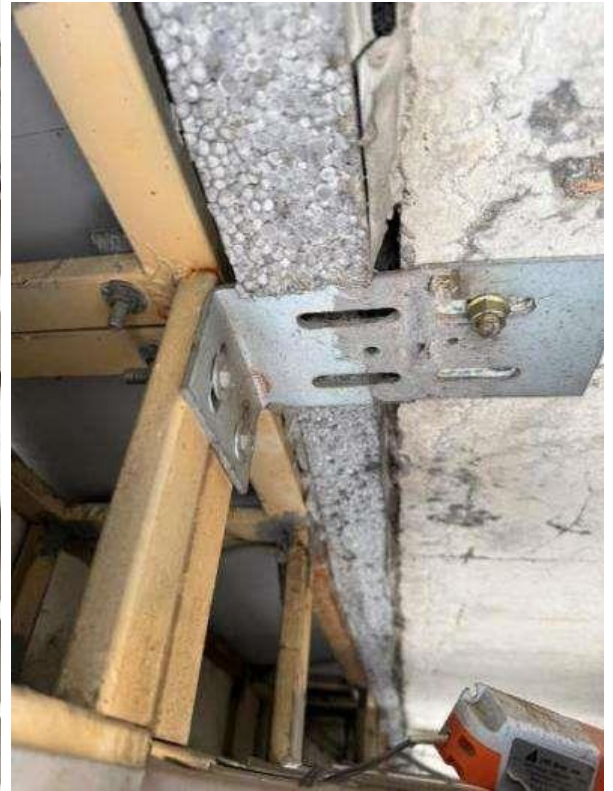
- Massive (more than 40%) minor defects in the form of the absence of a support (starting profile). Due to the absence of a project, this work could not have been included in the initial project because there was no strict requirement in the regulatory documents.

Figure 5.1.35. Fastening of the impost frame to the slab at elevation +6.000. Corrosion of frame elements. Lack of a support profile for the insulation. Non-continuous gluing of the insulation

7.1.4. When making decisions on major repairs by the Client, the General Designer shall consider the need to install the starting profile in accordance with the adopted facade system to ensure the geometric stability of the lower and subsequent rows of insulation and to improve the operational reliability of the facade. The scope of this work is 681 linear meters. The final decision will be made based on the design documentation.

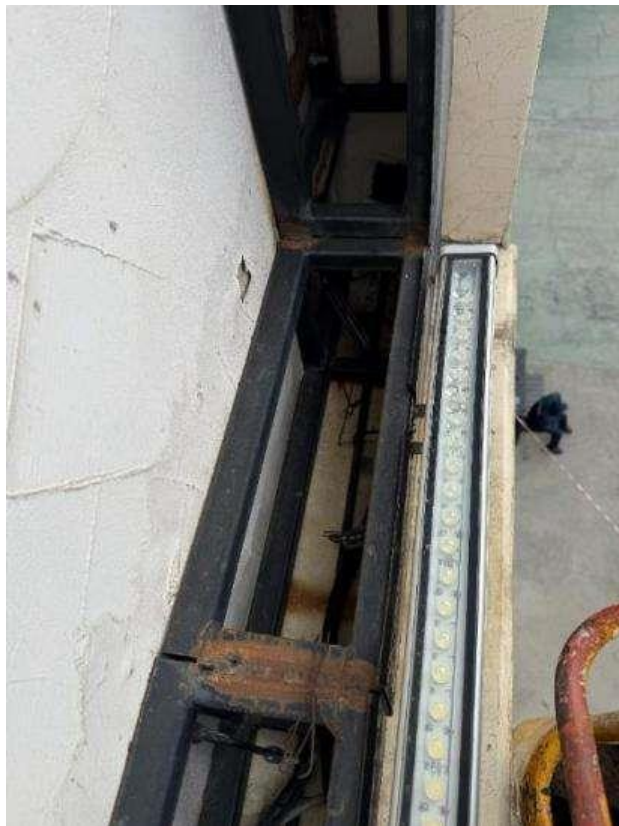
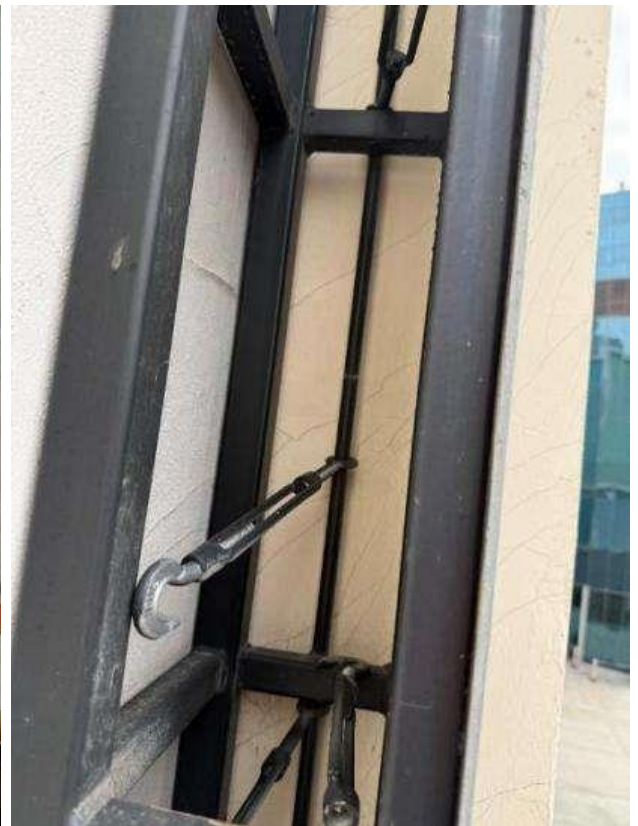
Figure 5.1.36. Frame for placing banners. Talpers in the frame structure. Corrosion of welded joints

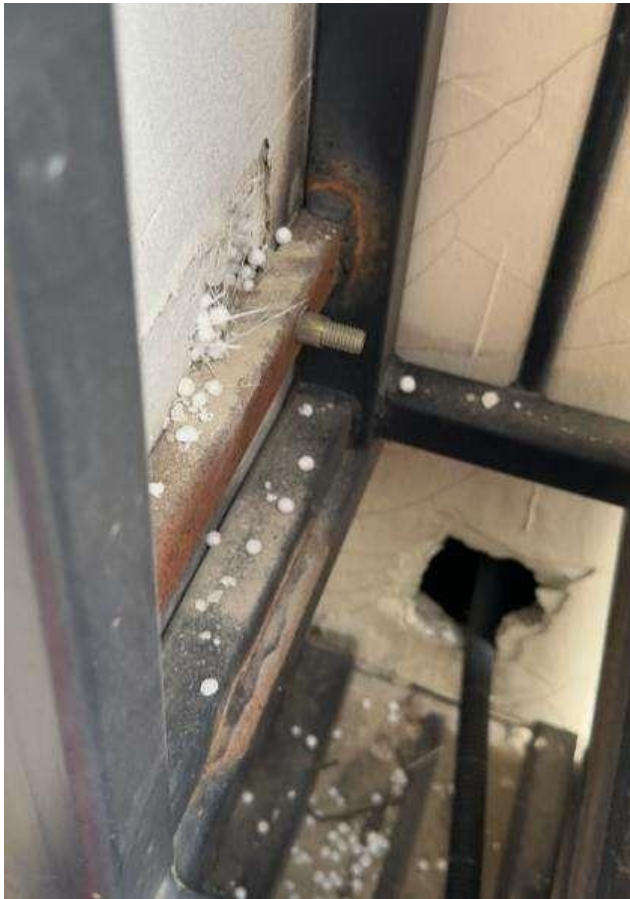
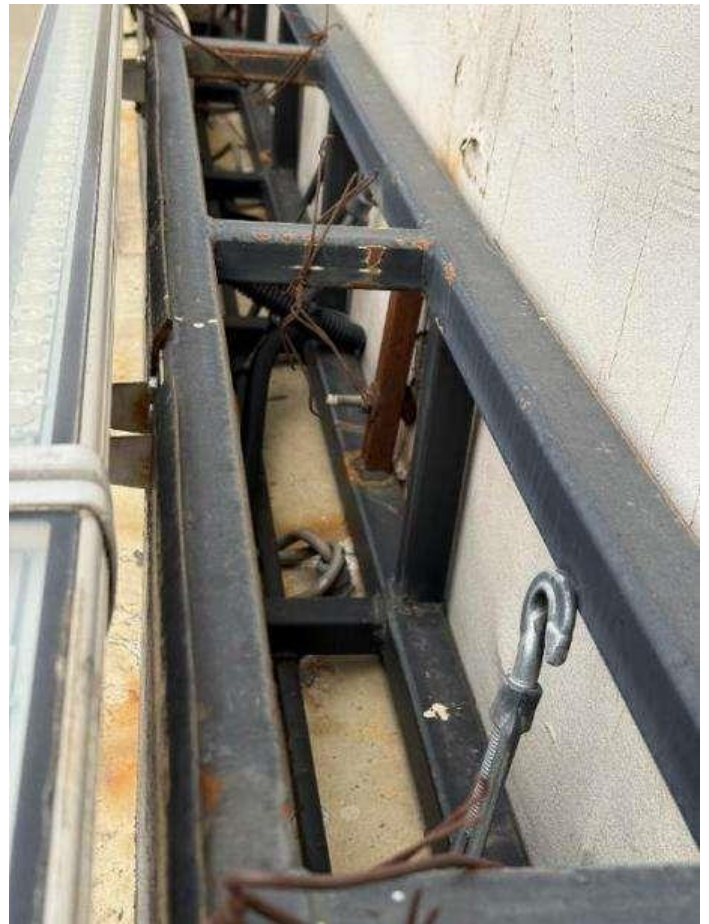
- isolated (up to 10%) significant defects in the form of missing nuts or insufficient tightening of nuts securing steel frames to the wall;

Figure 5.1.37. Fastening of the frame for placing banners. Lack of a clamping nut on the fastener
