Inspection of the technical condition of the Tbilisi Mall facade
Contract No. 01/12-2025 dated 02.12.2025

01/12-2025-TR		
		Sheet	No. doc	Signed	Date			
Director		Savchenko			01.2026	Inspection of the technical condition of the Tbilisi Mall facade		
Engineer		Shuranov			01.2026			
							Stage	Page
								Pages
								2 75

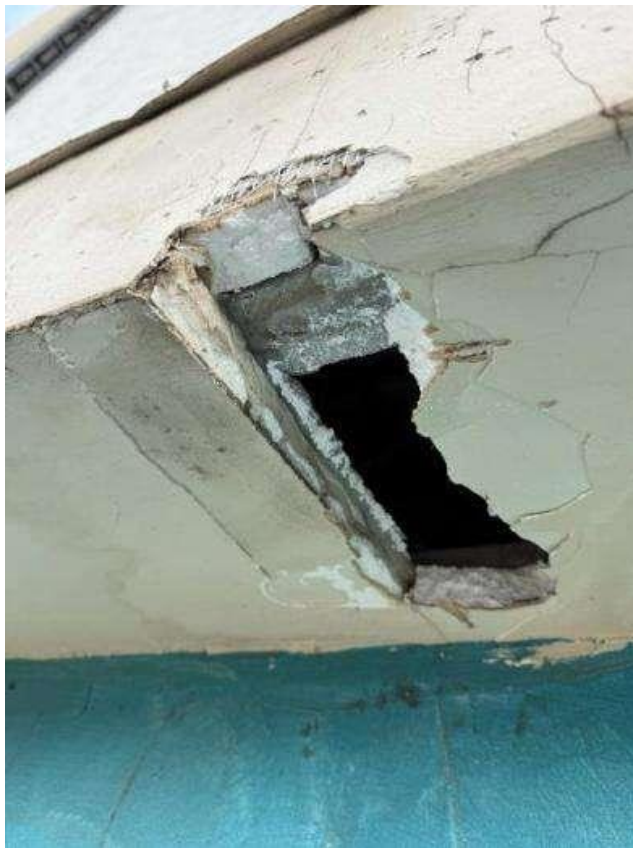
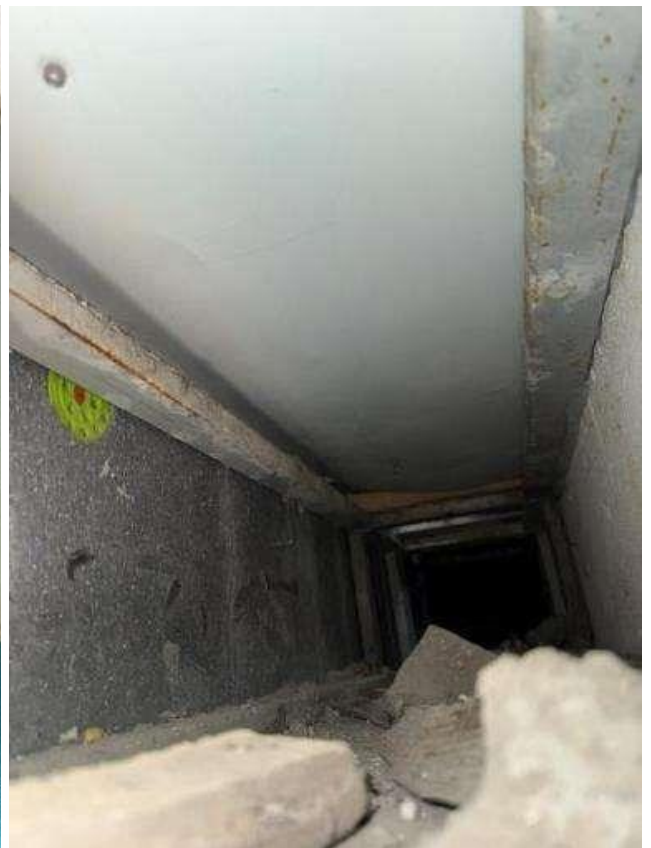
Figure 5.1.38. Opening of the horizontal impost. Areas of surface corrosion

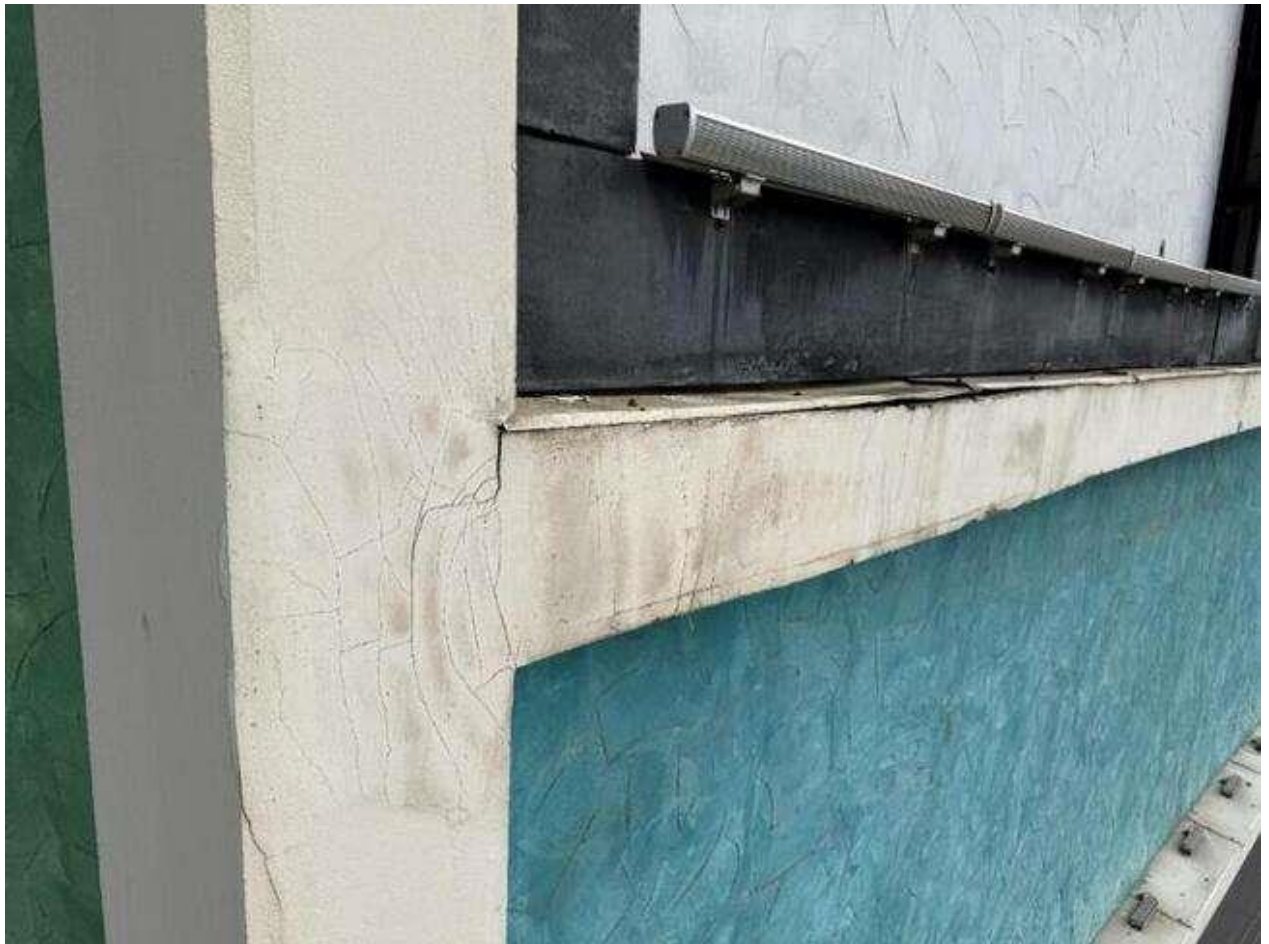
Figure 5.1.39. Cracks in the finishing layer of the horizontal impost

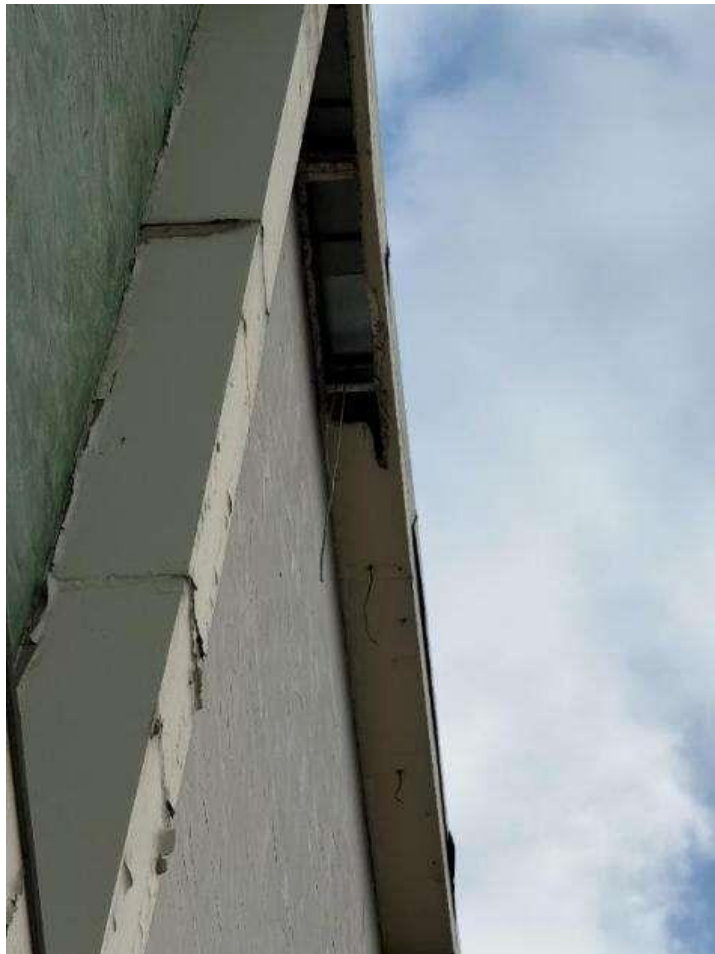
Figure 5.1.45. Destruction of the horizontal impot. Corrosion of the steel frame

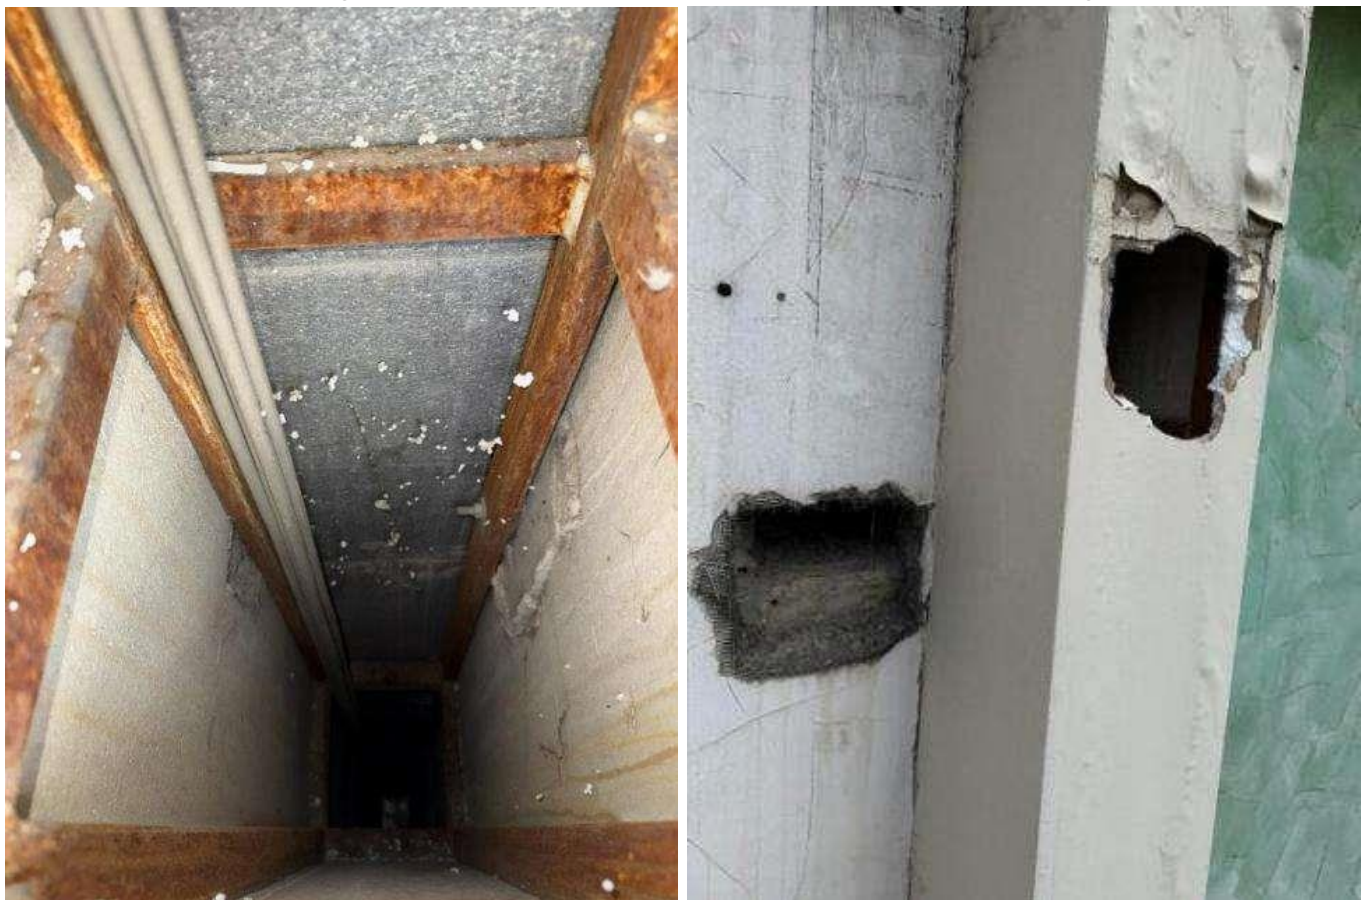
Figure 5.1.47. Corrosion of the building impost frame

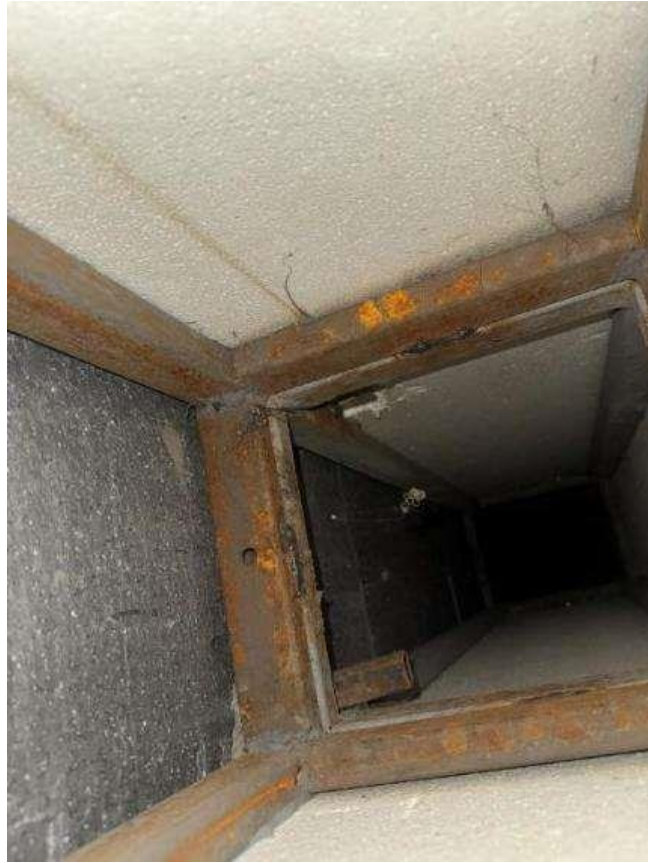
Figure 5.1.52. Corrosion of the impost frame

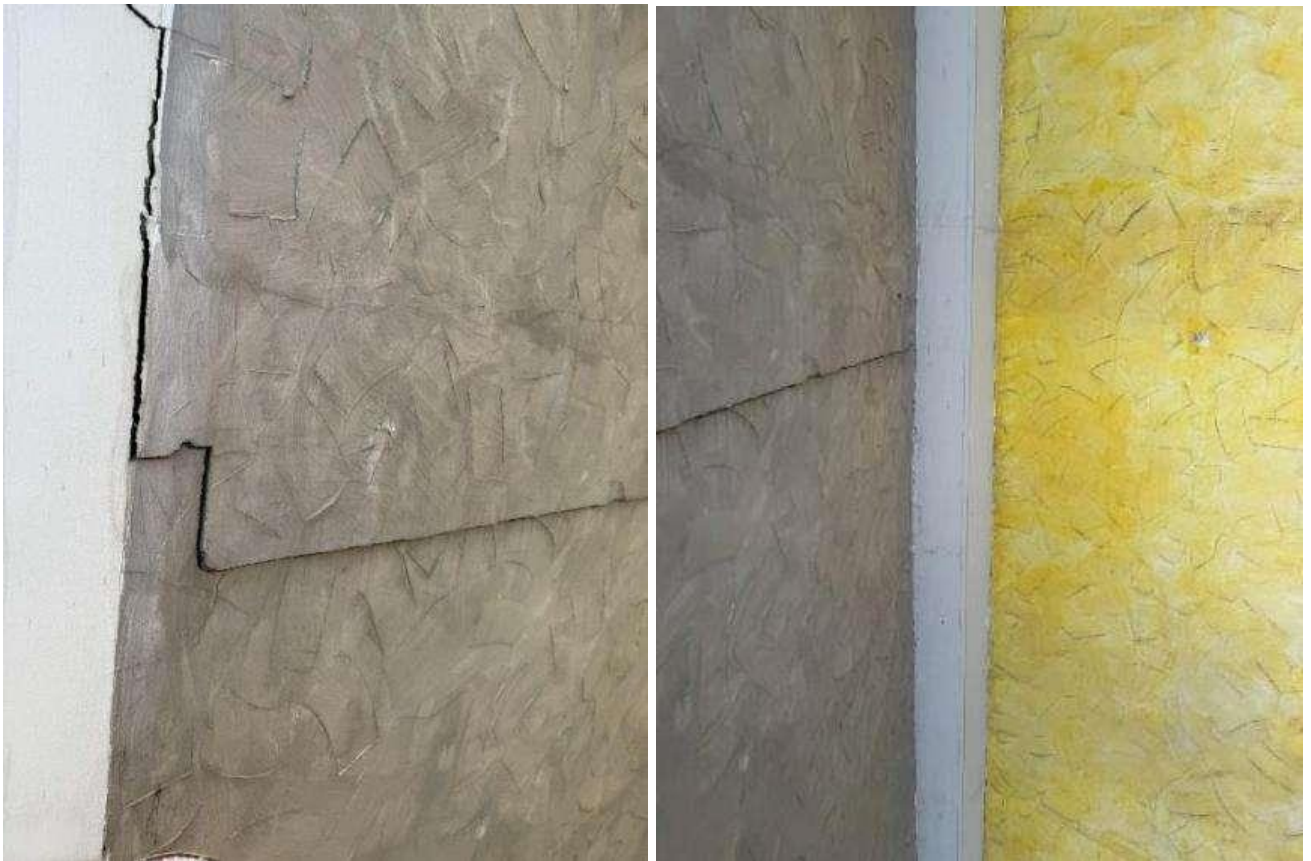
Figure 5.1.53. Crack on the facade of the building. Delamination of the insulation layer. This defect was caused by an uneven foundation and installation defects.

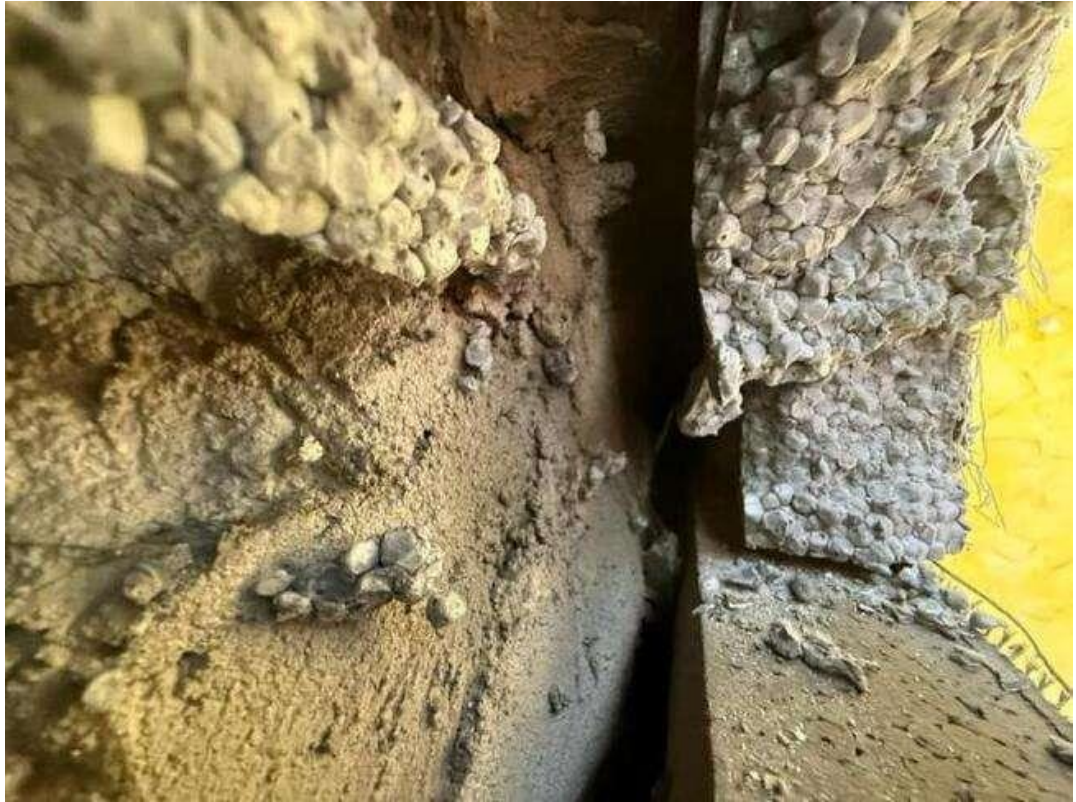
Figure 5.1.54. Gap up to 50 mm between the insulation and the wall

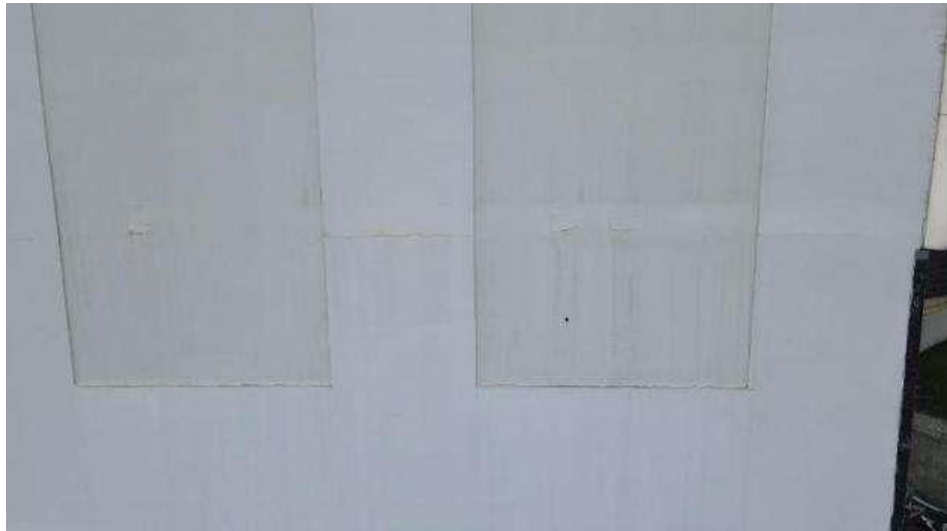
Figure 5.1.56. Cracks in the plaster layer of the lightweight insulation system in axes 1-6/C

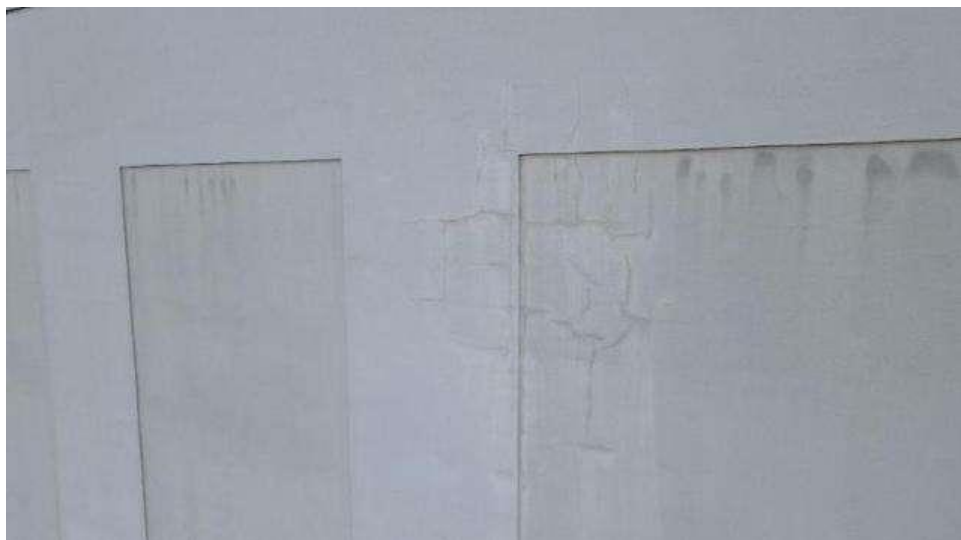
Figure 5.1.57. Cracks in the plaster layer of a lightweight insulation system

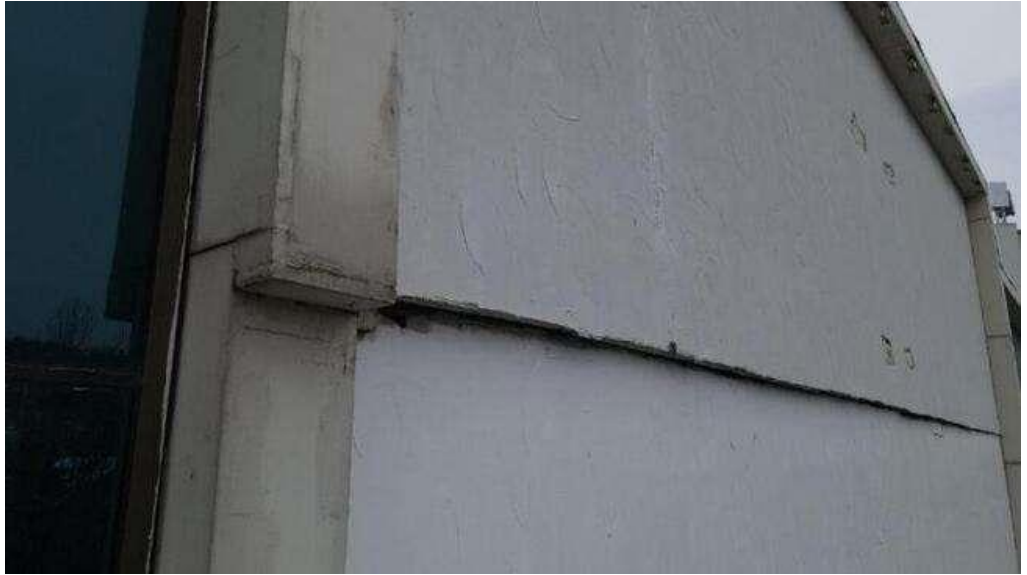
Figure 5.1.61. Crack on the facade of the building in axes 5-6/A. Delamination of the insulation layer.

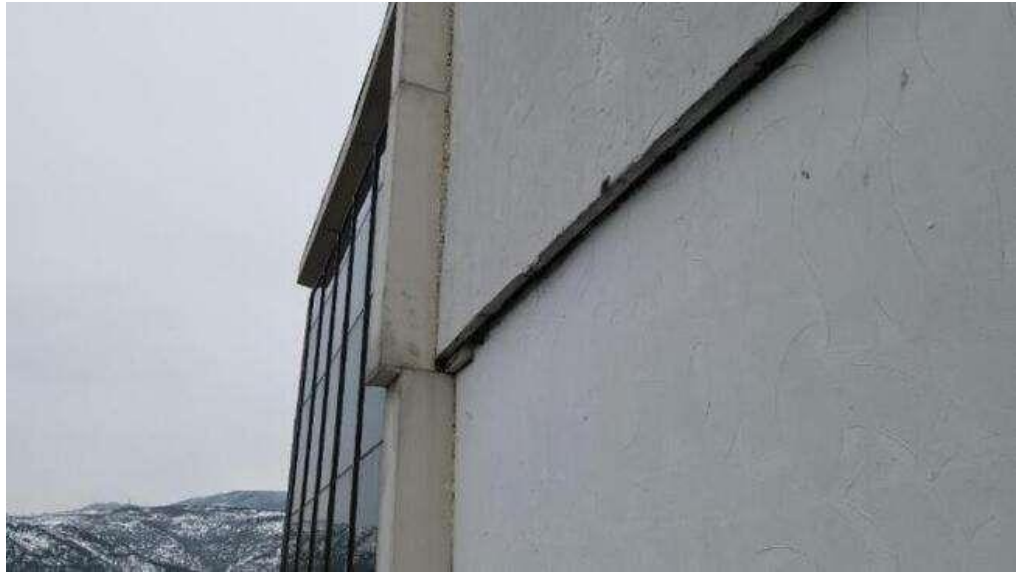
Figure 5.1.62. Crack on the facade of the building in axes 5-6/A. Delamination of the insulation layer.

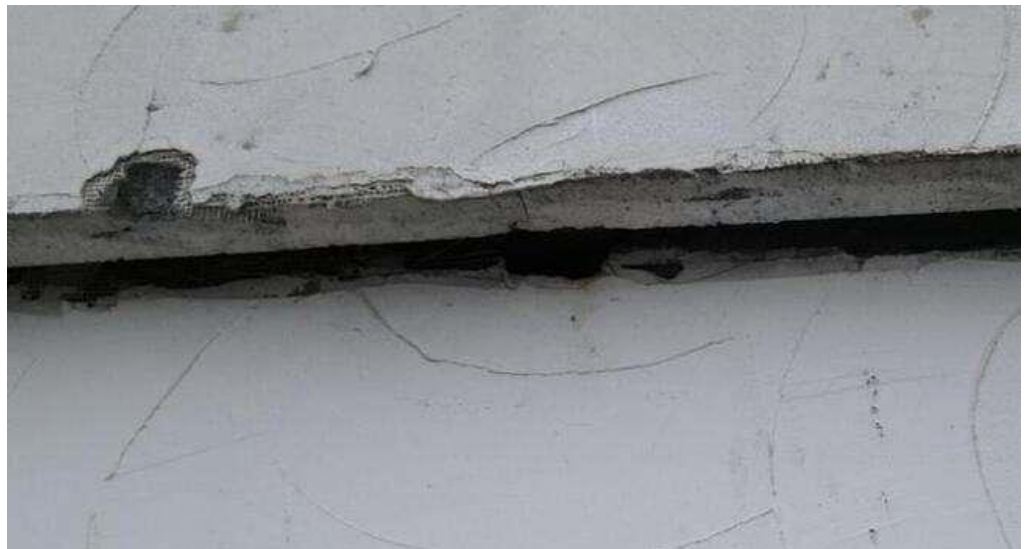
Figure 5.1.63. Crack on the building facade in axes 5-6/A. Delamination of the insulation layer.

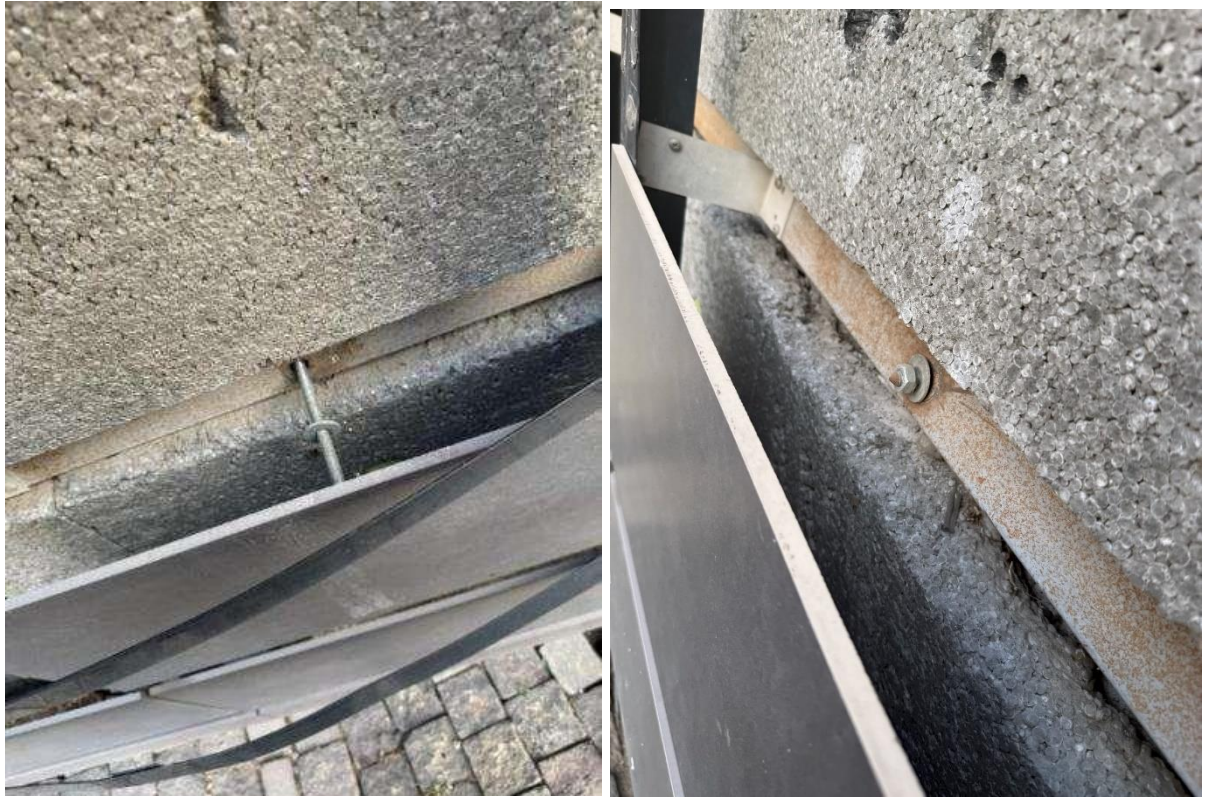
- isolated (up to 10%) significant defects in the form of missing nuts or insufficient tightening of the nuts securing the frame of the hanging system to the wall in axes 1-6/A-B at elevation 0.000...+6.000;

Figure 5.2.5. Failure to tighten the nut securing the frame to the wall

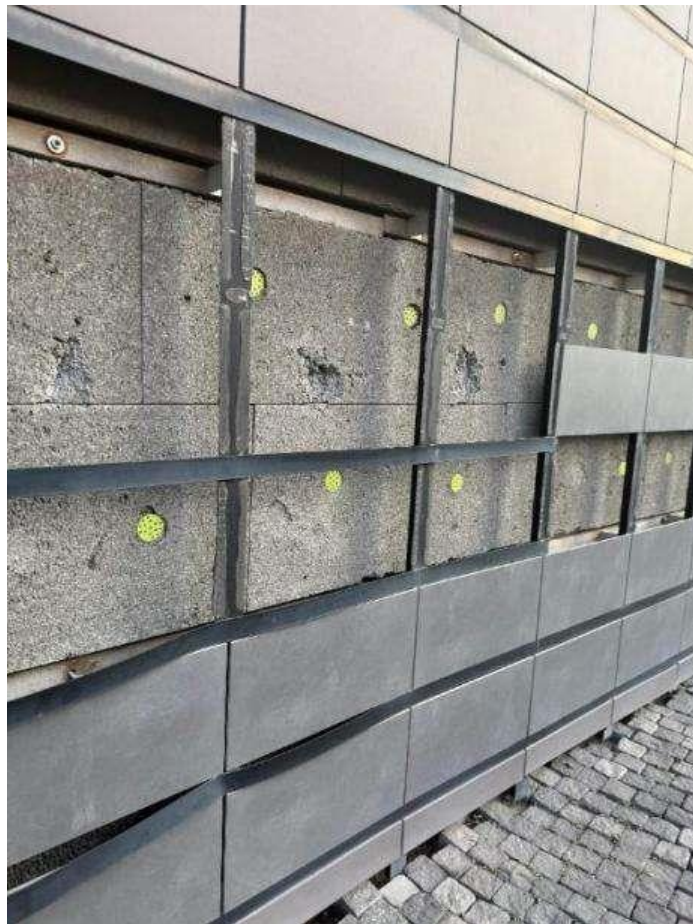
- numerous (covering more than 10% to 40%) minor defects in the form of delamination of slats and panels from the frame posts. This defect is due to physical wear of the adhesive composition;

Figure 5.2.6. Detachment of slats and panels from frame posts

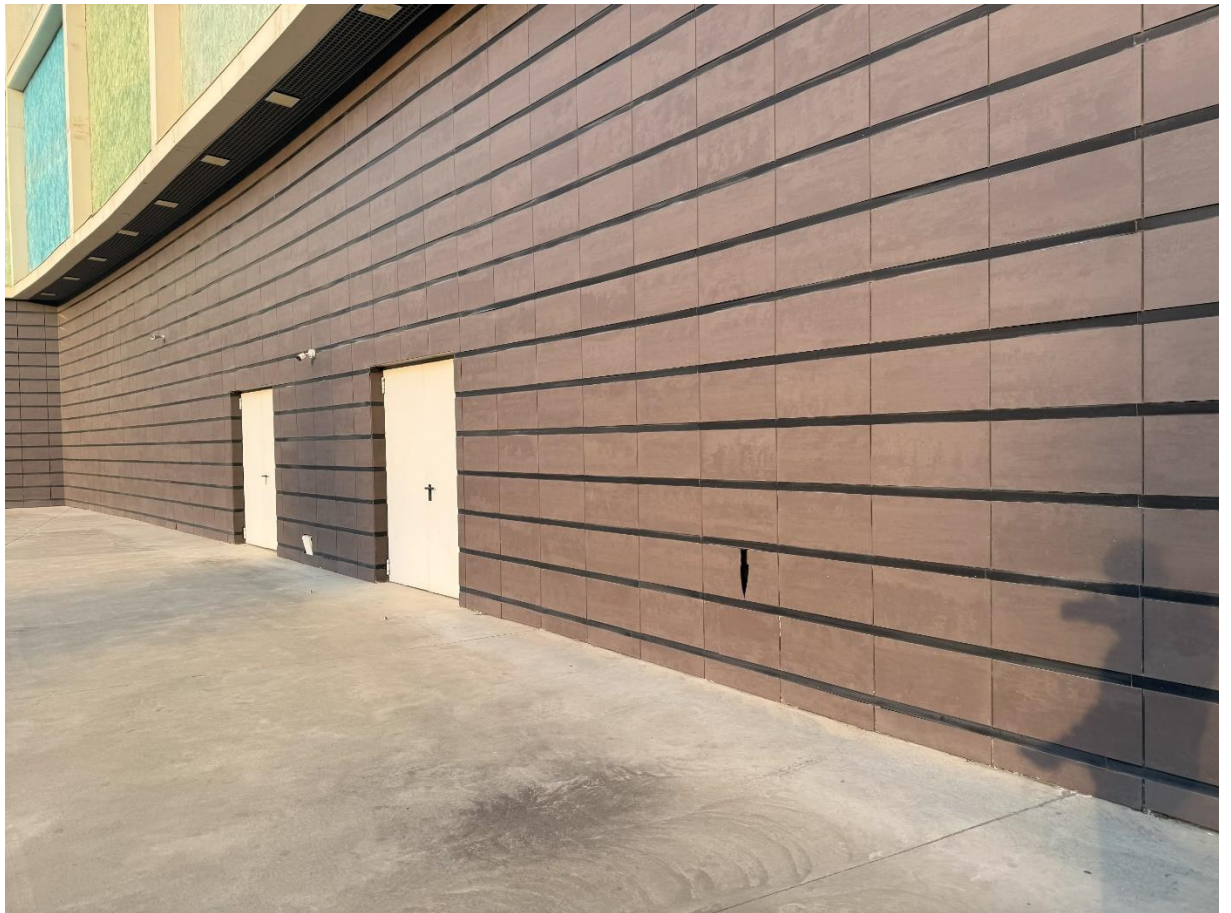
Figure 5.2.11. Delamination of battens and panels from frame studs with sealant.
Cracks and destruction of hanging panels

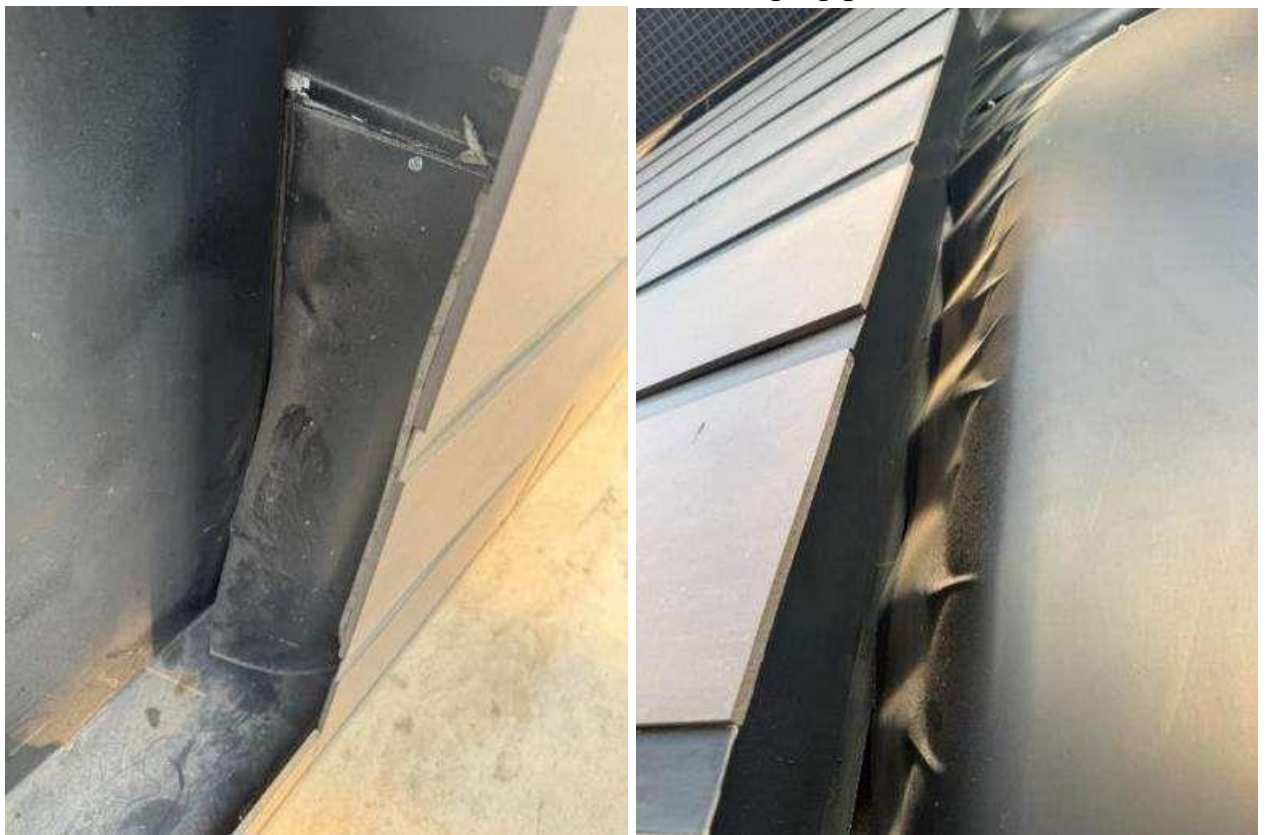
Figure 5.2.12. Destruction of the seam in the inscription "TBILISI MALL". Corrosion
of the facade system frame

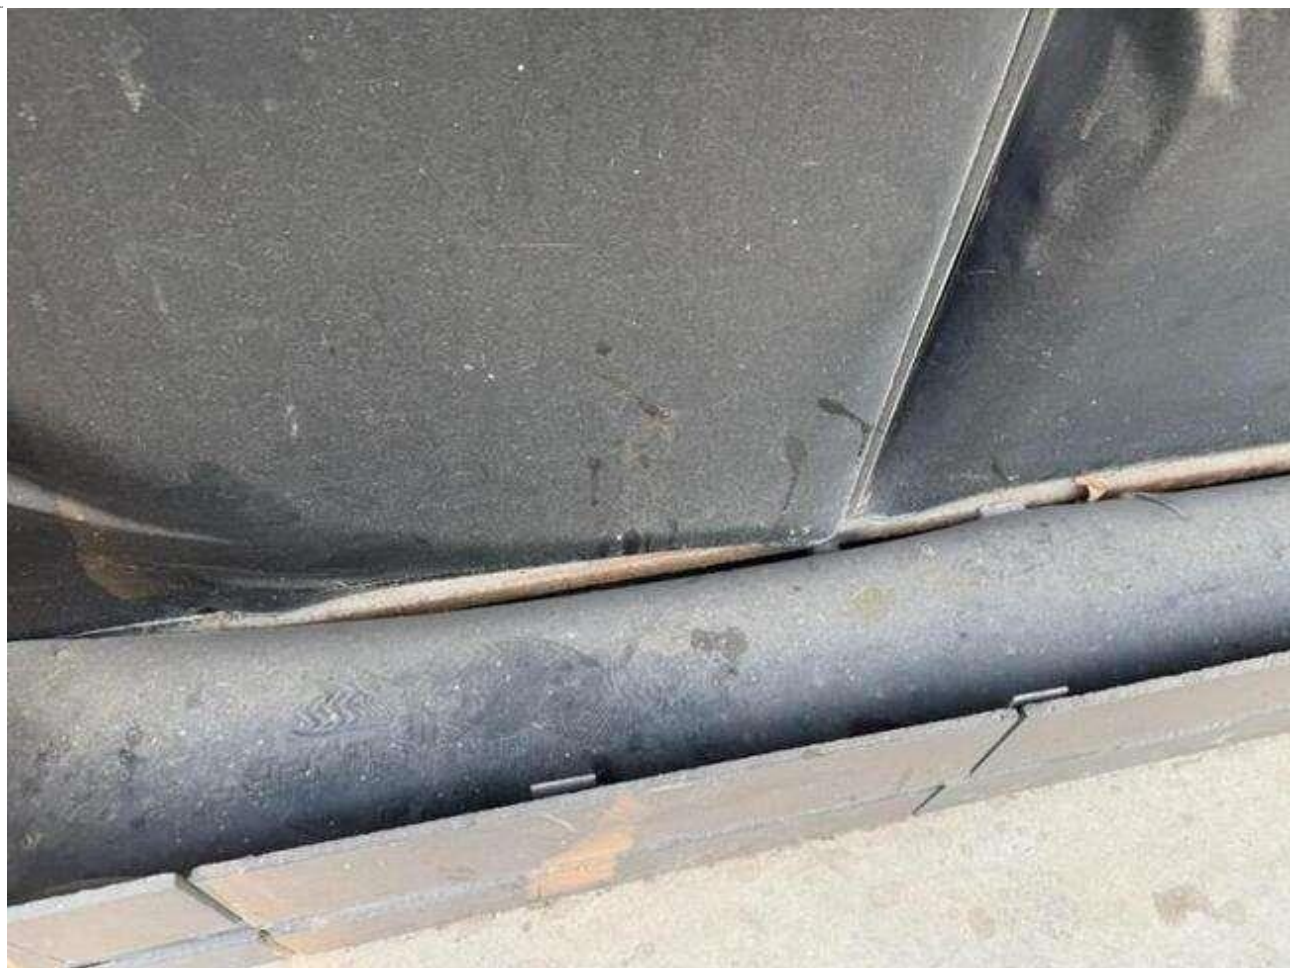
- massive (more than 40%) minor defects in the form of destruction of the stitching in the inscription "TBILISI MALL".
- massive (more than 40%) minor defects in the form of surface corrosion of the metal frame of the facade mounting system. This defect is due to partial destruction of the protective and finishing layer of the metal frame;

Figure 5.2.13. Destruction of the stitching in the inscription "TBILISI MALL" in axes 4-5/A. Corrosion of the facade system frame

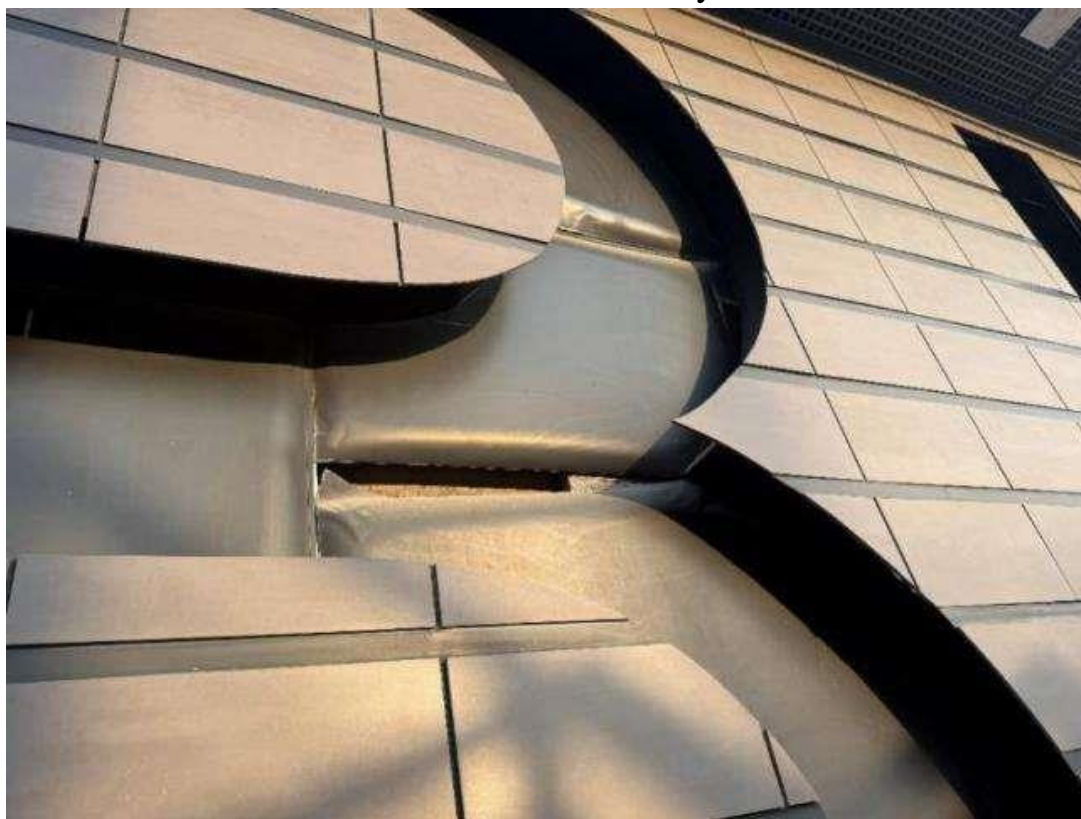
Figure 5.2.14. Destruction of the fastening in the "TBILISI MALL" sign in axes 4-5/A. Corrosion of the facade system frame

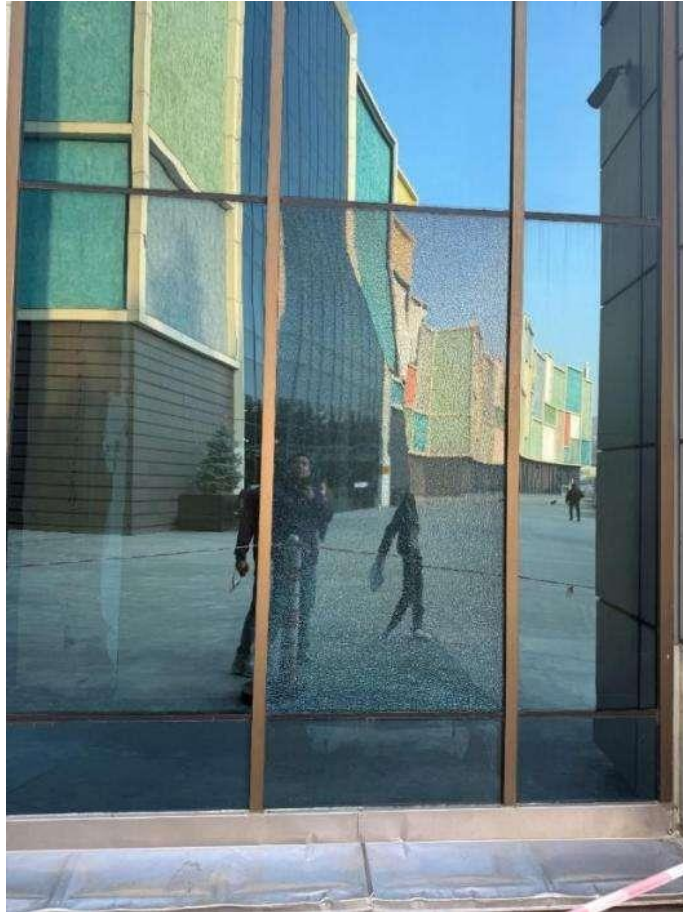
Figure 5.2.15. Broken stained glass window in axes 3/A

7.2.10. In the place of broken glazing of the stained-glass window in axes 3/A, dismantle the damaged glass unit and install new glazing that meets the strength and safety requirements.

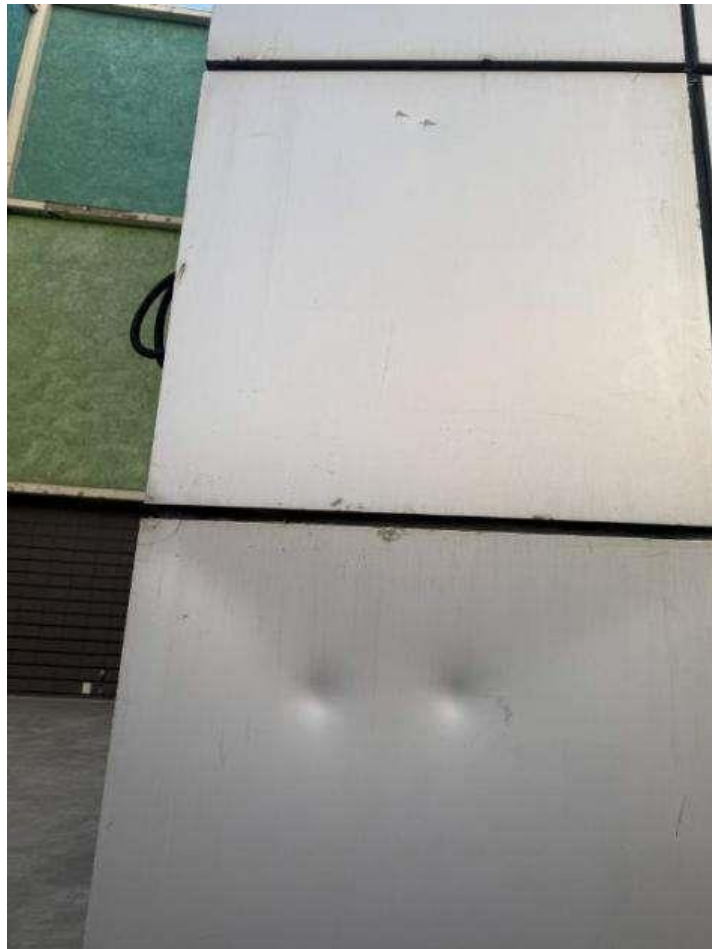
Figure 5.2.16. Mechanical damage (dents) on aluminum panels in axes 2-3/A'

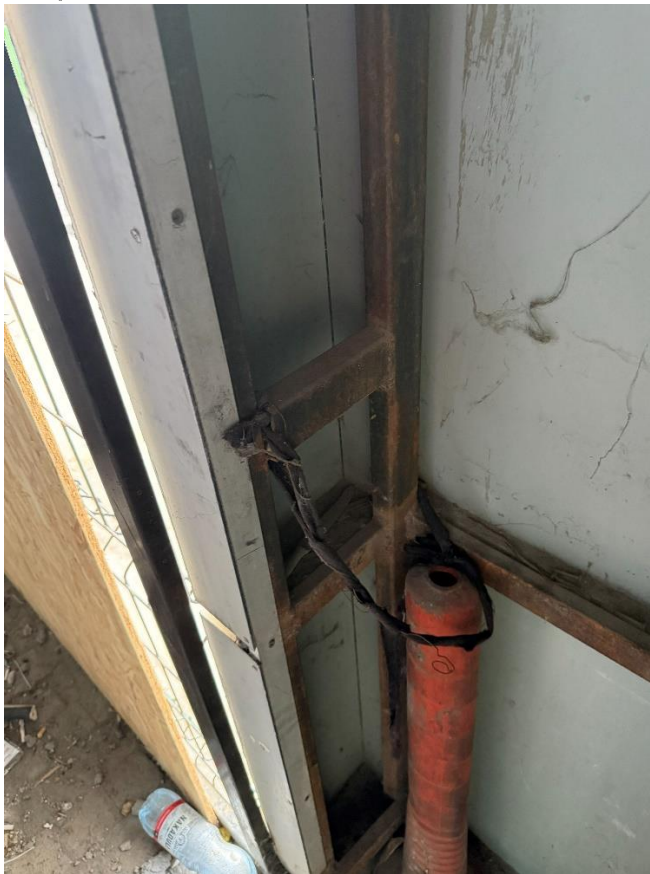
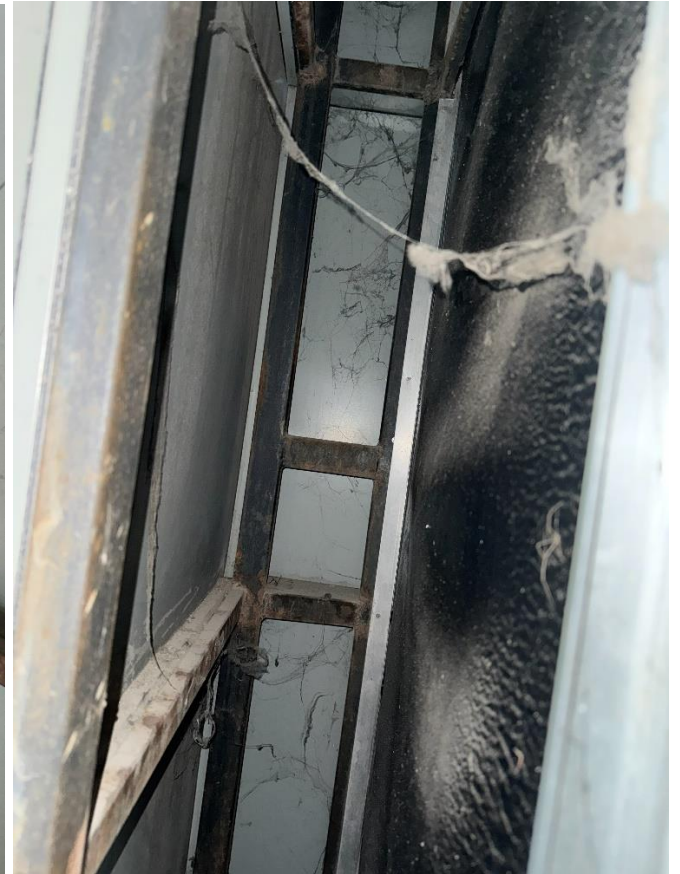
Figure 5.2.17. Corrosion of the frame of the suspended aluminum facade panels

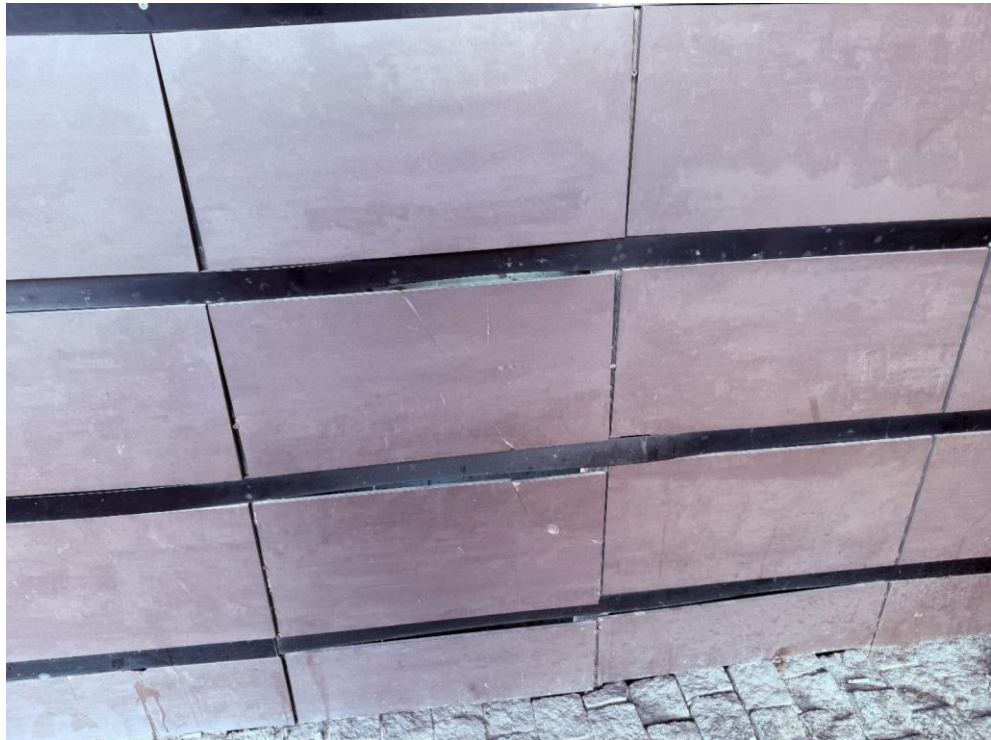
Figure 5.2.20. Delamination of battens and panels from the frame uprights. Cracks in the panels

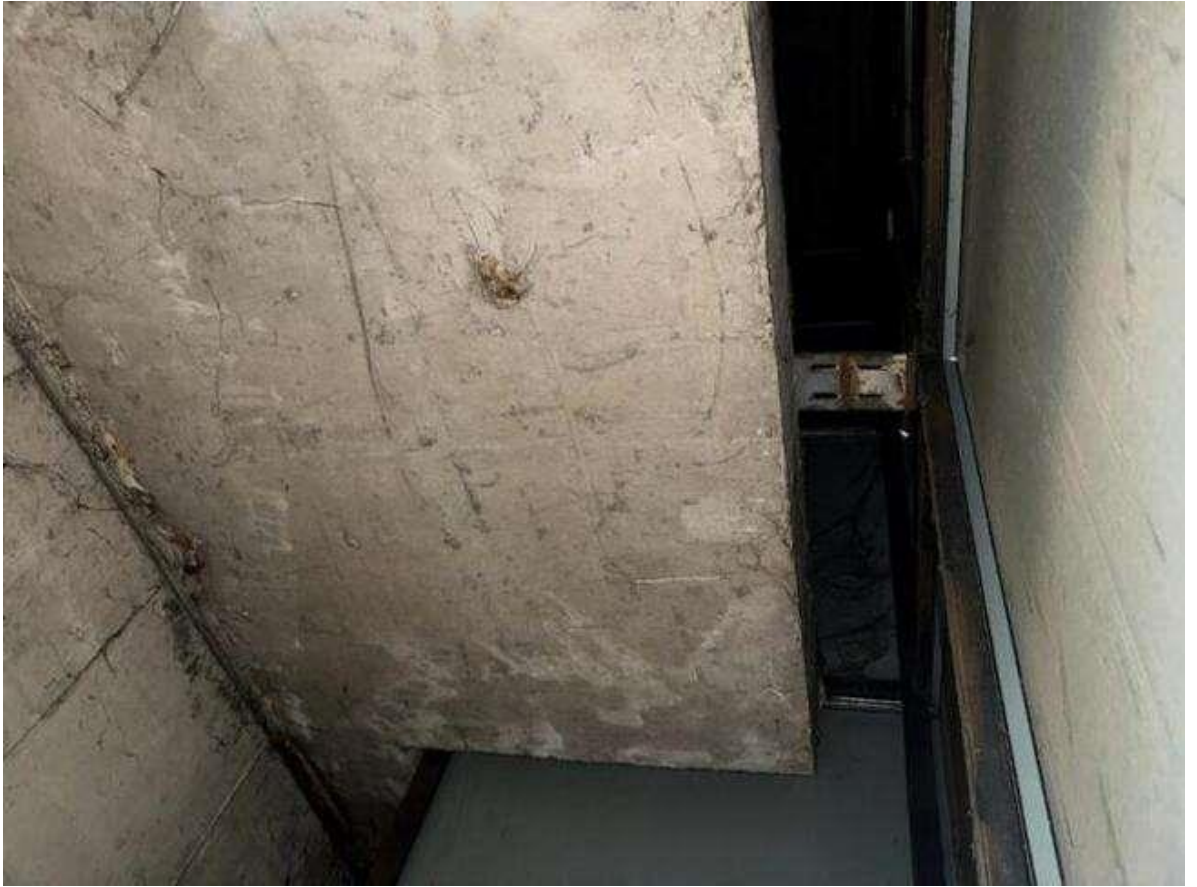
Figure 5.2.21. Corrosion of the frame of the suspended aluminum facade panels

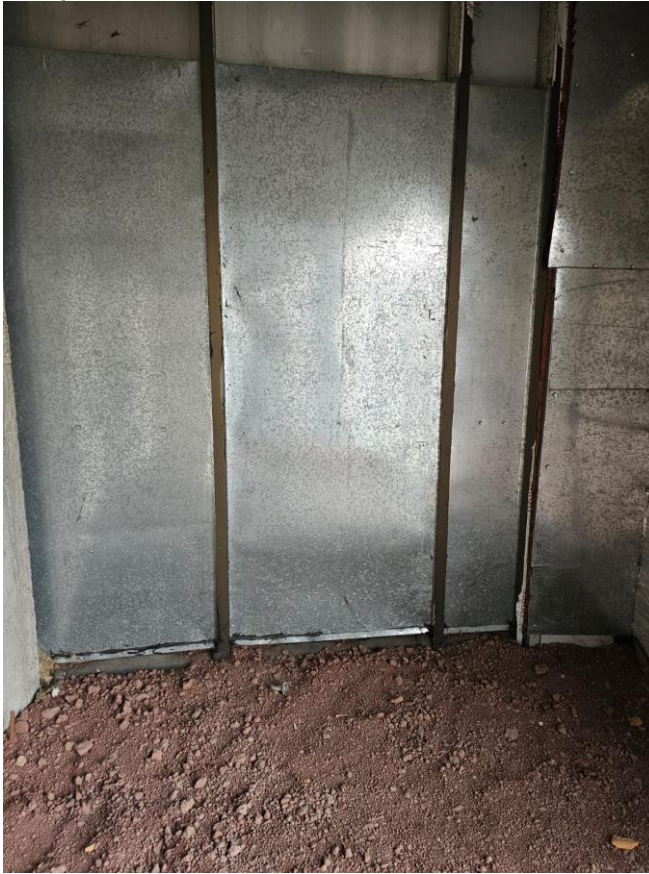
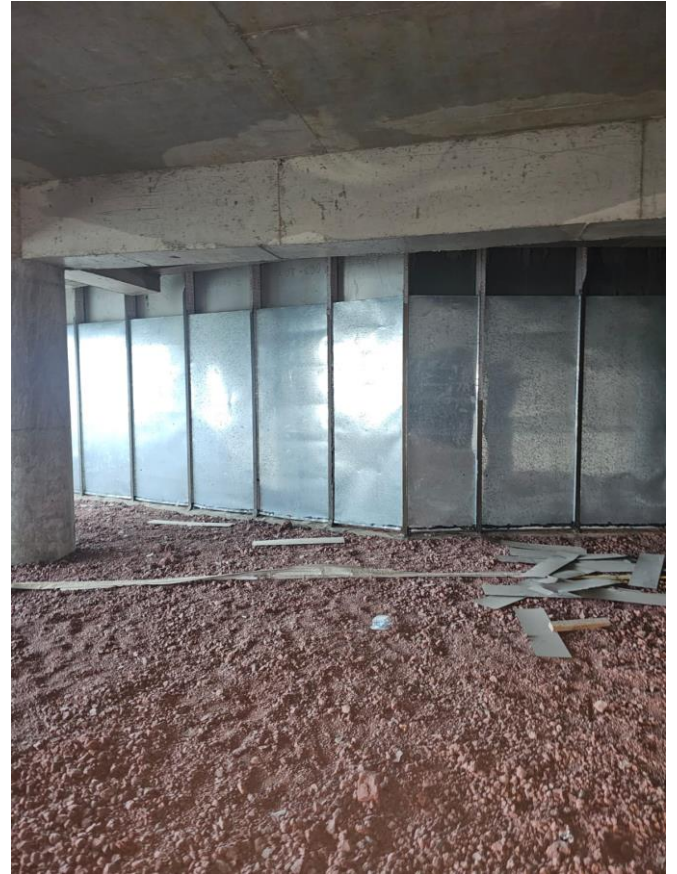
- massive (more than 40%) minor indirect defects in the form of leaks in facades made of aluminum panels due to leaks in ventilation grilles.

Figure 5.2.27. The ventilation grilles are currently not functional. These grilles are subject to leaks from precipitation (indirect defects). The inside is sealed with steel sheets and polyurethane sealant.

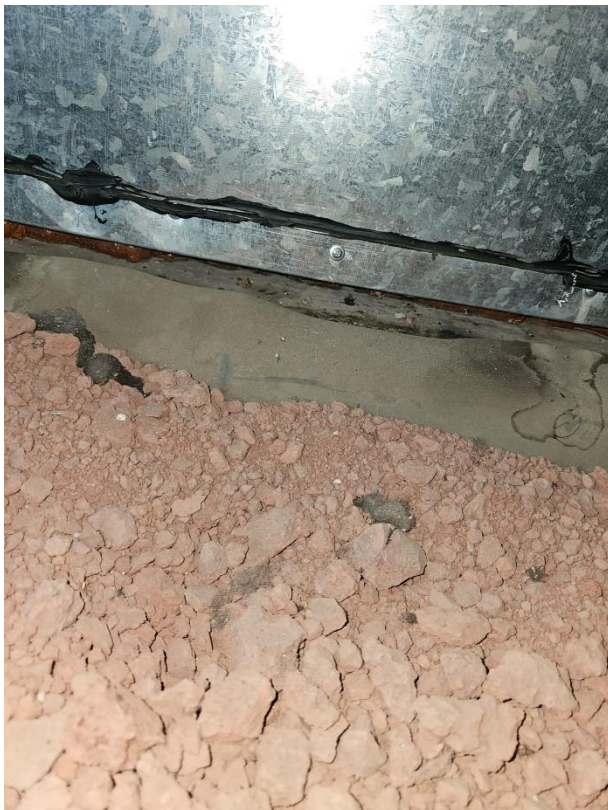
Figure 5.2.28. The ventilation grilles are currently not functional. These grilles are subject to leaks from precipitation (indirect defects). The inside is sealed with steel sheets and polyurethane sealant

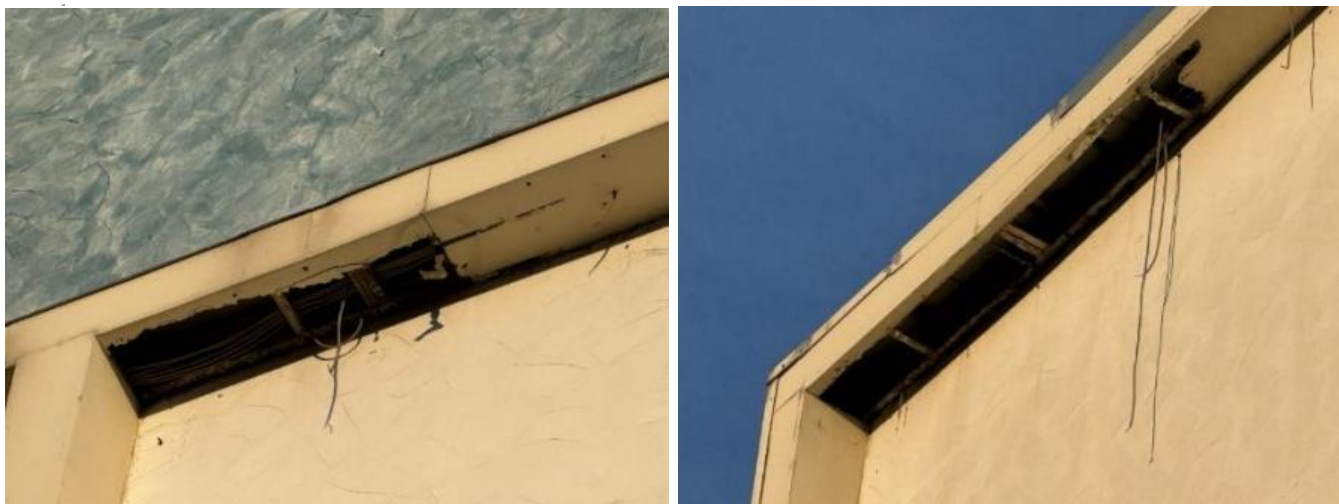
6. During the work, damaged wires were discovered. These utility lines will be inspected during the repair work. This defect was caused by the deterioration of the facade pilaster finish.

Figure 7.1. Areas of wire separation in the facade pilasters
