Inspection of the technical condition of the Tbilisi Mall facade
Contract No. 01/12-2025 dated 02.12.2025

01/12-2025-TR		
		Sheet	No. doc	Signed	Date			
Director		Savchenko			01.2026	Inspection of the technical condition of the Tbilisi Mall facade		
Engineer		Shuranov			01.2026			
							Stage	Page
								Pages
								2 75

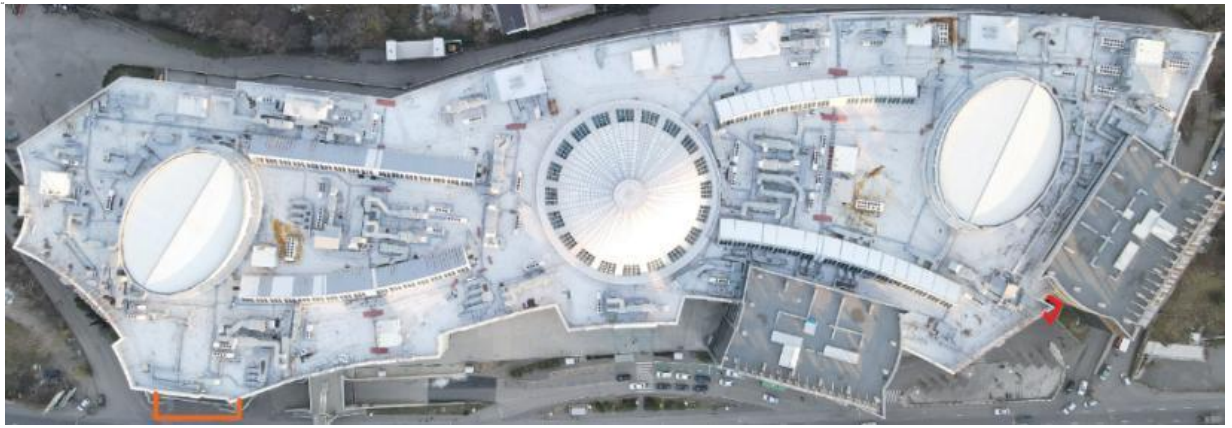
Figure 7.2. Recommended areas for fencing. Insulation boards are torn away from the surface.

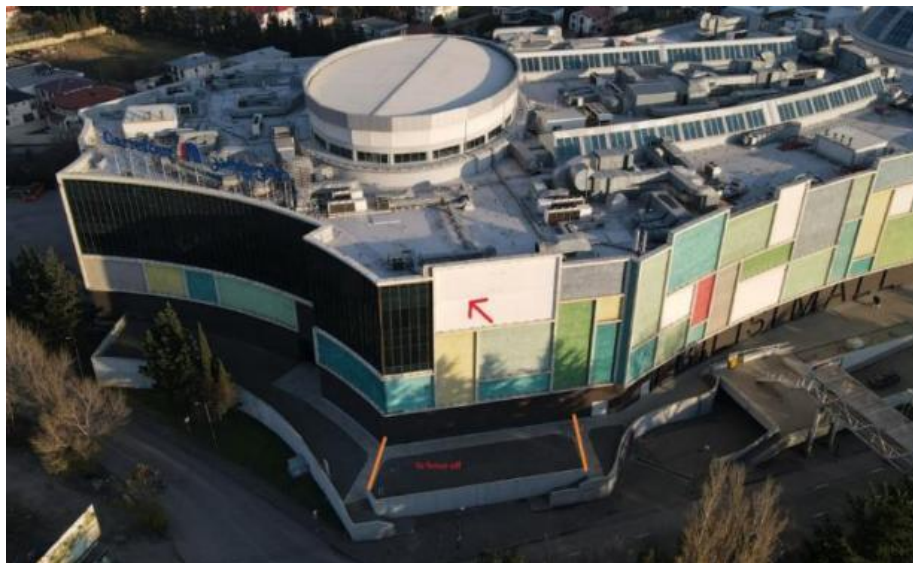
Figure 7.3 Recommended area for fencing in axes 5-6/A. Separation of insulation boards from the surface
