4 SITE INSPECTION 2014

GEORGIAN WATER & POWER LTD

JINVALI TAILWATER TUNNEL REHABILITATION
**JINVALI TAILWATER TUNNEL SCHEME
ACCESS ROADS, COMMUNICATION
SHAFTS, CONSTRUCTION CAMP**

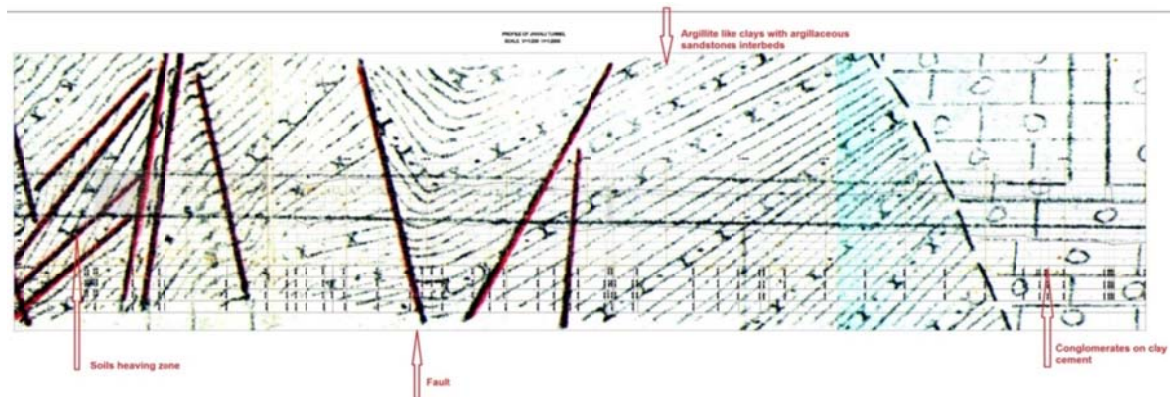
Figure 3-2: Geological profile of design section

circumstances it is difficult to determine how improvement of hydraulic performance on the selected section will affect on hydraulic performance of the whole tunnel.
