WALKABILITY CONCEPT

Batumi (Old Town)

Analysis Report

28th of February 2022

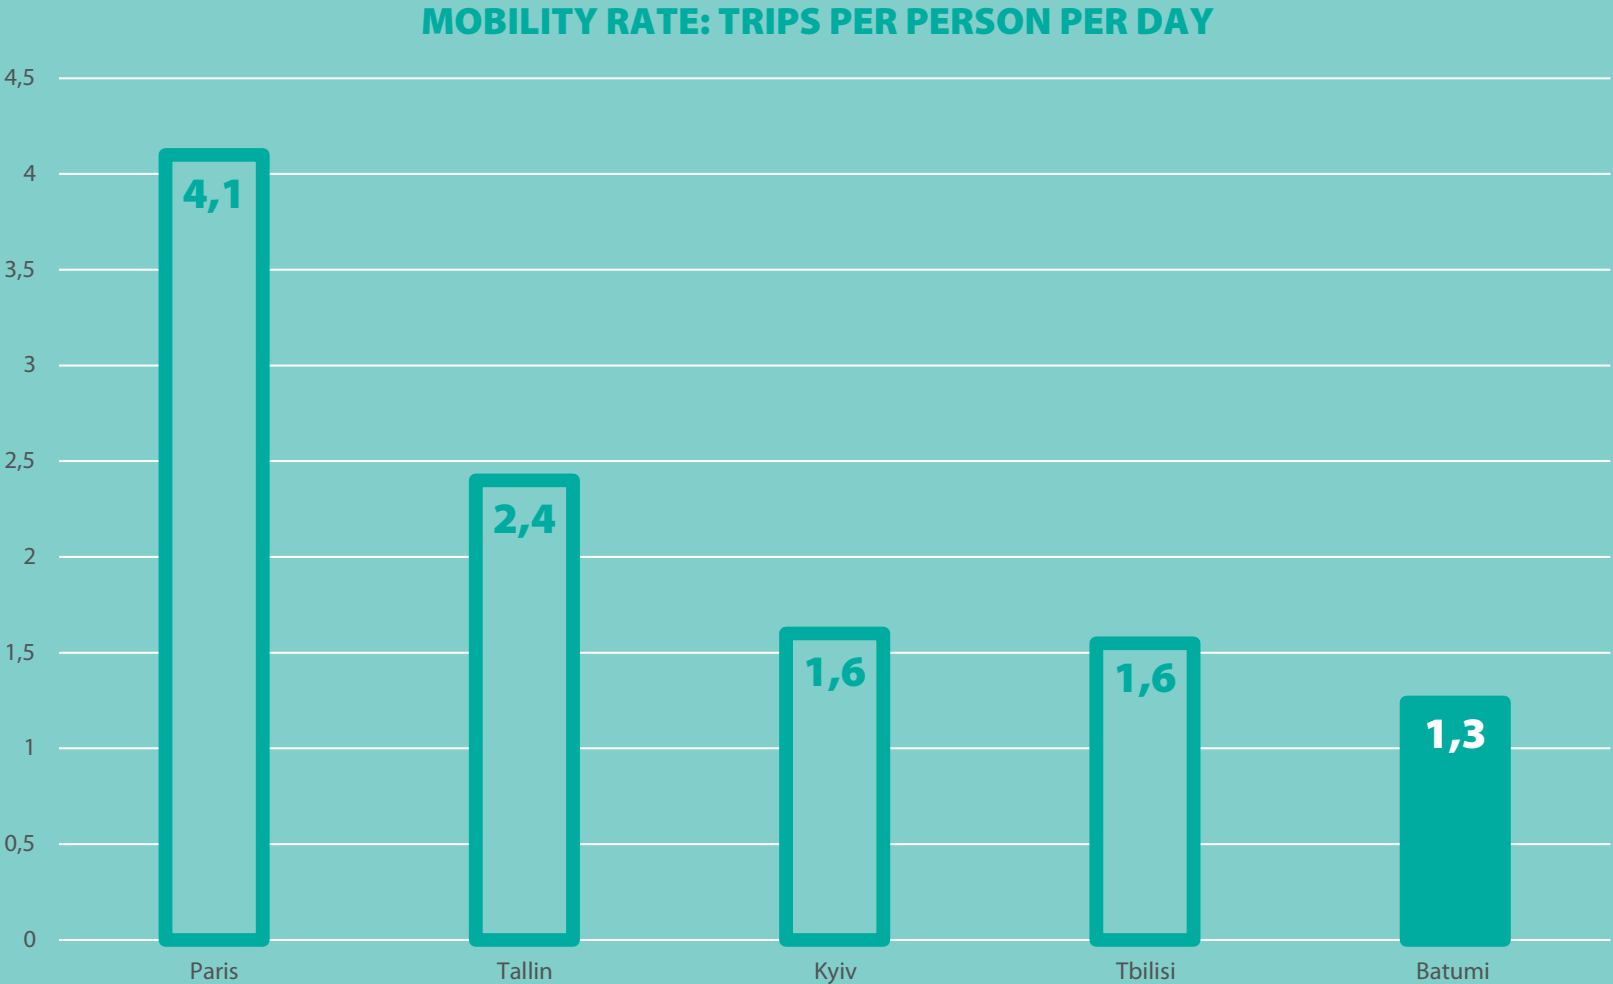
Mobility rate

The diagram on the right shows the mobility rate for the city of Batumi. The mobility rate metric represents the average number of trips made by each citizen in the respective area per day. It's critical to comprehend how people move around the area. In addition, this indicator indirectly refers to city welfare and transportation system convenience: in the case of low mobility, people try to avoid extra trips, only taking the ones that are required (to work or school and back home) and refusing to engage in extracurricular or leisure activities.

As can be seen in the graph, in developed economies the mobility rate is usually higher. The average number of trips per person per day in Batumi is at 1.24. This is a relatively low value, especially compared to other cities.

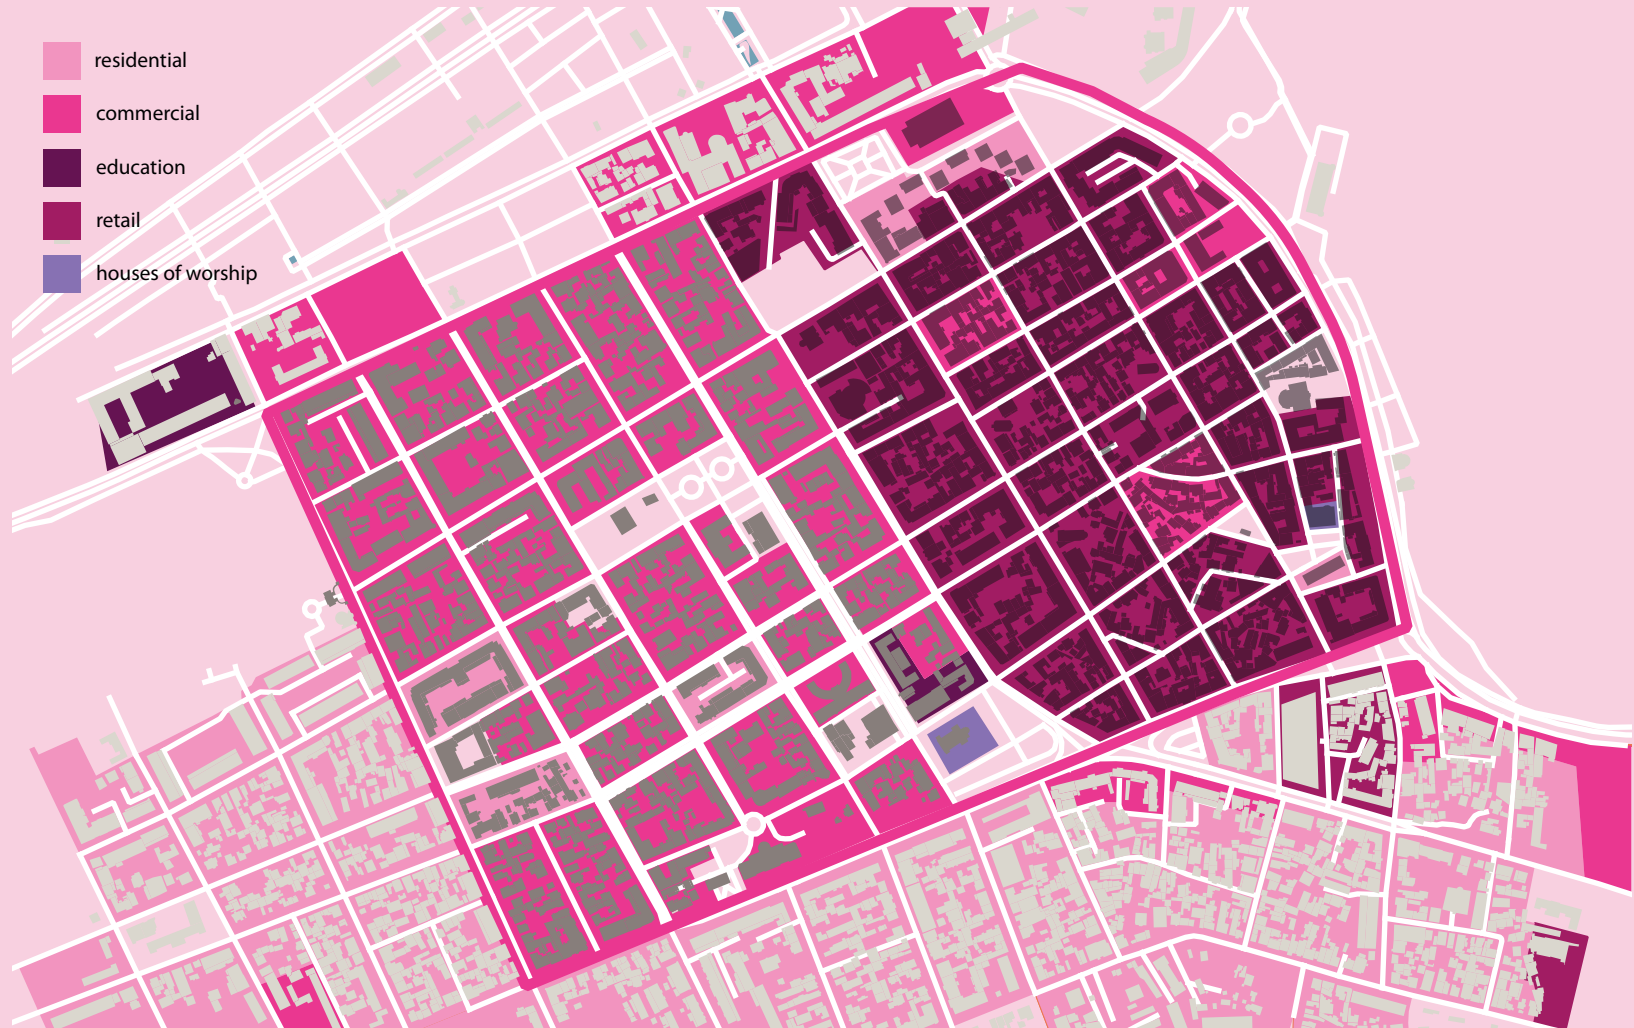
Landuse

Very little residential occupancy can be observed in the study area, mainly in the south-west part. It significantly increases southern of that area, which is outside of the current project's study area.

A few recreational and public spaces can also be observed in the city centre of Batumi. In the analysis area there is also landuse with educational and worship purposes.

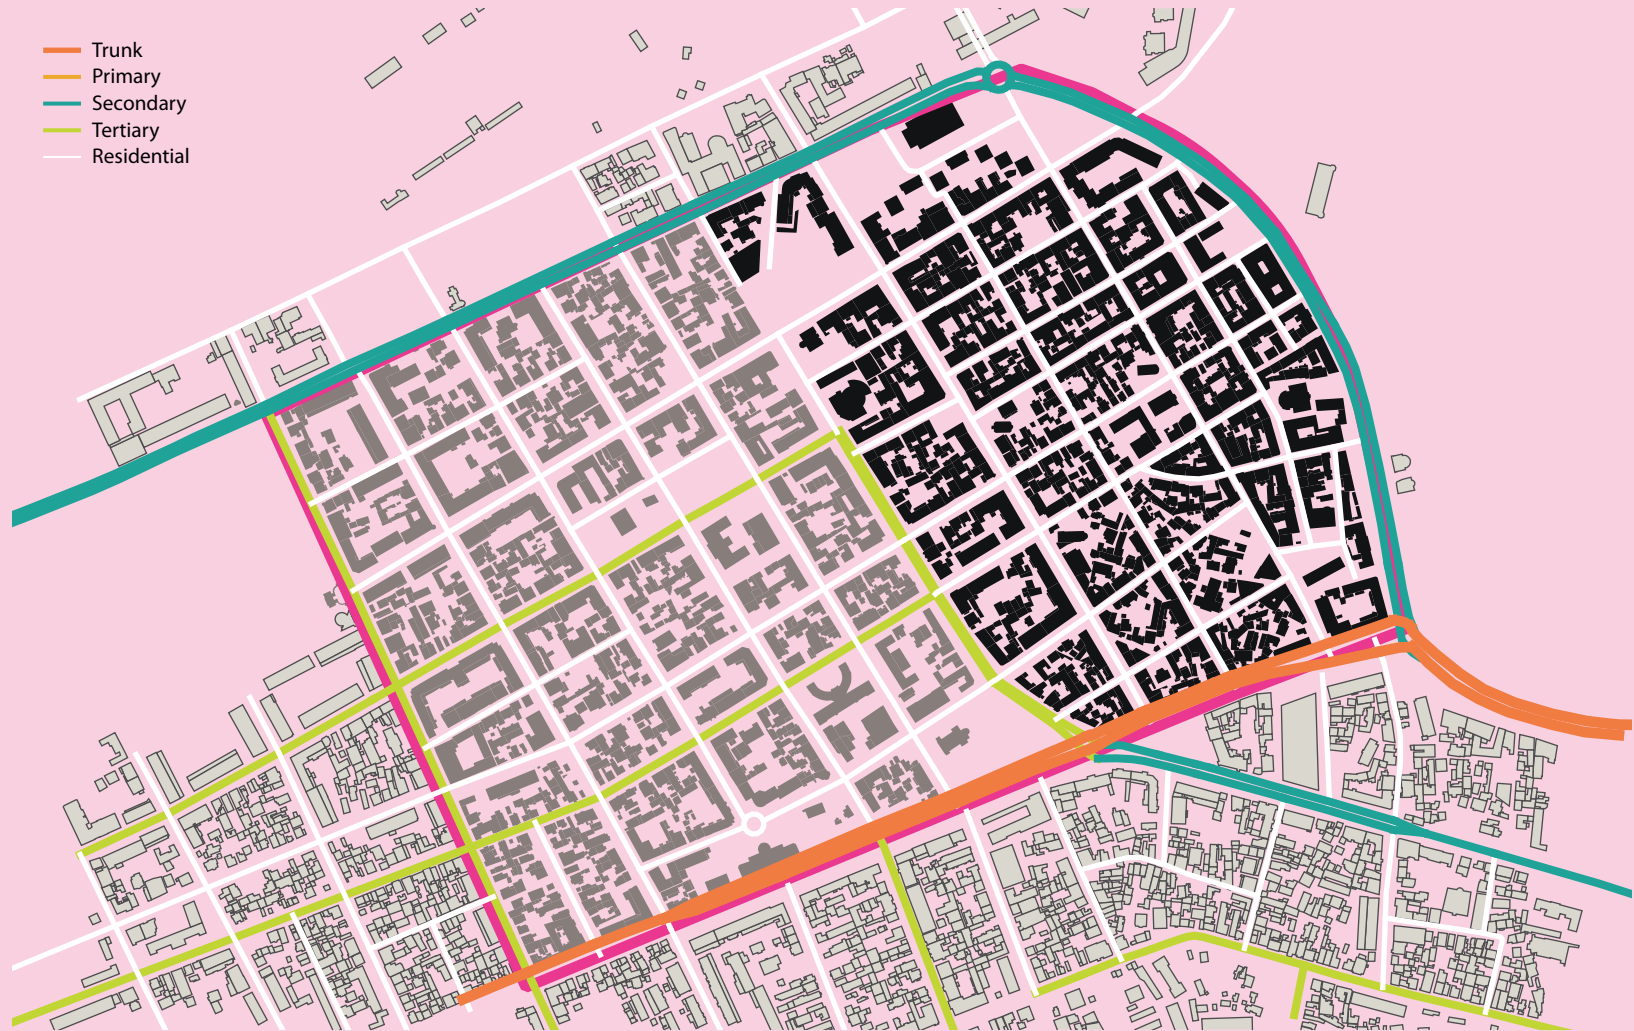
Road network

The study area is surrounded by high traffic roads in the southeast, with a trunk road, and in the northeast and northwest with secondary streets. Also, three tertiary streets can be found in the study area.

The rest of the streets of the study and project area are all residential streets, which should make it easier to facilitate a walking culture.

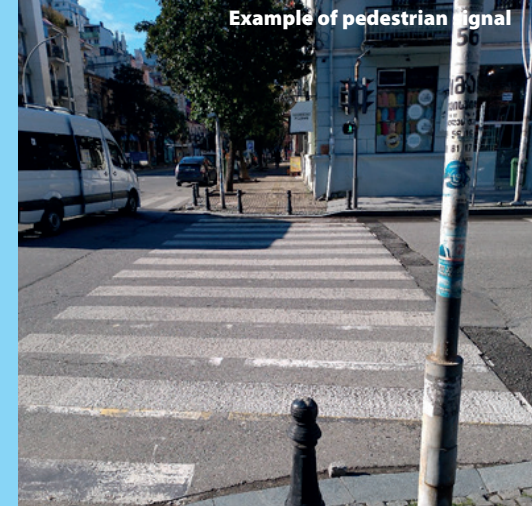
Pedestrian Signal Availability

Pedestrian signals provide safe conditions for pedestrians to cross during pedestrian crossing phases. Pedestrian signals and the associated pedestrian push buttons were checked for availability and functionality. The indicator was only studied and assessed at streets/segments with two or more lanes.

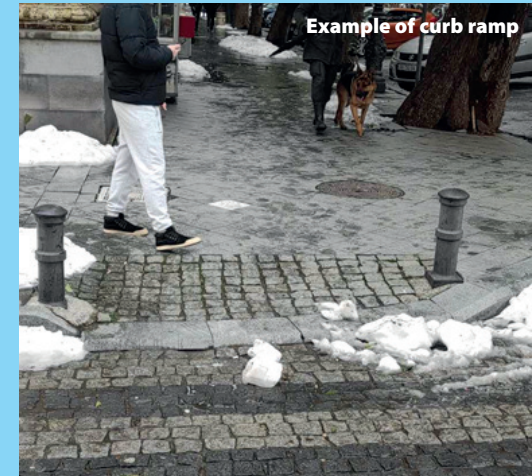
Curb ramp availability

Curb ramps are necessary for pedestrians who use mobility devices and for blind and low-vision users to have a convenient transition between the sidewalk and the street. To be compliant, a curb ramp must have a proper running slope and a detectable warning surface. All the curb ramp points, with respective photos have been logged into the GIS database, and are coded with the Ramp, Segment & Side ID numbers.

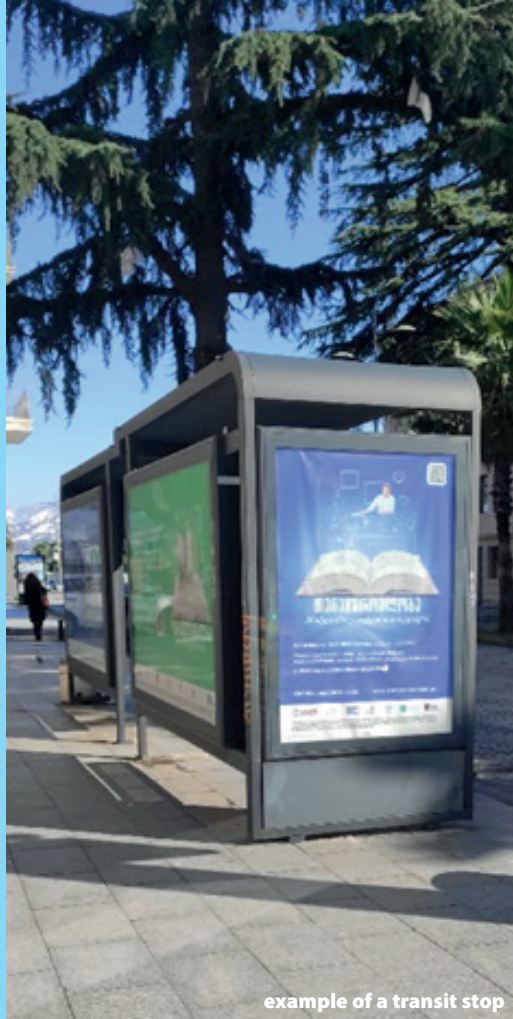
example of a transit stop

The presence of transit stops is one of the key elements that attract pedestrian activities. However, it must be mentioned that the project area with its characteristics doesn't allow for transit stops to be present as such (for scoring considerations). The transit stops were mapped from existing Batumi PT Stop GIS Database for further analysis of the corridors.

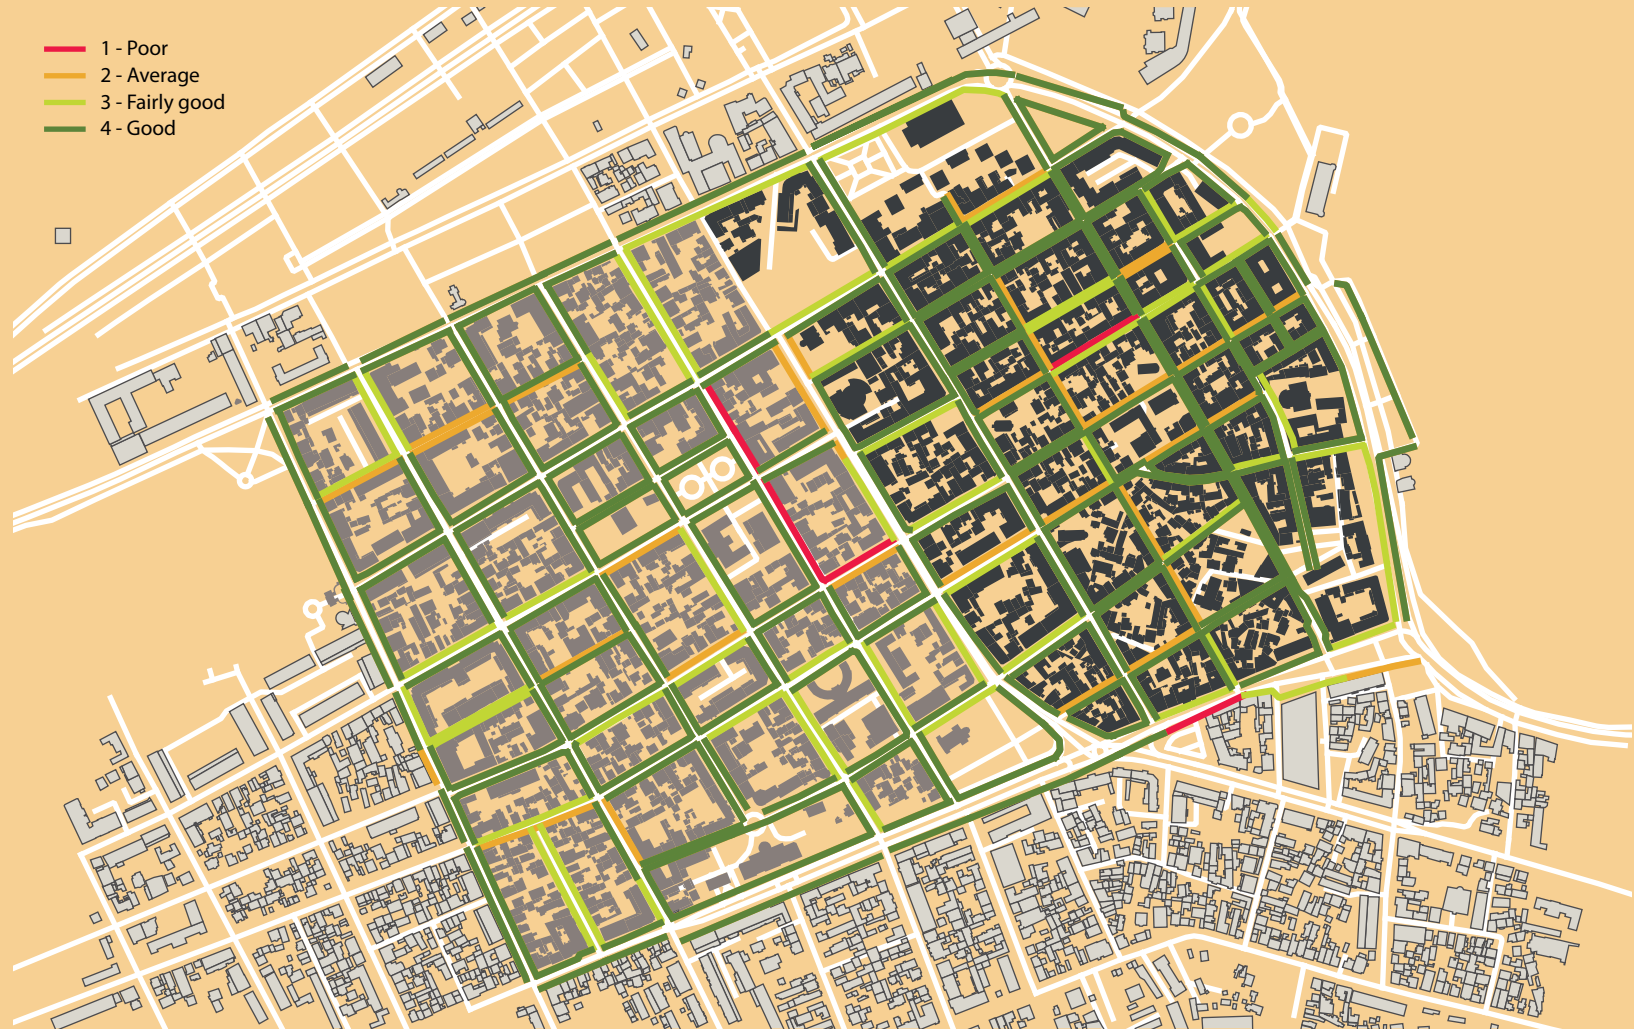
As it can be seen, the continuity in the sidewalks for the study area, can be characterized as mostly fairly good (3) and good (4). The average continuity of the sidewalks score a total of 3.55.

In the project area, while there seems to be a big number of sidewalks with good continuity and only a few parts with continuity characterized as poor, there is a significant amount of sections of the sidewalks that have average (2) continuity.

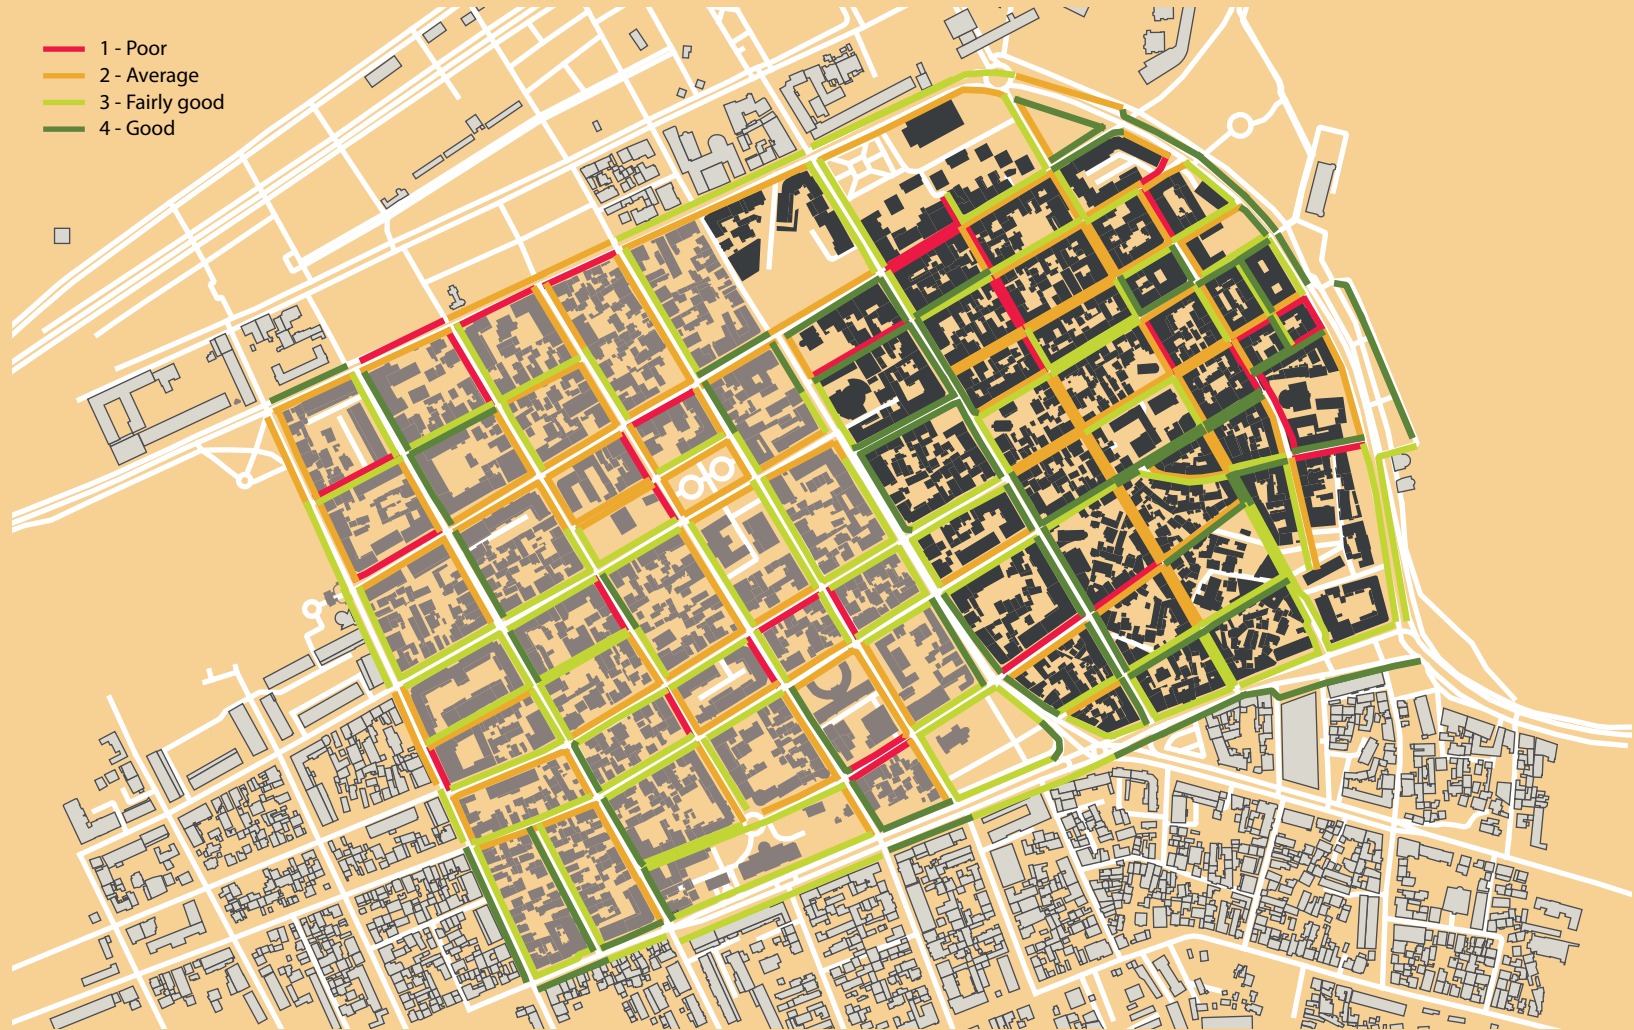
As it can be seen, the state of the sidewalks from the existence of obstructions, for the study area, can be characterized as mostly average (2) and fairly good (3). The average obstructions of sidewalks score a total of 2.77.

In the project area, while there seems to be a big number of sidewalks with good clearance of obstructions, it cannot be overseen that there is a significant amount of sidewalks with poor (1) and average (2) scoring, in terms of obstructions existence. This means that a significant number of obstructions can be observed along these sidewalks.

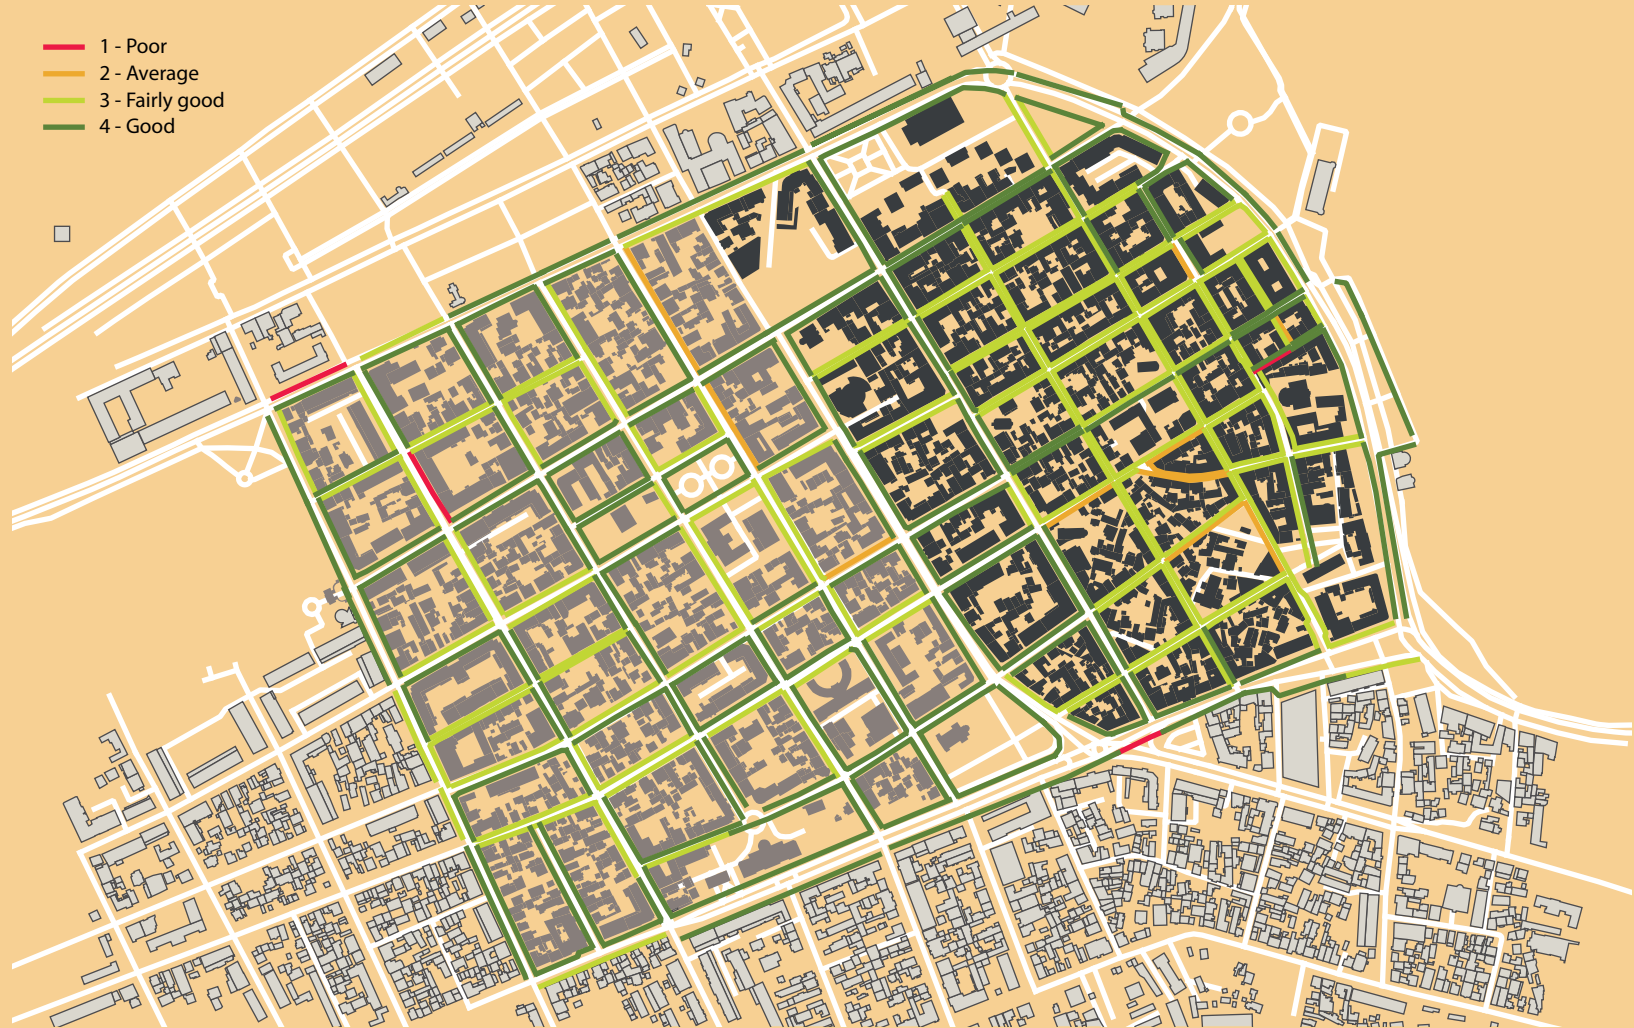
Shade trees

In the project area, while there seems to be a big number of sidewalks with almost no trees along them, or with an average number of trees, mostly in the northern part, close to Gogebashvili St. The situation changes slightly in the SW part of the project area, as Konstantine Gamsakhurdia St. seems to have a very good rating.

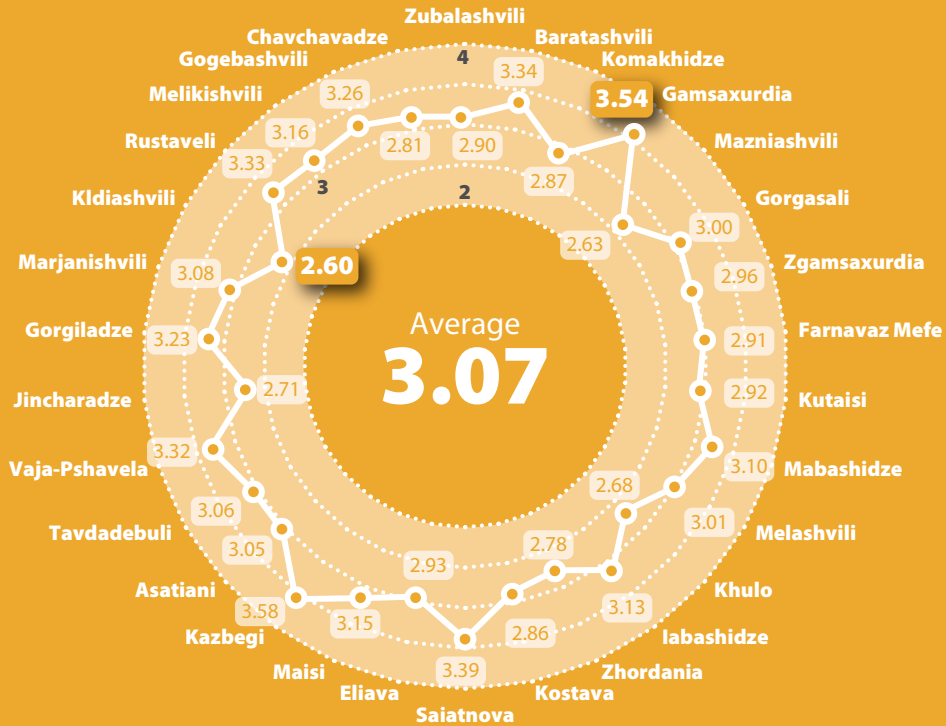
AVERAGE SCORE OF PROJECT AREA (NON-WEIGHTED)

In the diagram below, it can be observed the average score of all streets sidewalks, according to the study that was conducted by STS. In general, the sidewalks have gotten satisfying results, though still there is room for improvement. The most important observation, is the

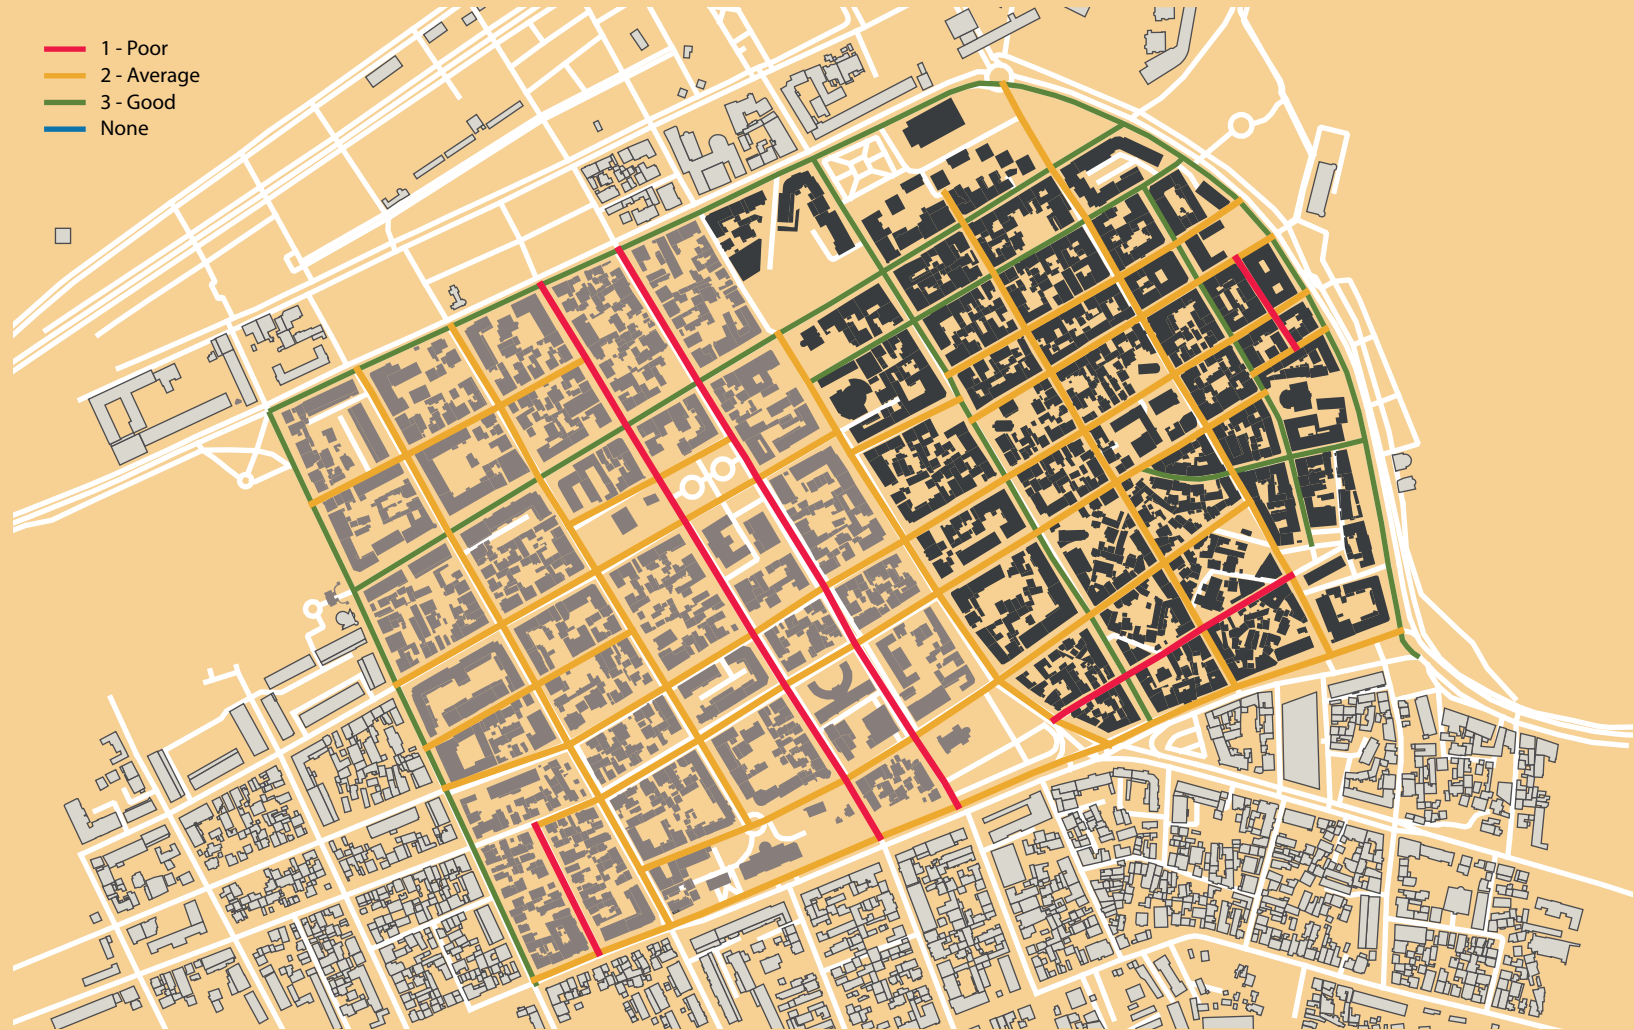
Ramps

The results of the survey, regarding ramp availability, are rather disappointing. While there are 4 corridors, which run the study area from NW to SE and have good availability of ramps, and few corridors with average availability, the majority of the corridors seem to have poor availability of ramps. In a city that does not have big elevations, the mobility of people with disabilities can be significantly be easier when ramps are available.
