Central Atrium Dome

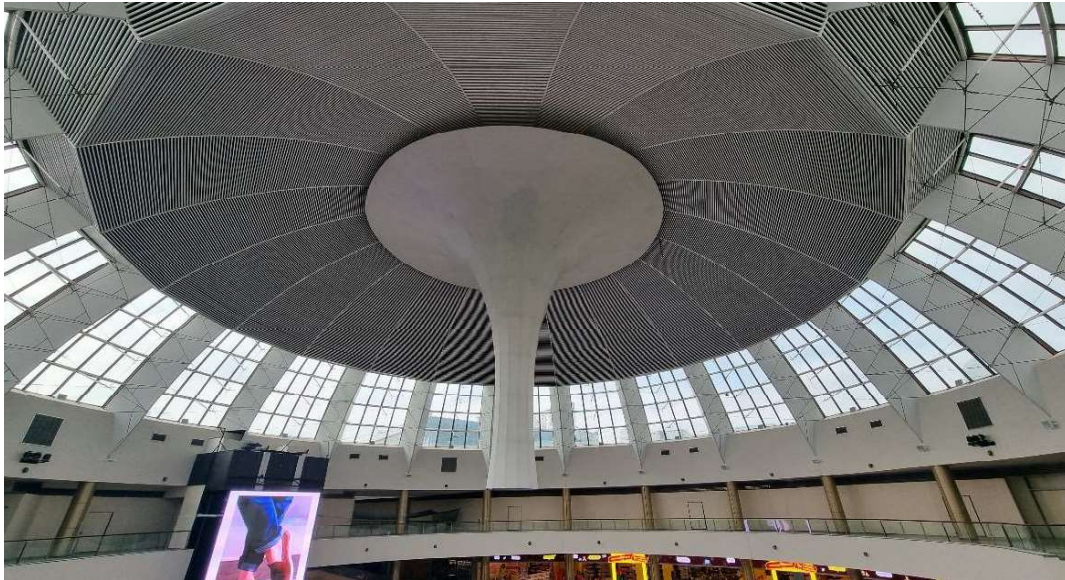
The Dome's internal façade is hung from the main triangular cladded space trusses

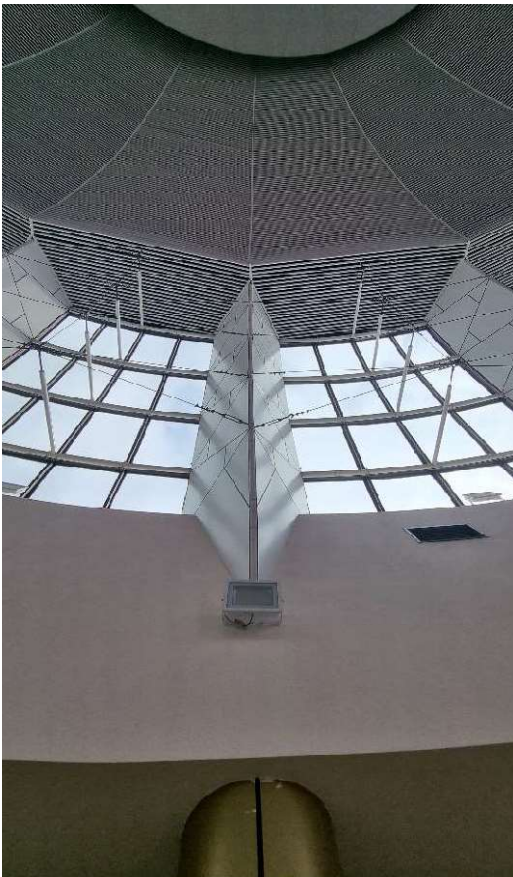
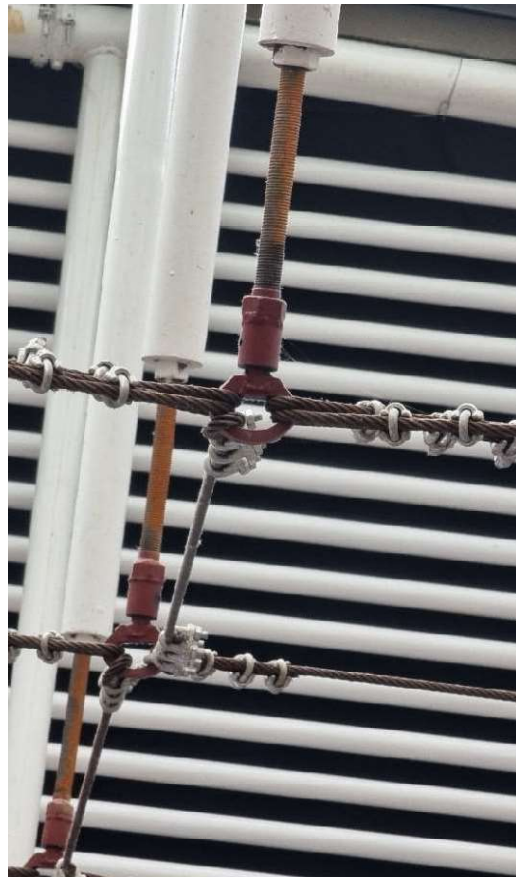
A network of steel bracing cables is providing for additional lateral support to the structure of the dome above the central atrium of the mall. See Figures below.

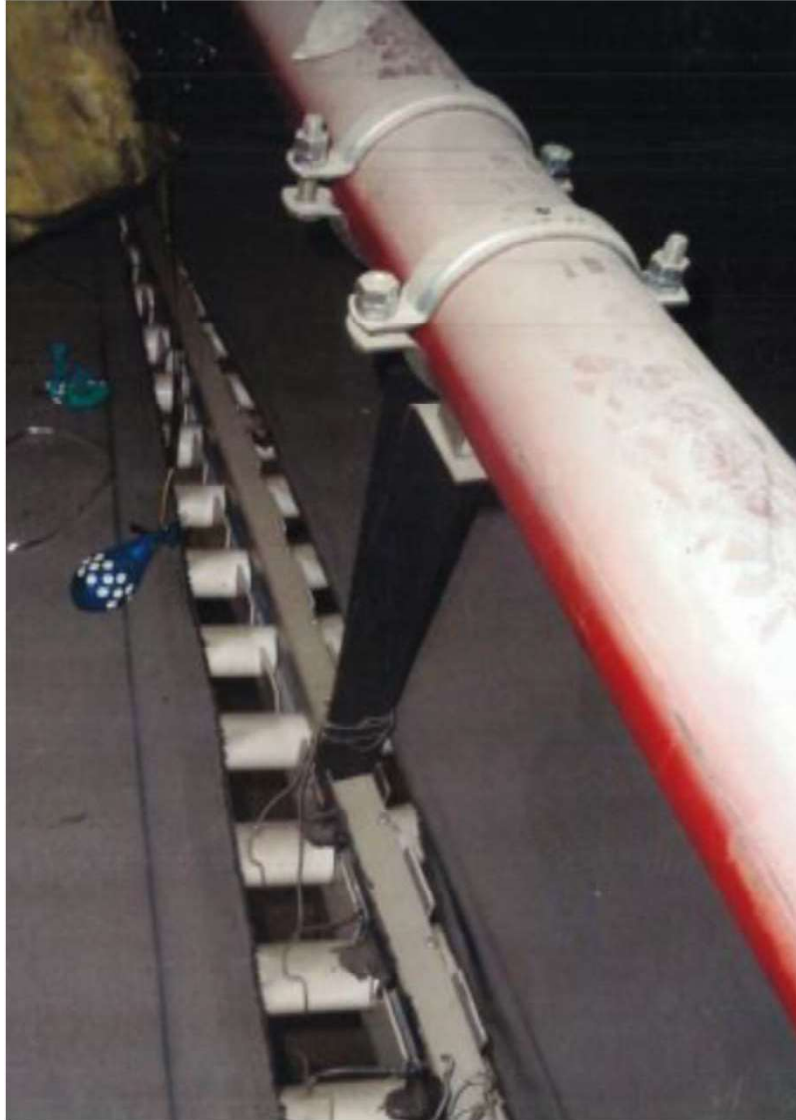
An arrangement of architectural steel or aluminum pipes is lining the inside face of the top section of the central atrium dome. The pipes located in the uppermost area are arranged horizontally while the remaining sections are arranged tangentially.

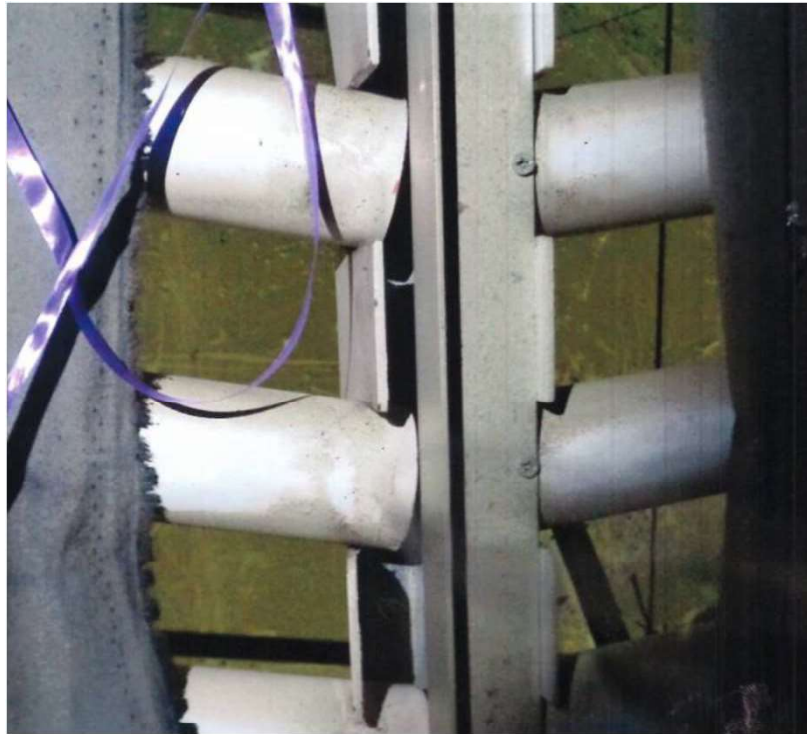
The pipes are supported at each end by steel or aluminum channels. There are numerous instances where the pipes are not connected to the rafters at these support locations and are free to be lifted out of place. Likewise, in many instances, very little bearing is observed.

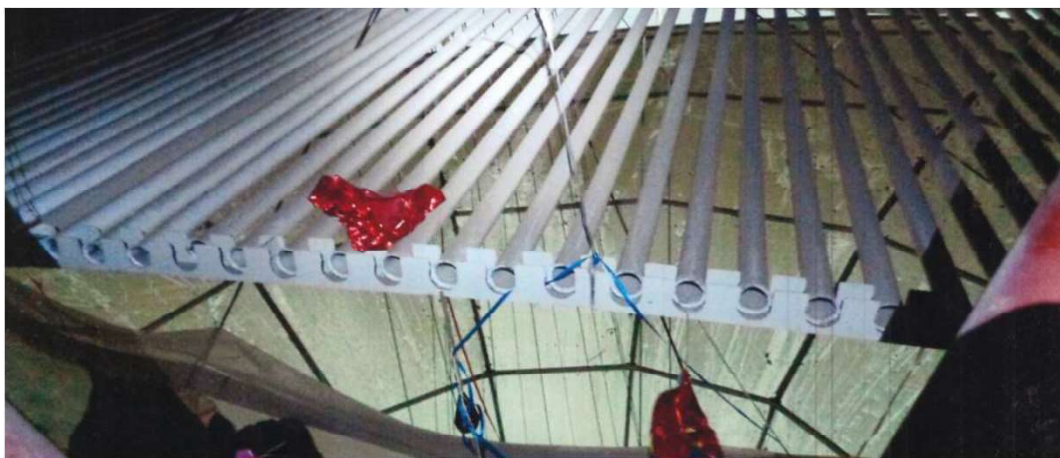
The rafters that are supporting the pipes in the uppermost area (the central part of the Dome) are connected to the steel truss work of the dome via steel tie wires. These tie wires appear inadequate to provide any lateral stability because they are not braced, in the central dome area.

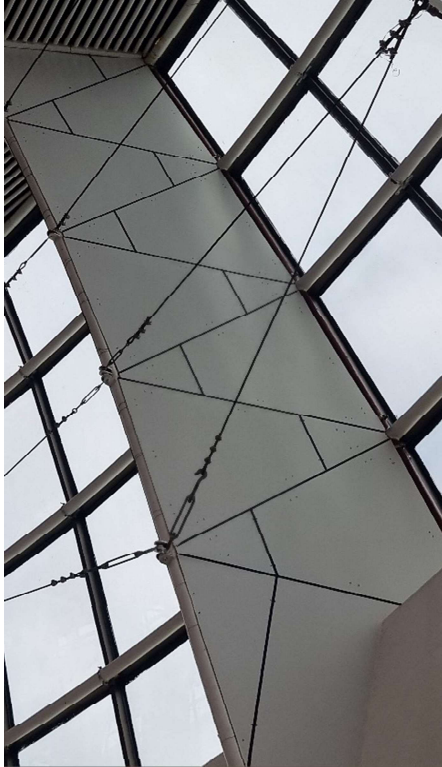
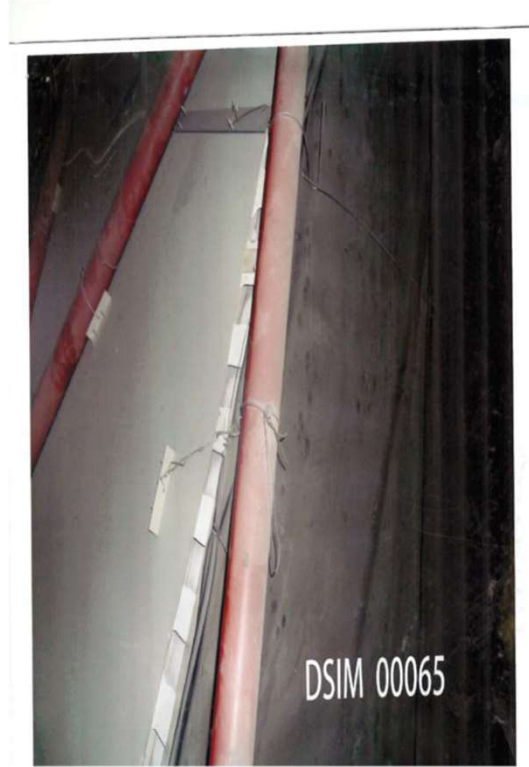
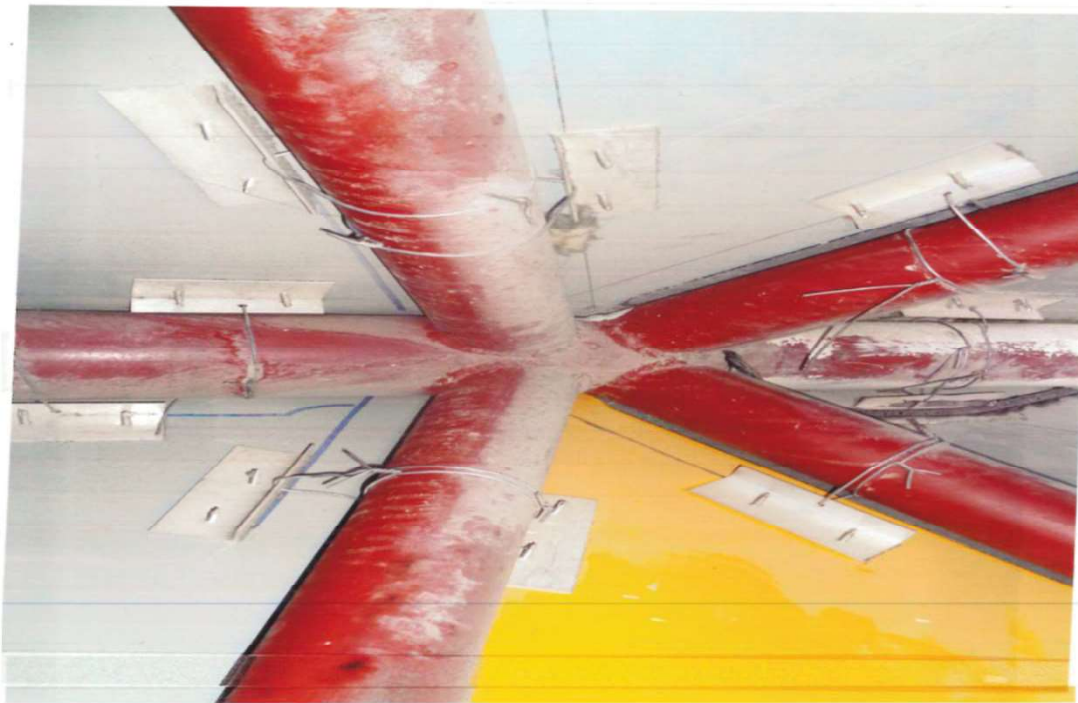
Side panels are covering main steel structure of the dome, internal inspection gave clear picture that some bracings are missing or they were replaced with wires
