Georgian Water and Power LLC

The results of the visual inspection of water reservoirs located near Chatmi mountain in city Rustavi

## Notice to Client #1

**Tbilisi, 03 October 2024**

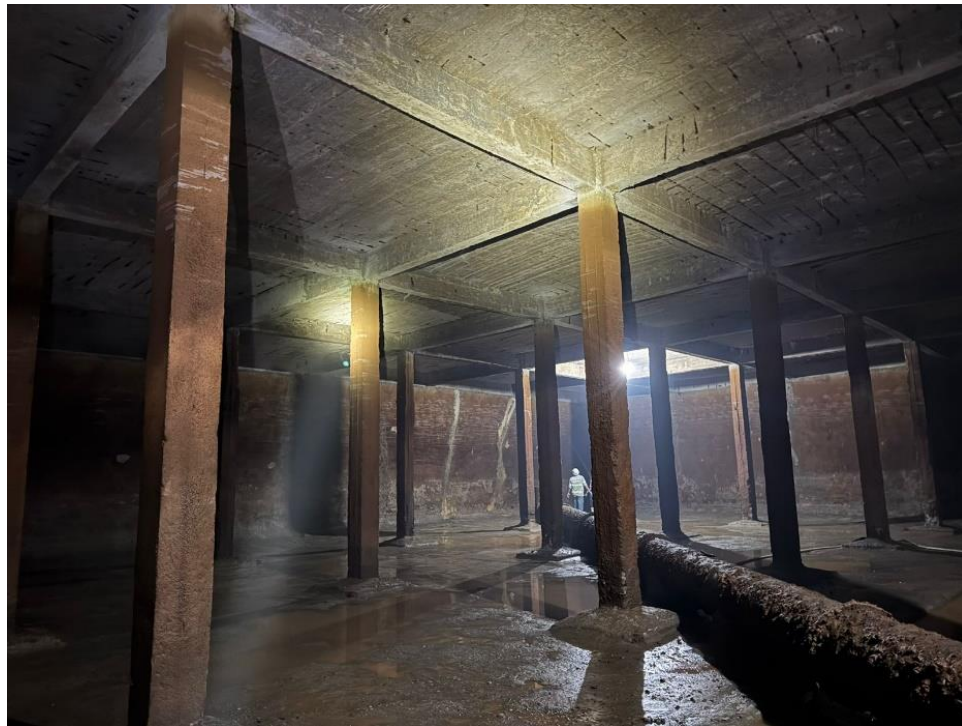
*Photo 3-1 Water reservoir No.1*

Water Reservoir No.1 (60x25m) represents reinforced concrete structure, including two similar sections. Reinforced concrete columns are arranged in the middle part of the reservoir, which are tied with beams in the upper part. The roof slab, basement and walls represent reinforced concrete structures (Photo 3-1).

Based on visual inspection it was observed that the right section of the reservoir is more damaged than the left. It was also revealed that during previous rehabilitation after opening of cracks reinforcement bars were not damaged and corroded.

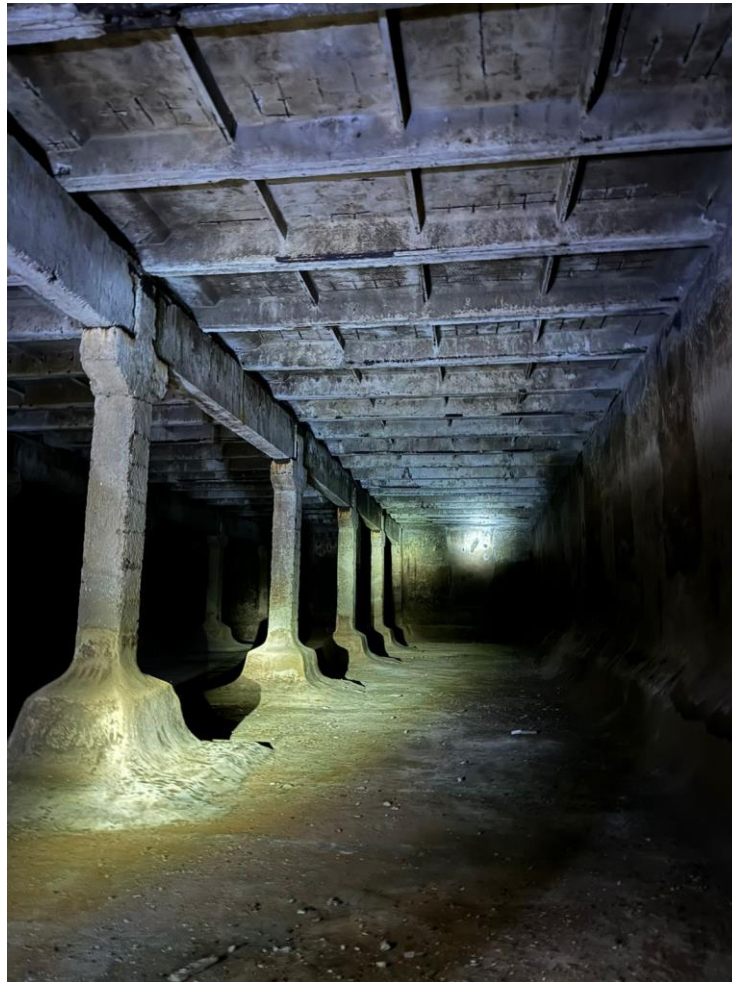
*Photo 3-6 Water reservoir No.2*

Water reservoir No.2 (36x36 m) was built with reinforced concrete precast structures, probably according to the typical design ТП 901-4-82с84 (Photo 3-6).

During the visual inspection, the following main damages of the water reservoir were observed:

1. On the precast roofing slabs the stripped off reinforcement bars are seen (Photo 3-7).
2. Cracks are observed on the walls and invert of the water reservoir (Photo 3-8).
3. The waterproofing layer is damaged on the inner side of the water reservoir (Photo 3-9).
4. According to the local engineers information, the Ø300 mm drain pipe of the reservoir is damaged and not operational (Photo 3-10).

1. Cleaning and treatment of the stripped reinforcement bars of reservoir structures with anti-corrosion material.
2. Treatment of cracks on reservoir walls and invert should be carried out according to the degree of damage and opening width.
3. After the treatment of the cracks, the layer of reinforced mortan should be arranged on the water reservoir invert.
4. A new insulating layer should be arranged on the invert and walls with a waterproofing material, applicable for drinking water reservoirs.
5. The damaged Ø300 mm drain pipe of the reservoir should be replaced.
