Inspection of the technical condition of the Tbilisi Mall facade
Contract No. 01/12-2025 dated 02.12.2025

01/12-2025-TR		
		Sheet	No. doc	Signed	Date			
Director		Savchenko			01.2026	Inspection of the technical condition of the Tbilisi Mall facade		
Engineer		Shuranov			01.2026			
							Stage	Page
								Pages
								2 75

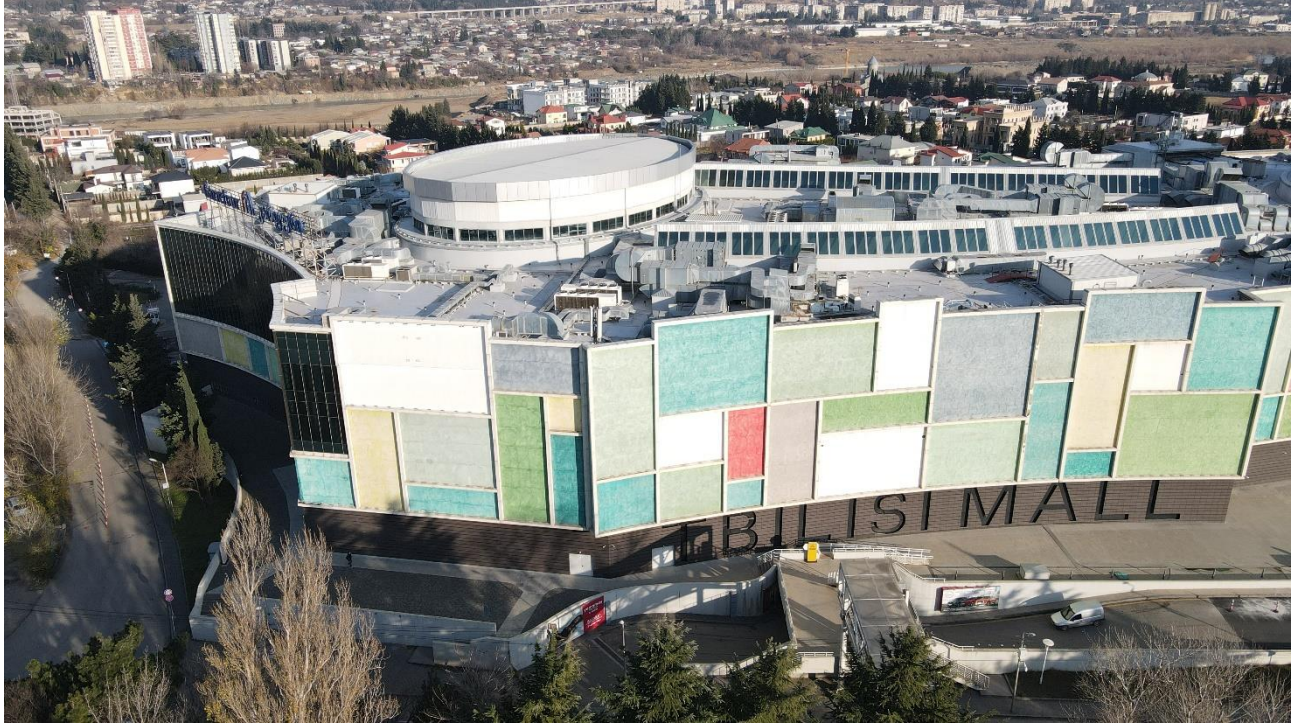
Figure 5.1.1. General view of the facade in axes 4-6/A

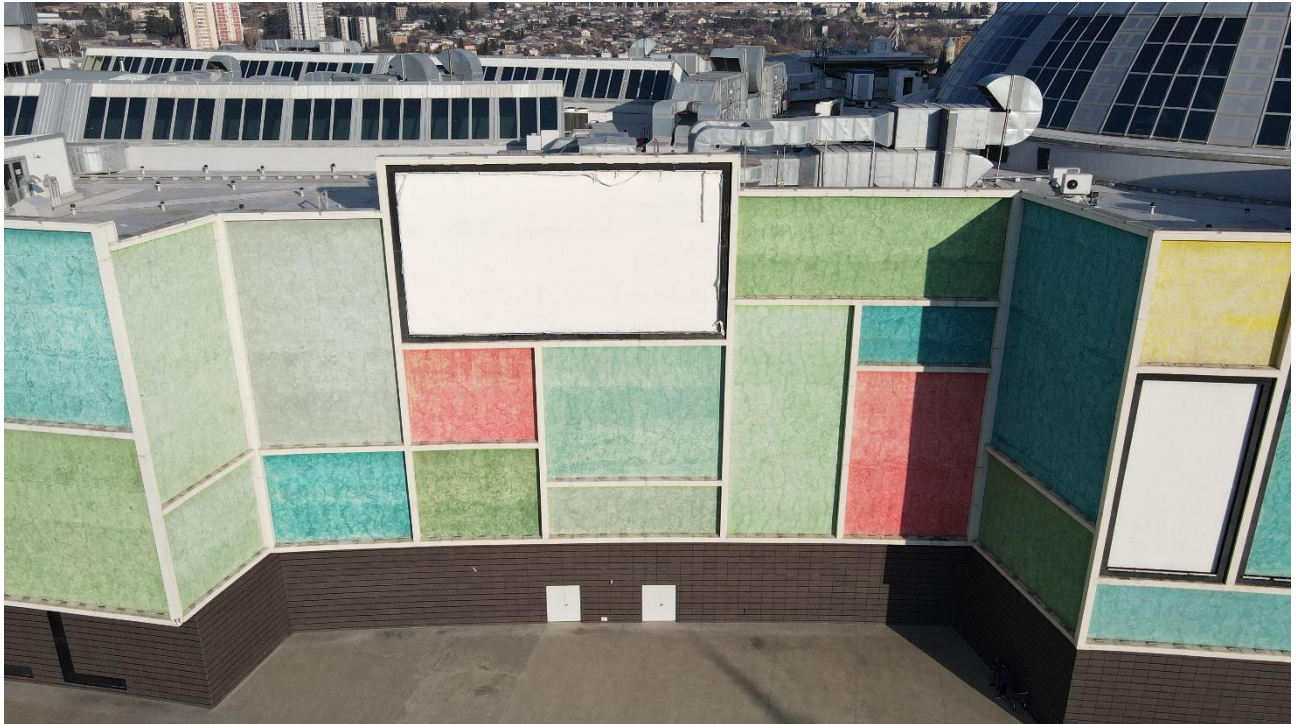
Figure 5.1.2. General view of the facade in axes 3-4/A

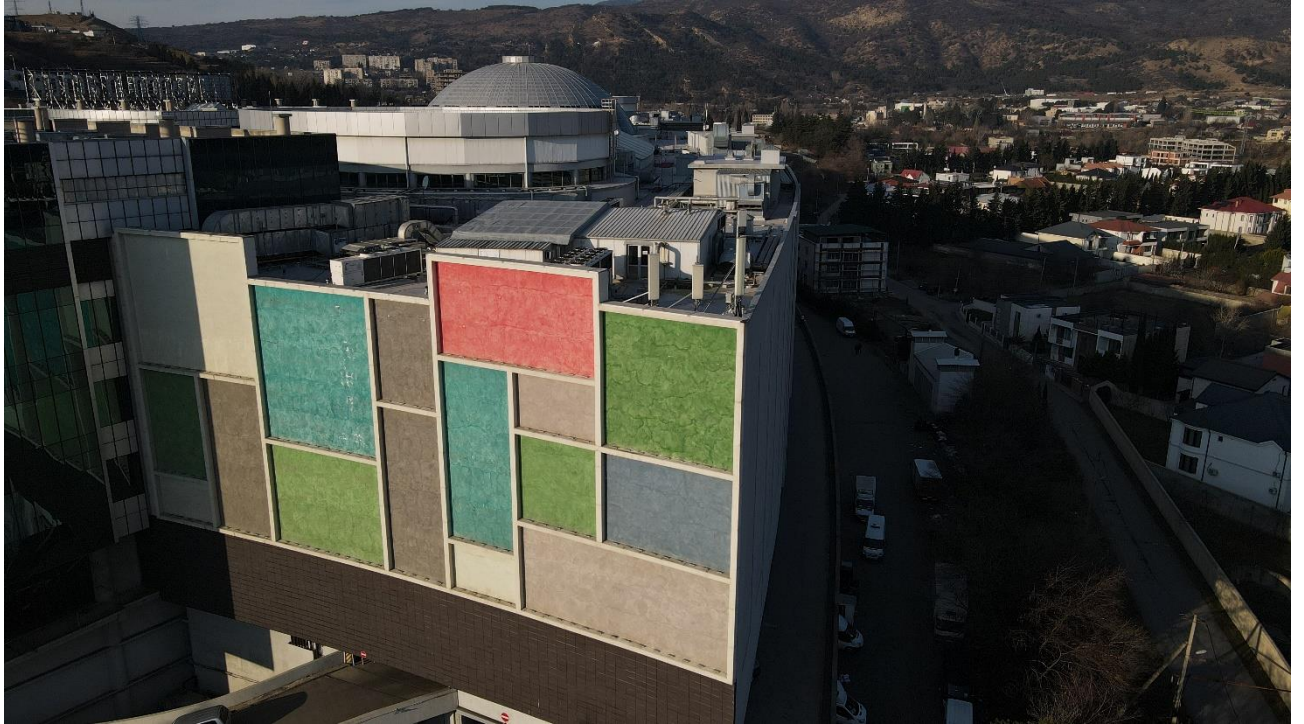
Figure 5.1.4. General view of the facade in axes B-C/1

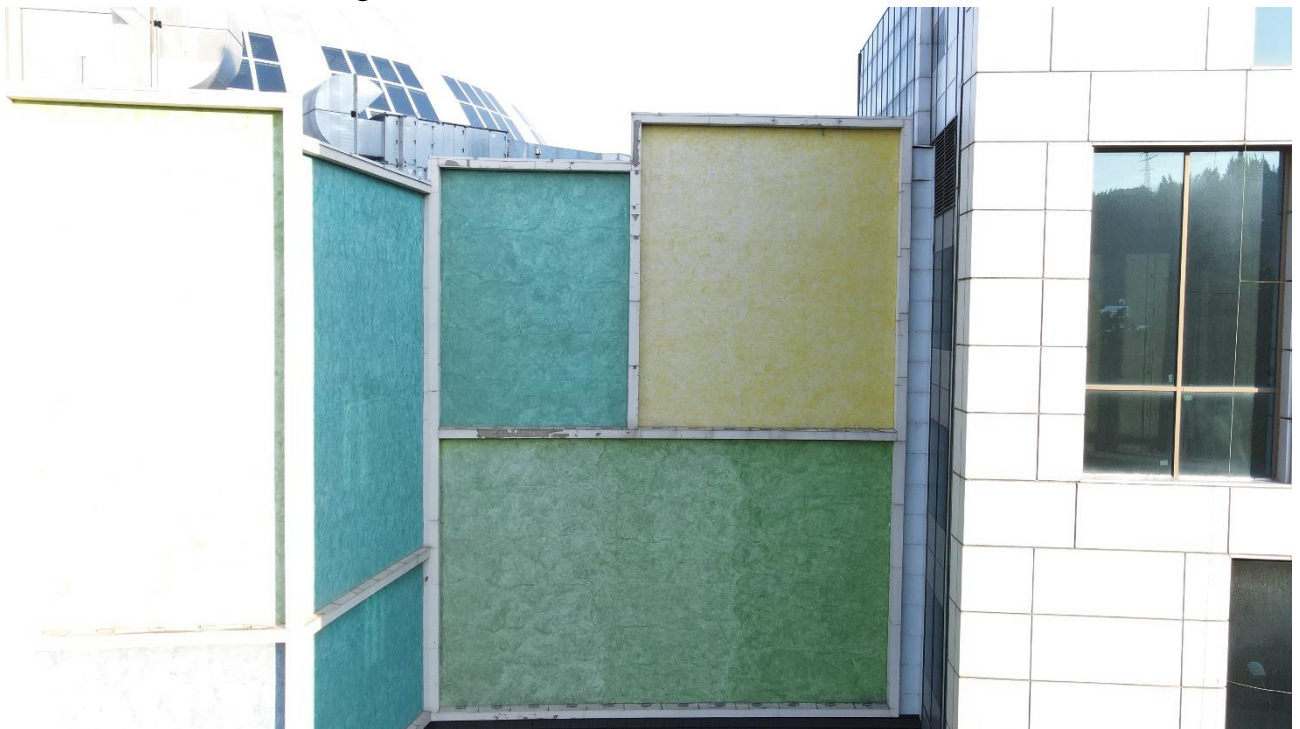
Figure 5.1.6. General view of the facade 3-4/A

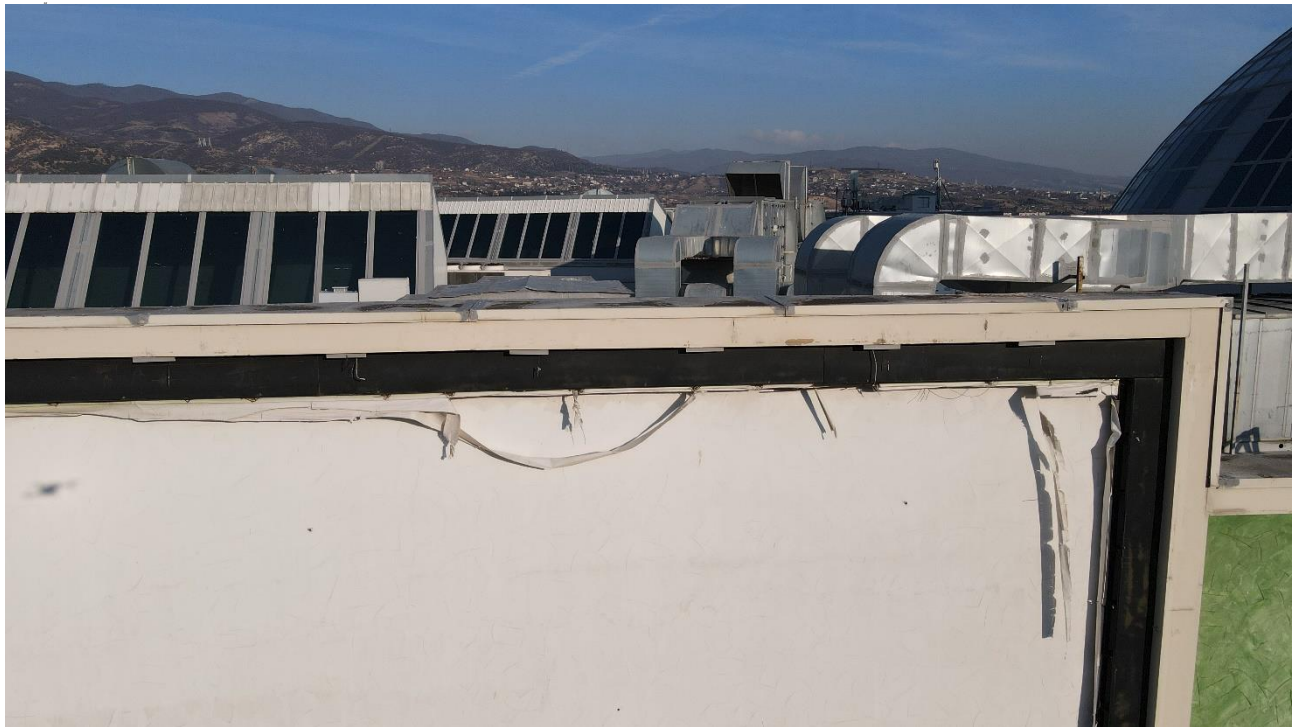
Figure 5.1.7. Place for attaching an advertising banner. Fragments of the banner

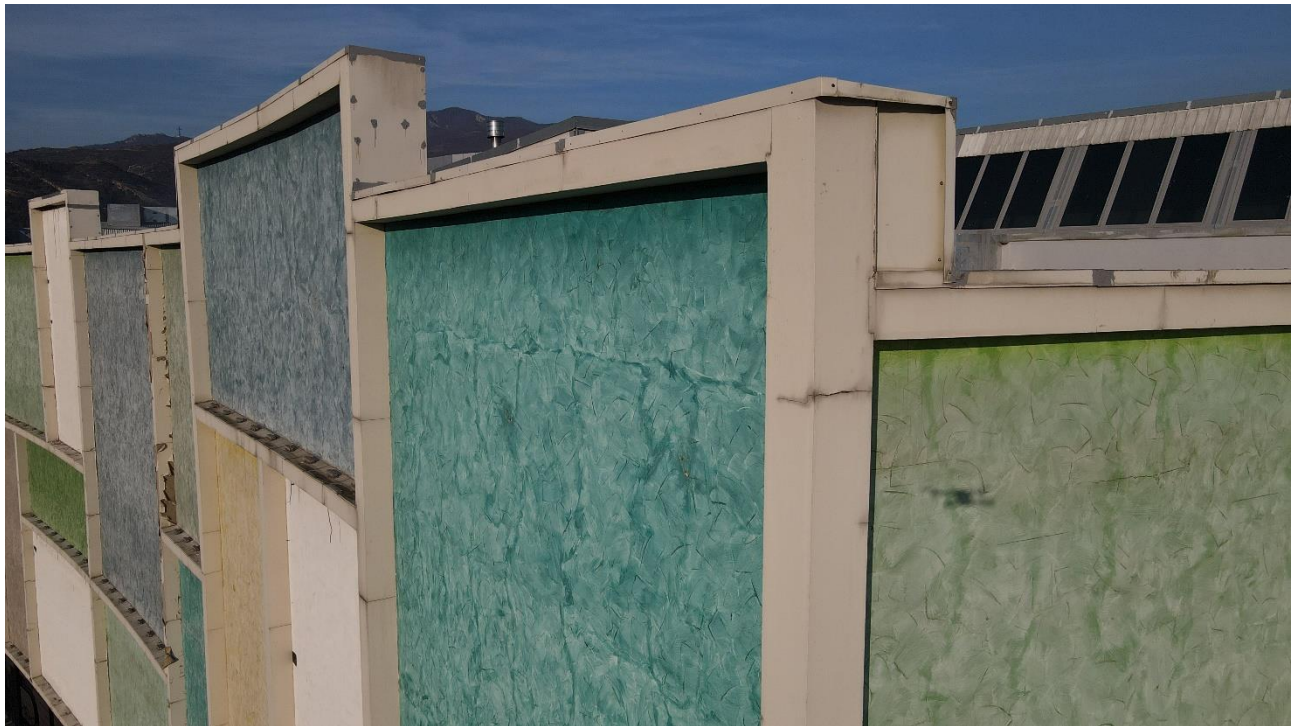
Figure 5.1.8. General view of the facade

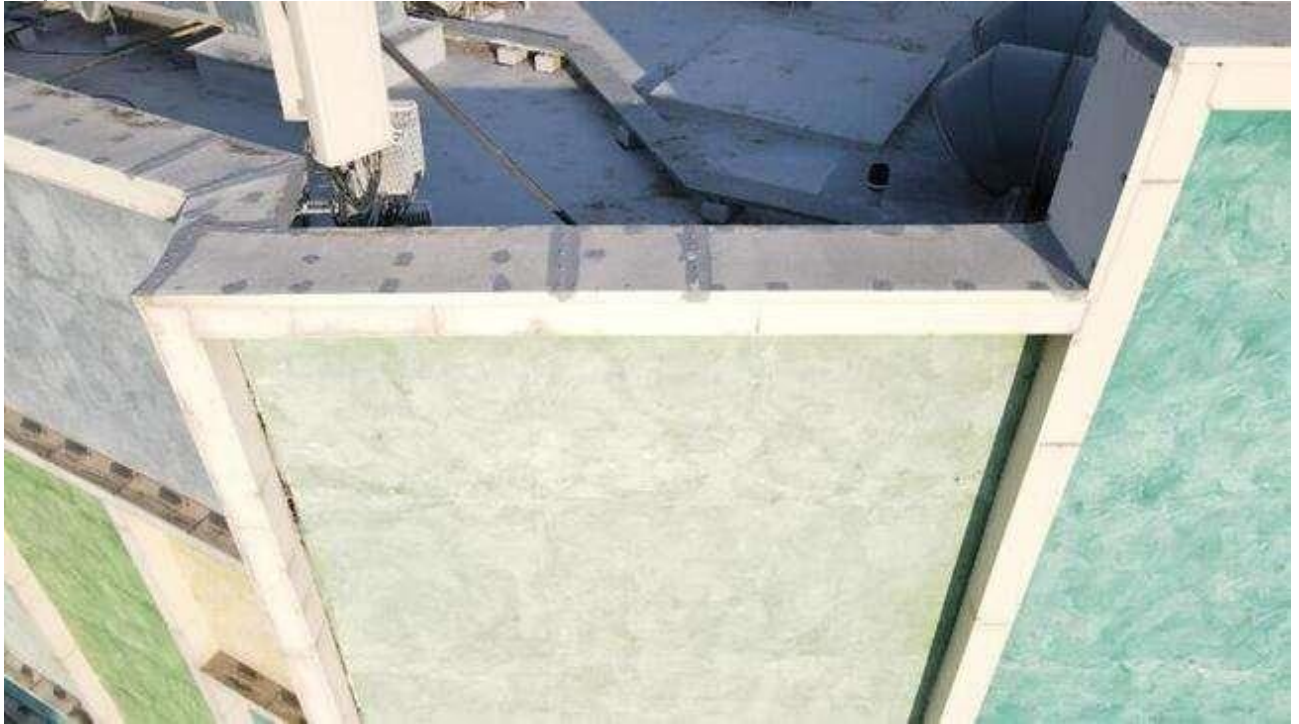
Figure 5.1.11. Drip molding along the upper edge of the facade. The joints of the drip molding are treated with sealant

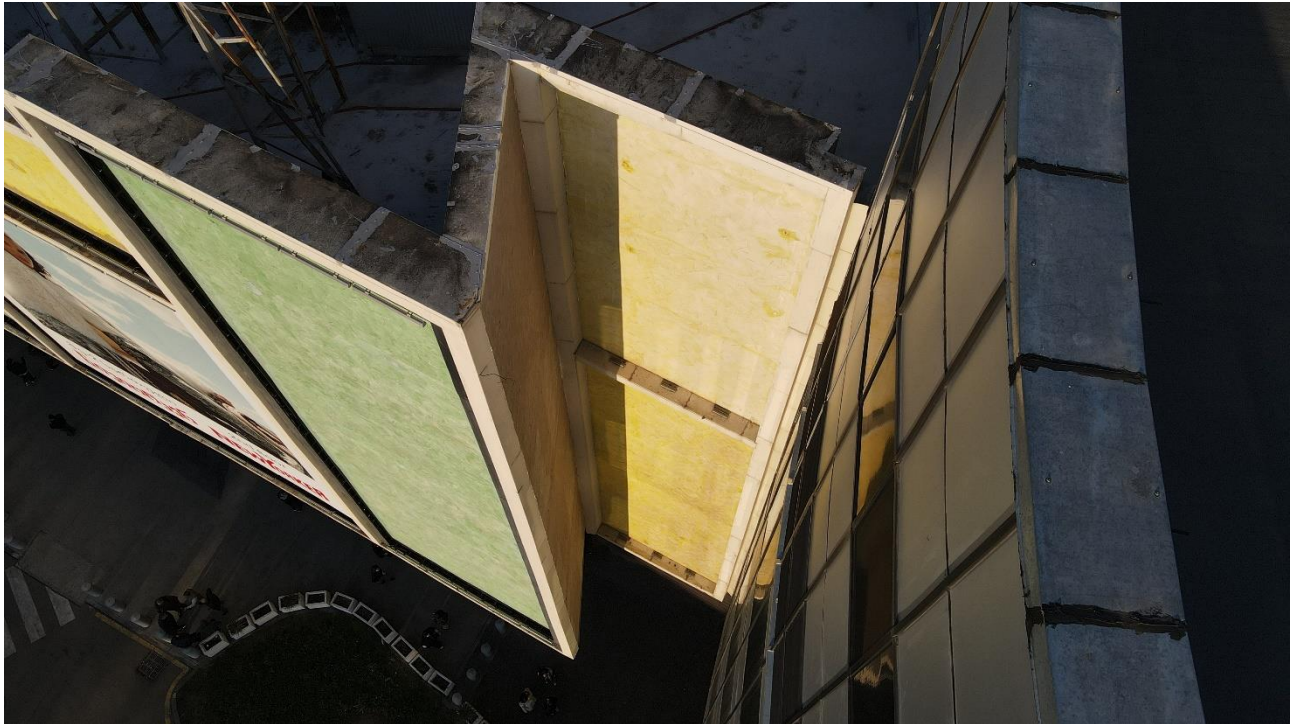
Figure 5.1.21. Section of the building facade

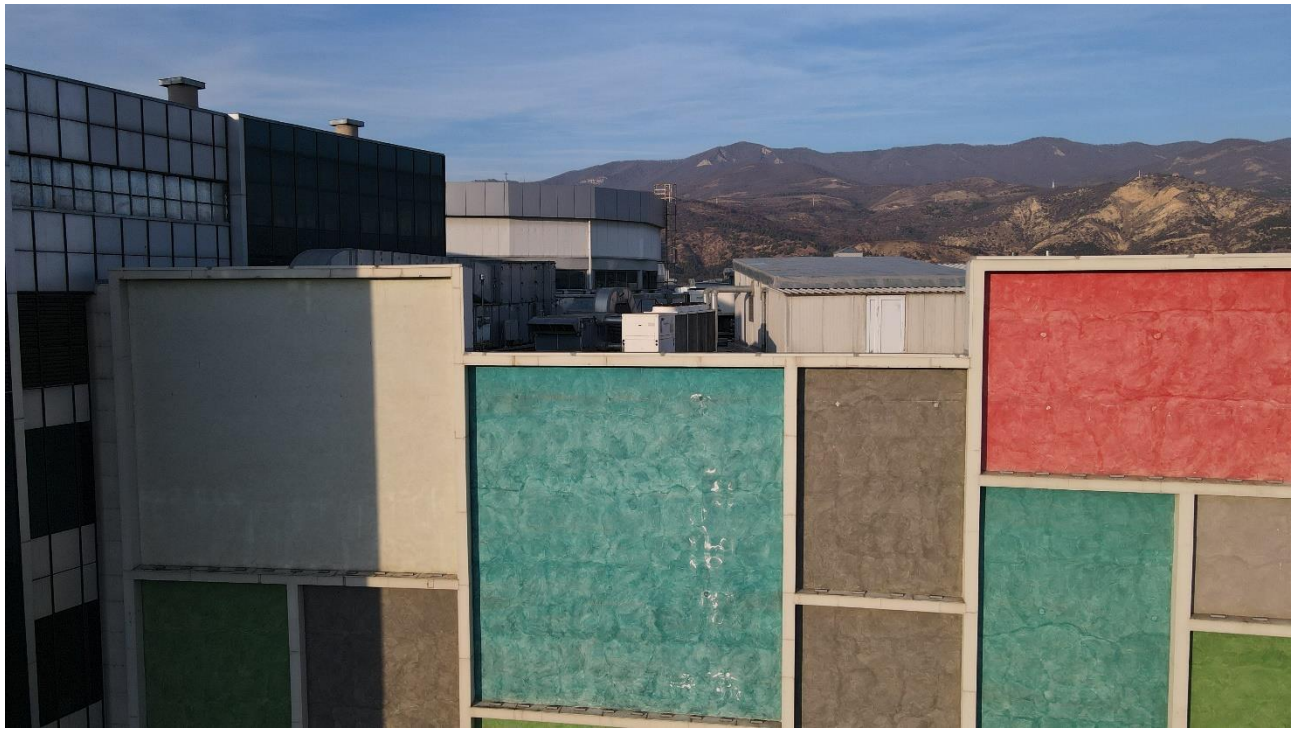
Figure 5.1.22. Section of the building facade

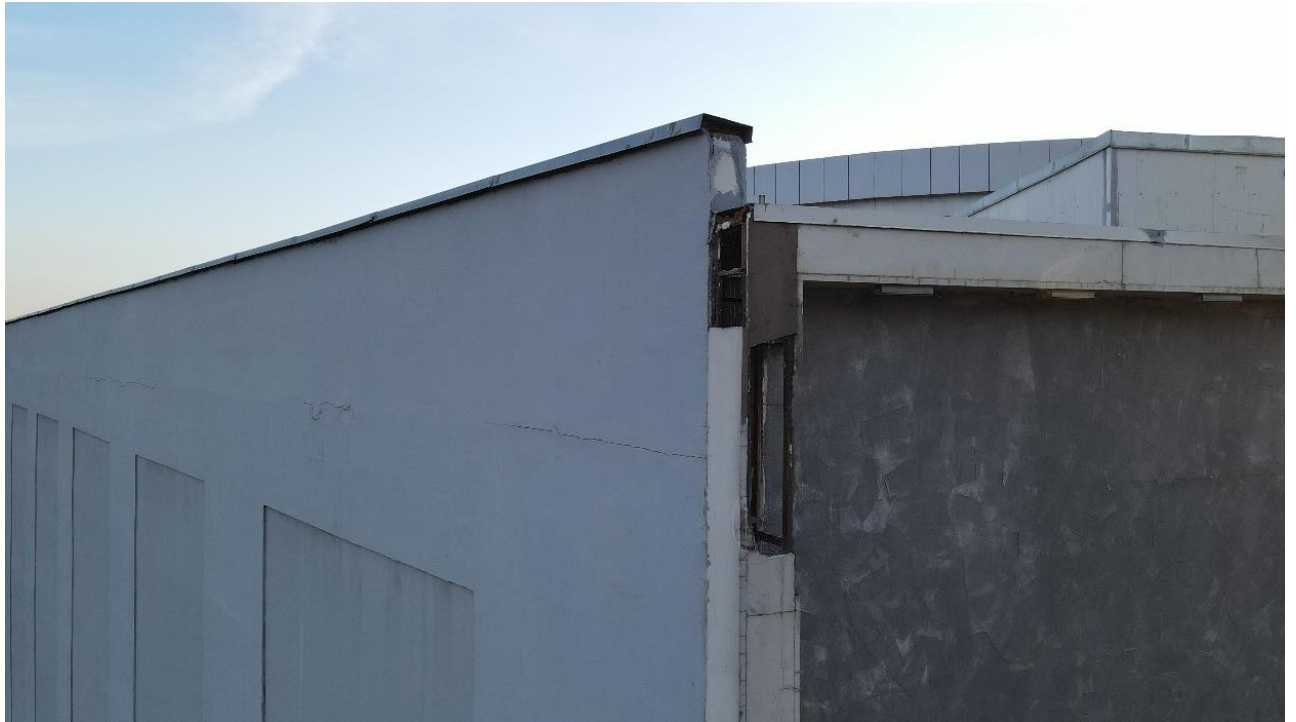
- Massive (more than 40%) minor defects in the form of surface corrosion of the metal frame of the pilasters. This defect is caused by partial destruction of the protective and finishing layer of metal;

Figure 5.1.25. Facade junction along axis 6/C. Destruction of vertical impost

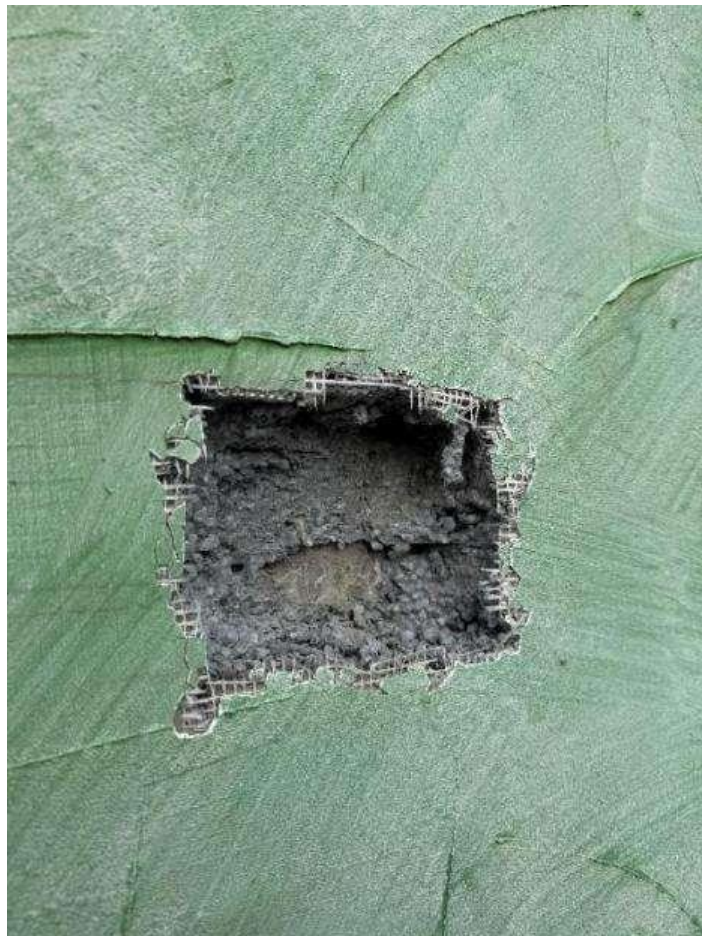
Figure 5.1.30. Opening of the facade

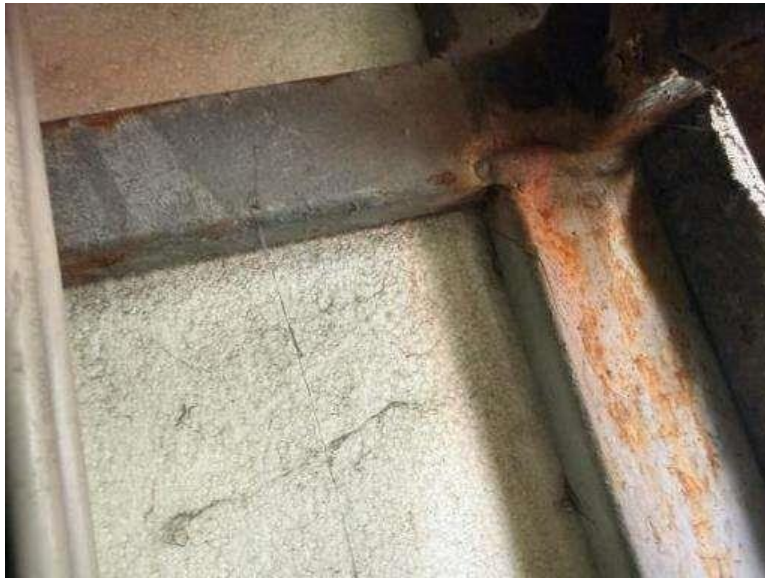
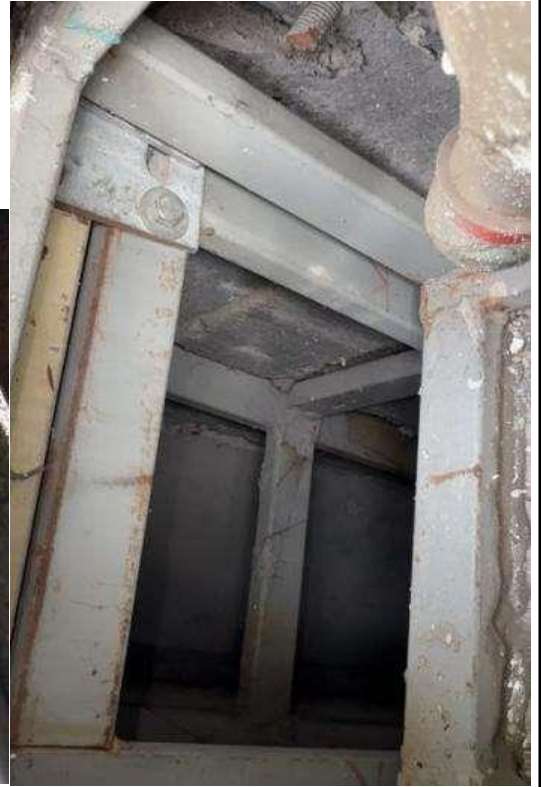
Figure 5.1.31. Connection of the vertical and horizontal frames of the facade impost.
Surface corrosion

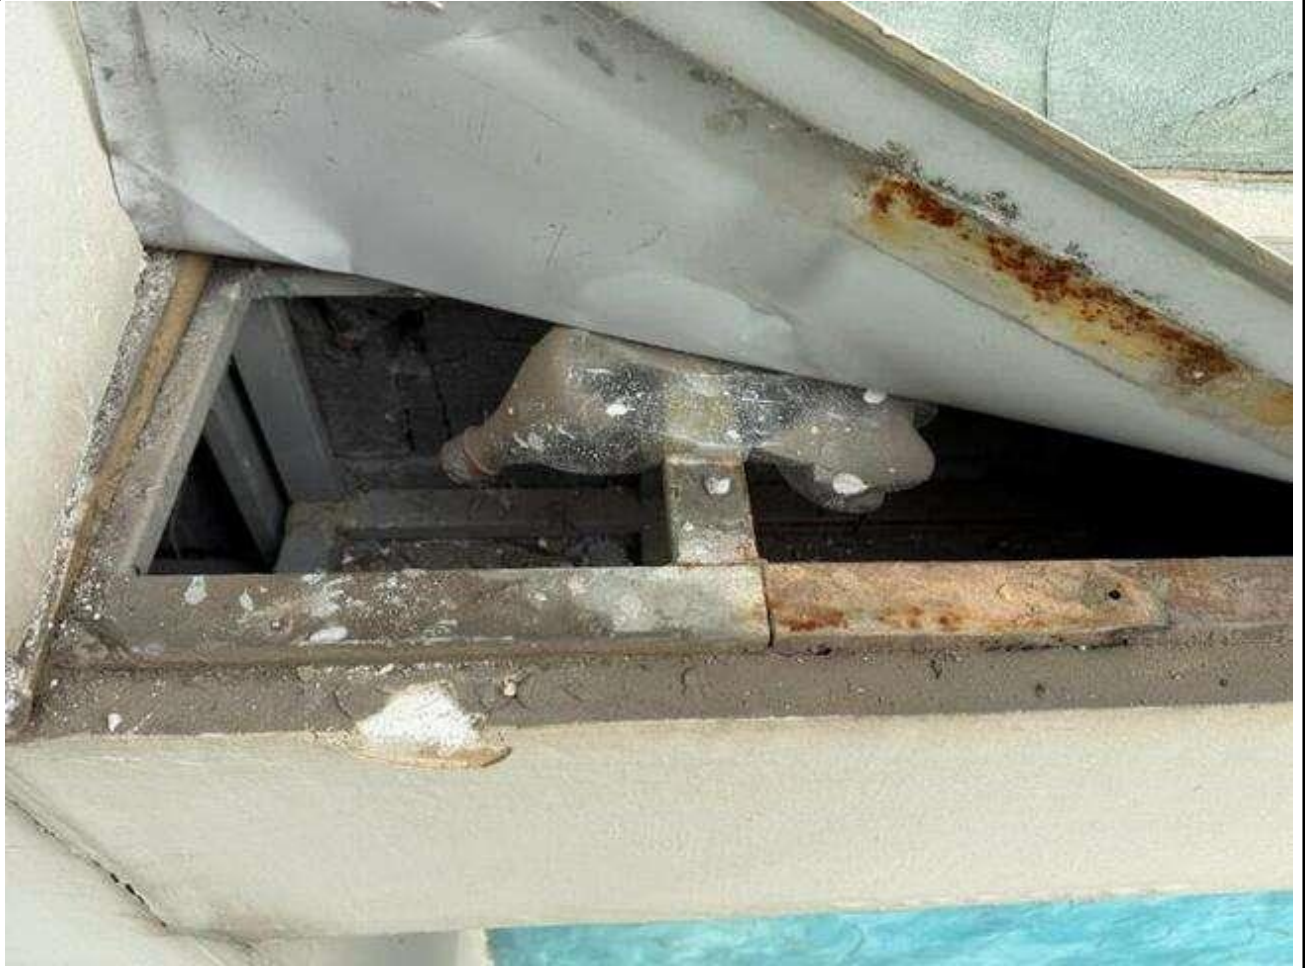
Figure 5.1.33. Opening of the horizontal impost

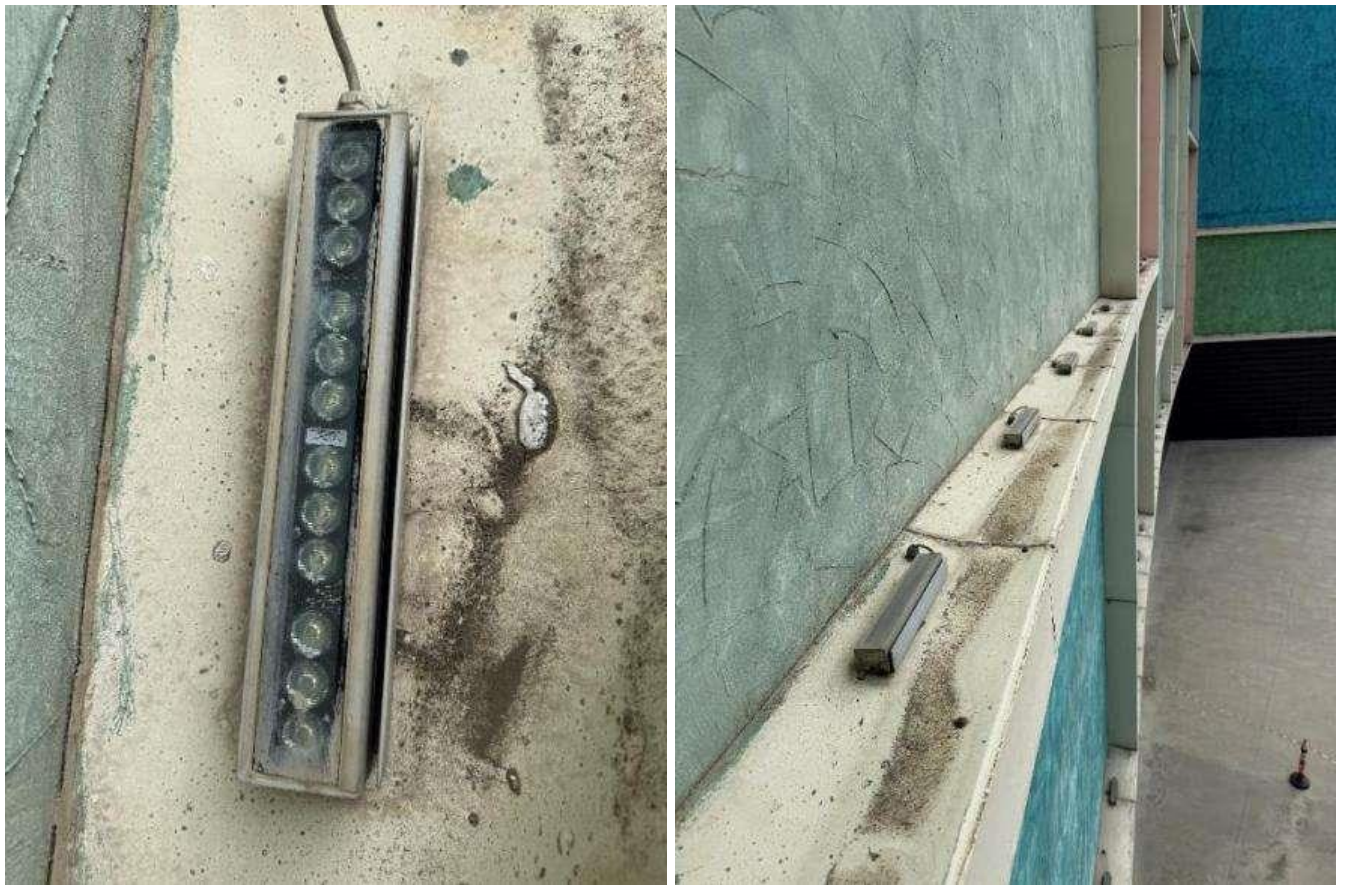
Figure 5.1.34. Facade lighting in the design of horizontal imposts

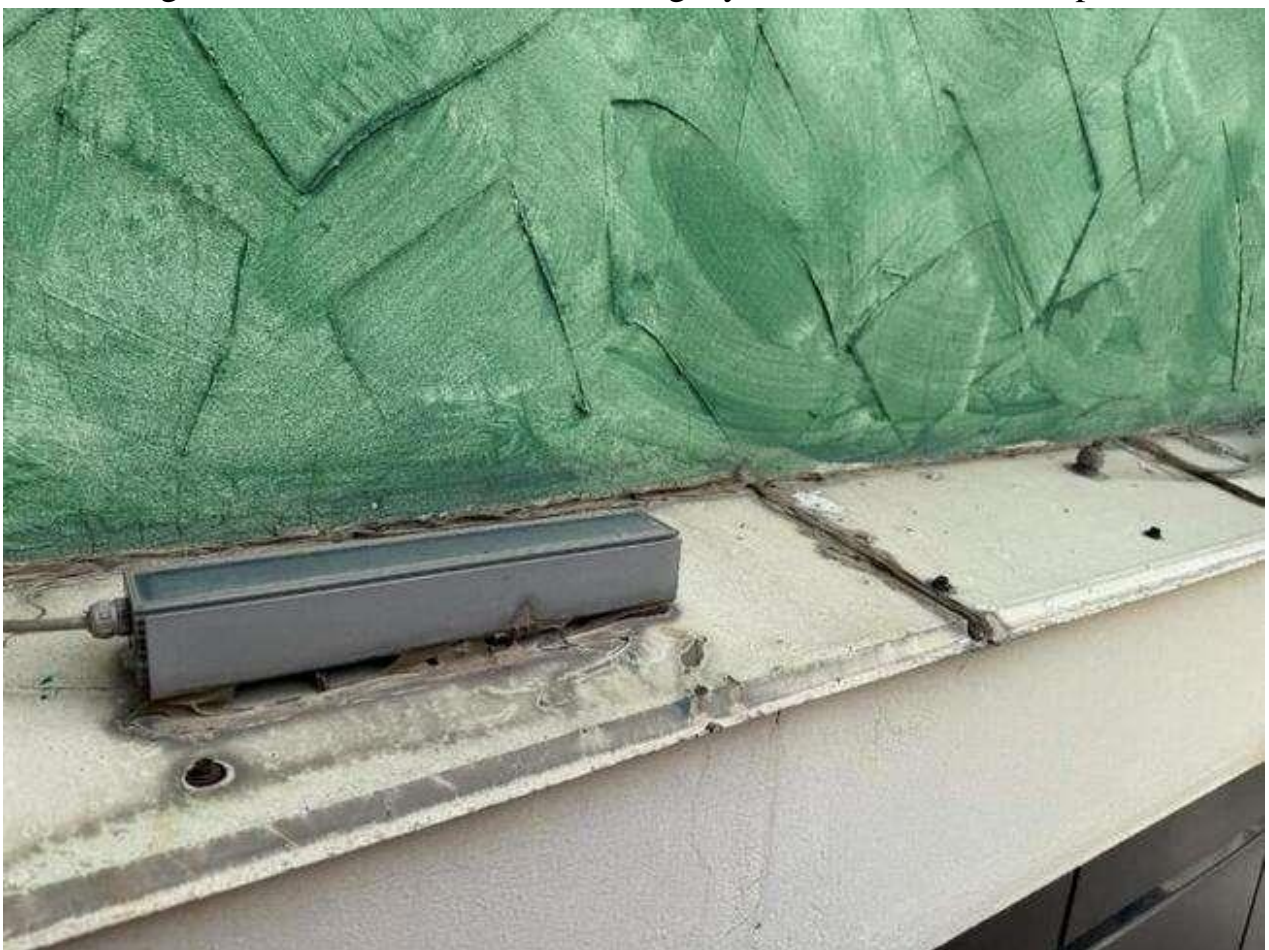
Figure 5.1.40. Sealant in the flashings of horizontal imposts

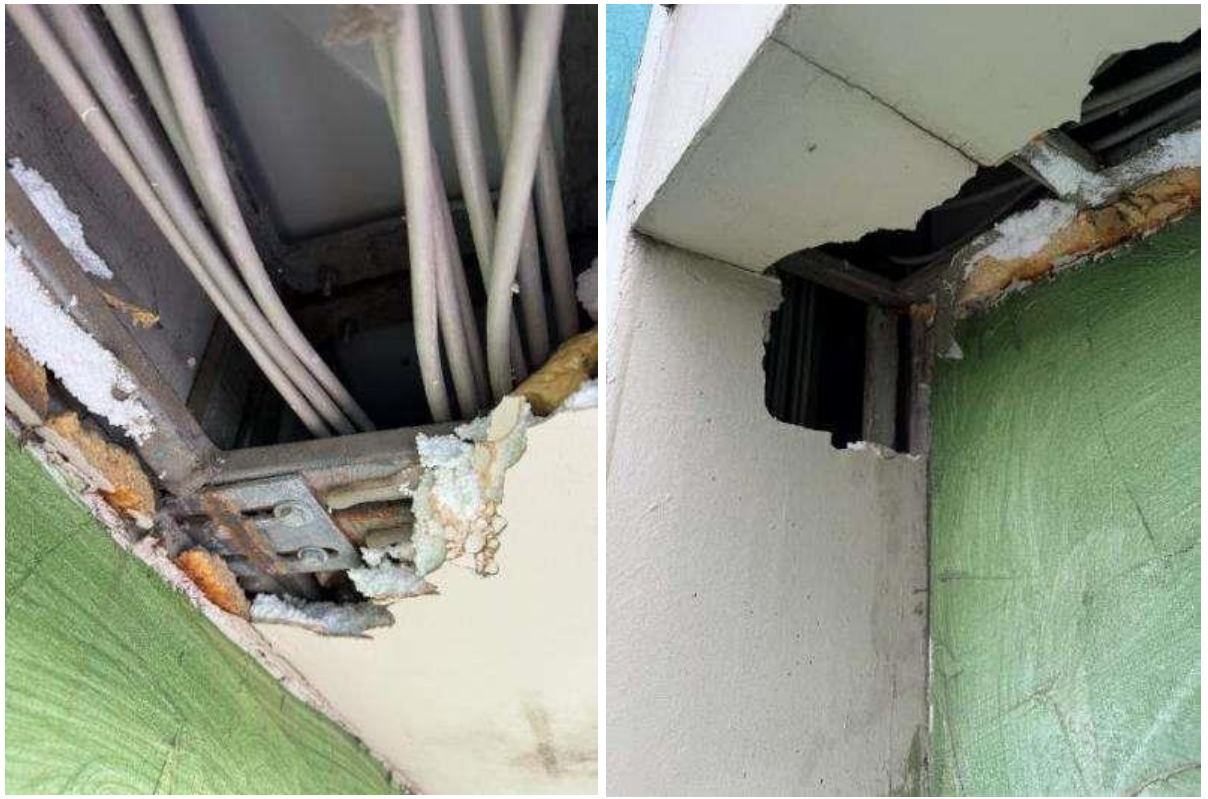
Figure 5.1.41. Fastening of horizontal imposts to the wall

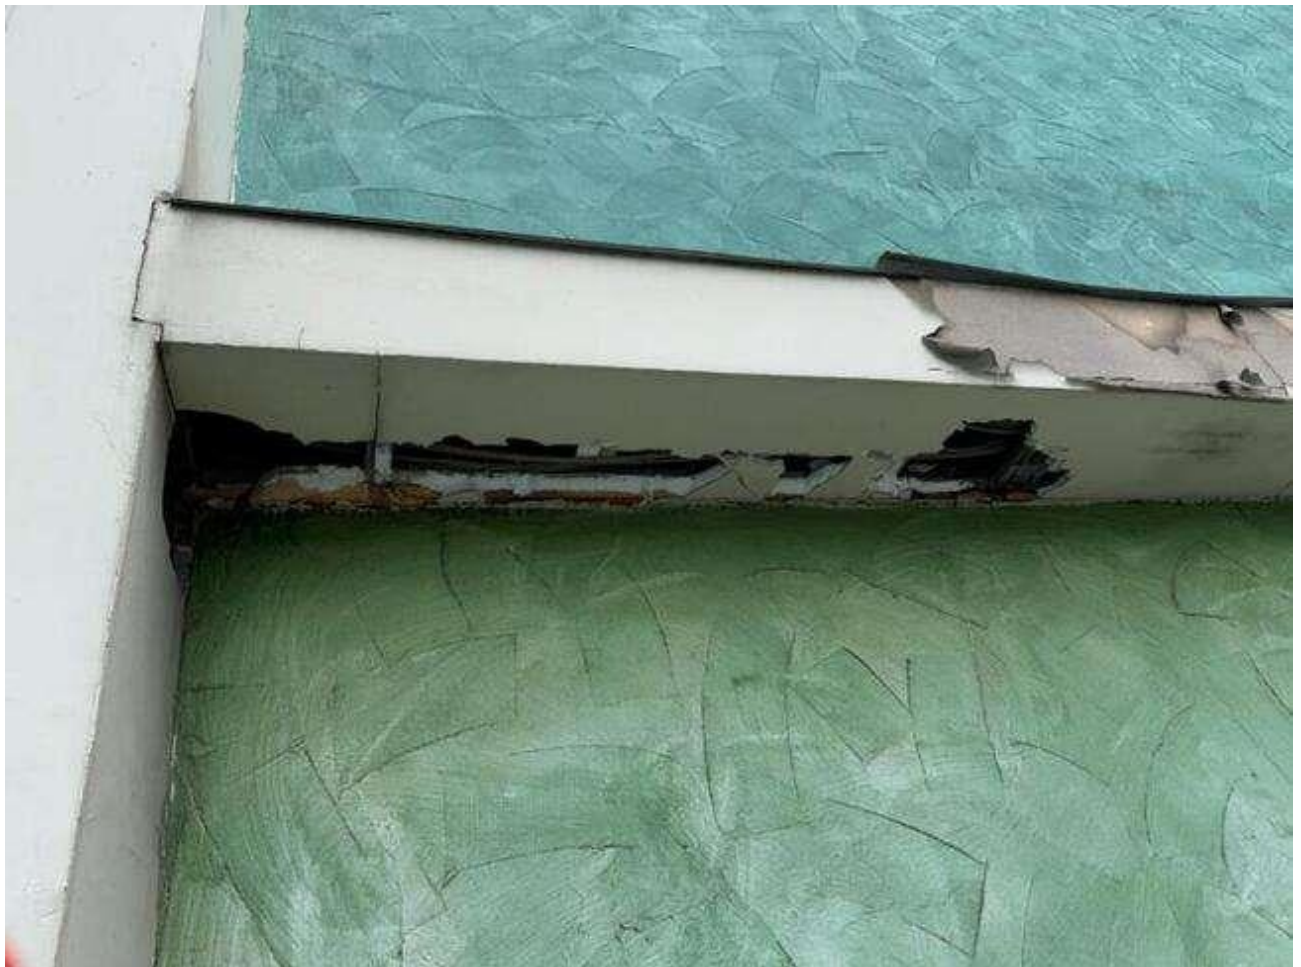
Figure 5.1.42. Opening the finishing layer of the horizontal impost

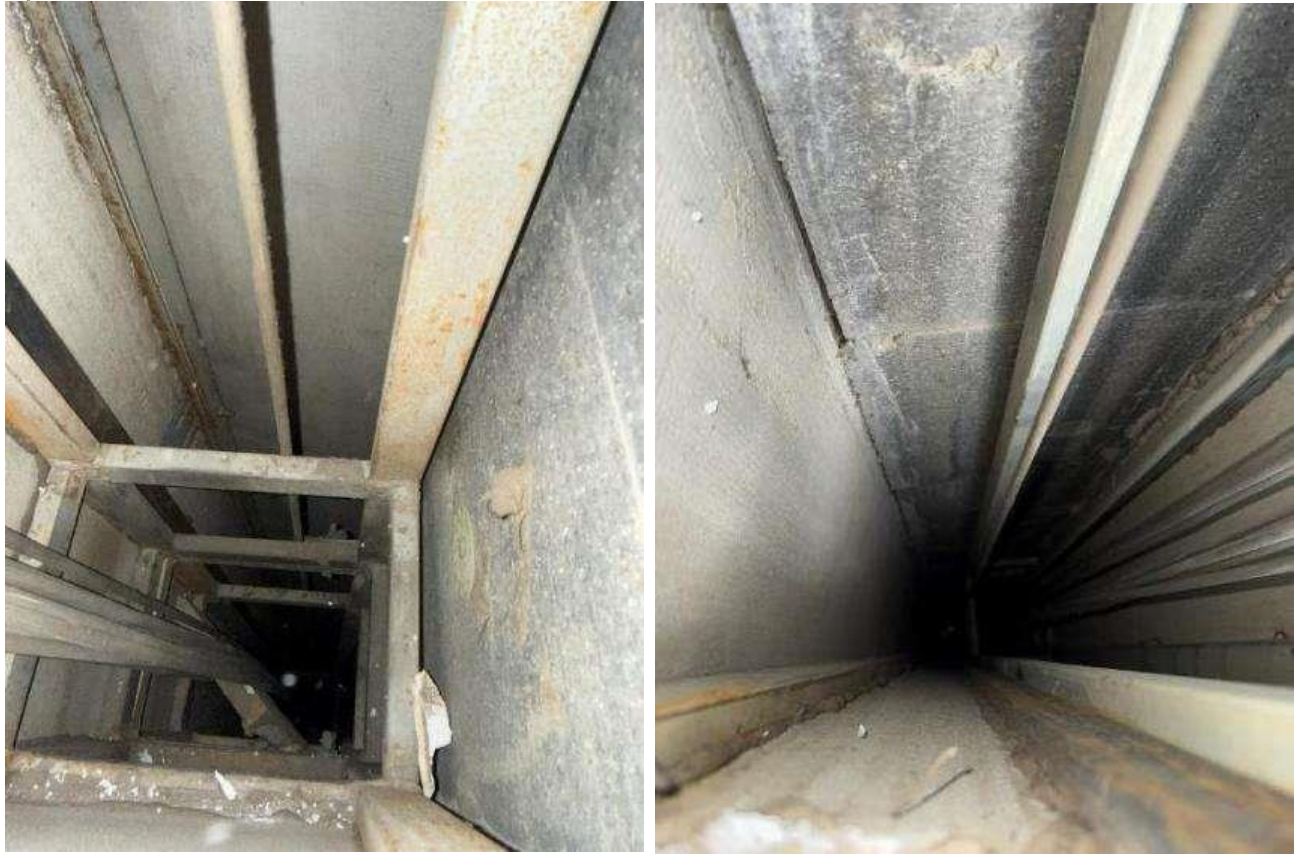
Figure 5.1.42. Frame of a vertical impost

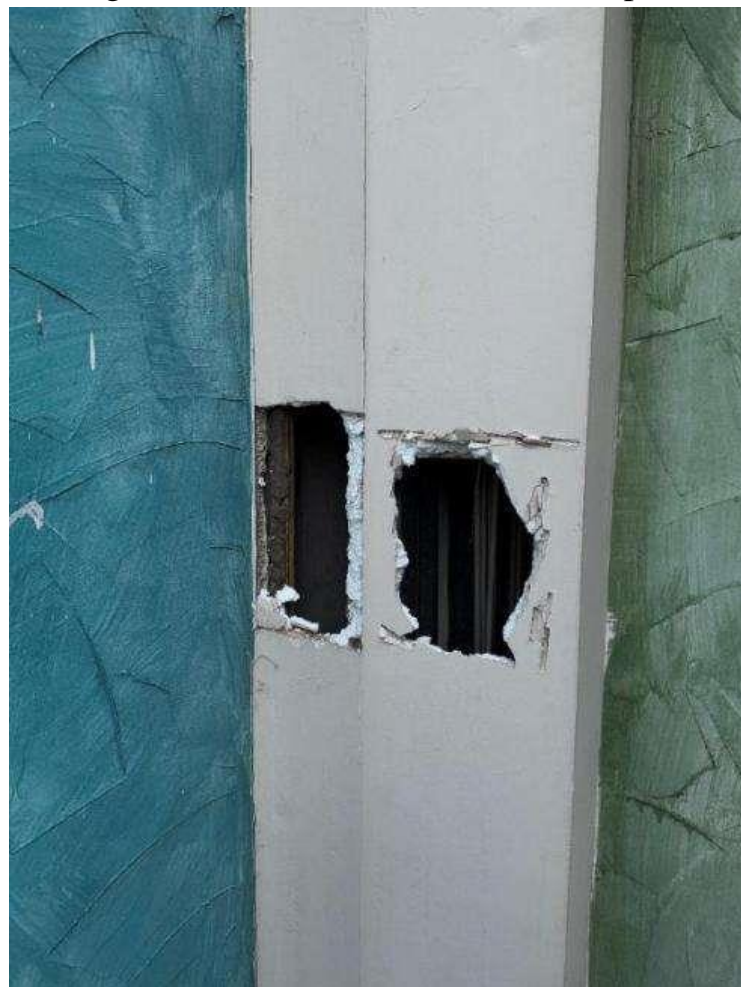
Figure 5.1.43. Opening the finishing layer of a vertical impost

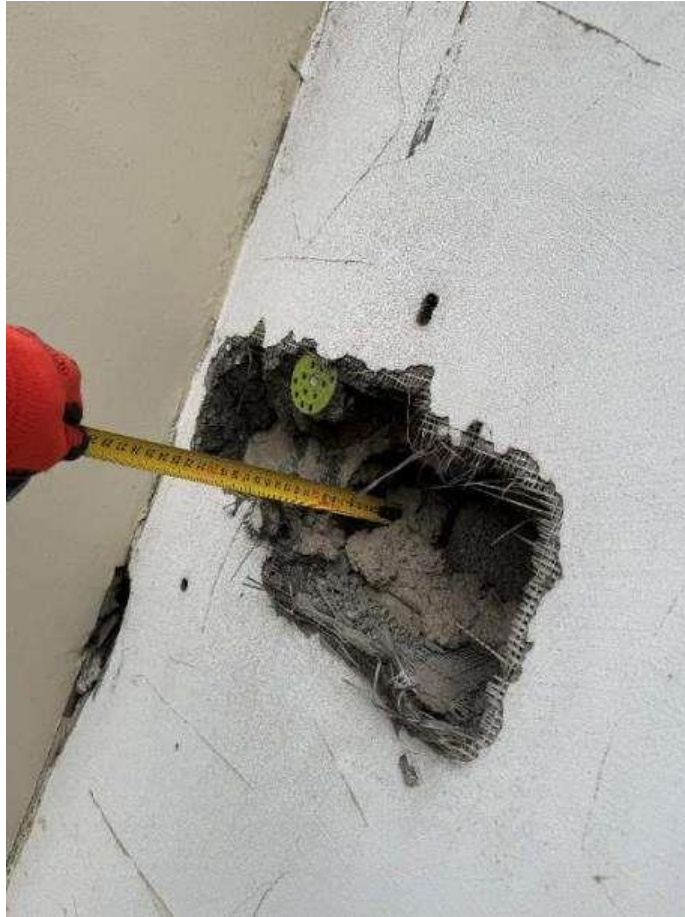
Figure 5.1.44. Exposure of the wall finishing layer

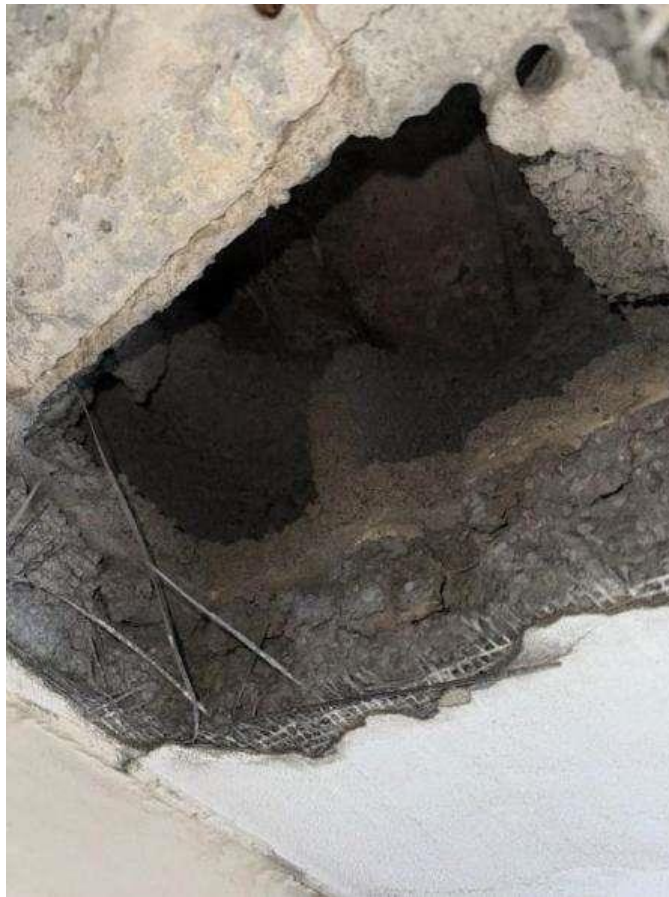
Figure 5.1.46. Aerated concrete block of the building wall

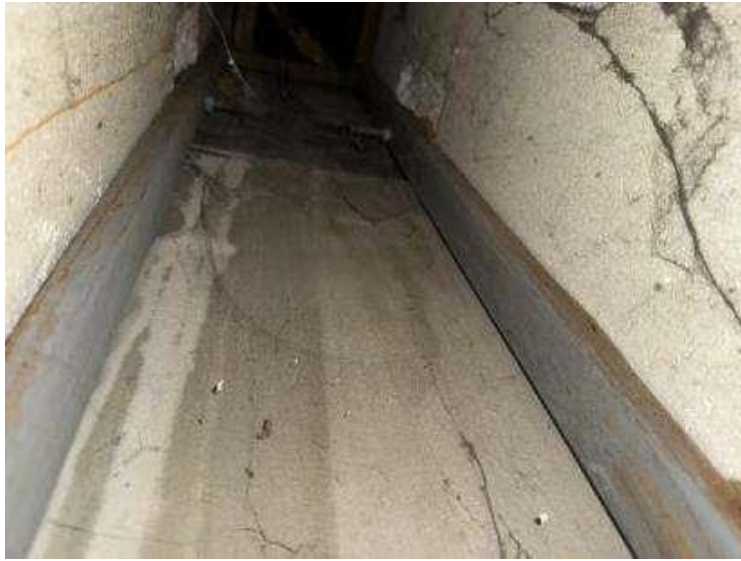
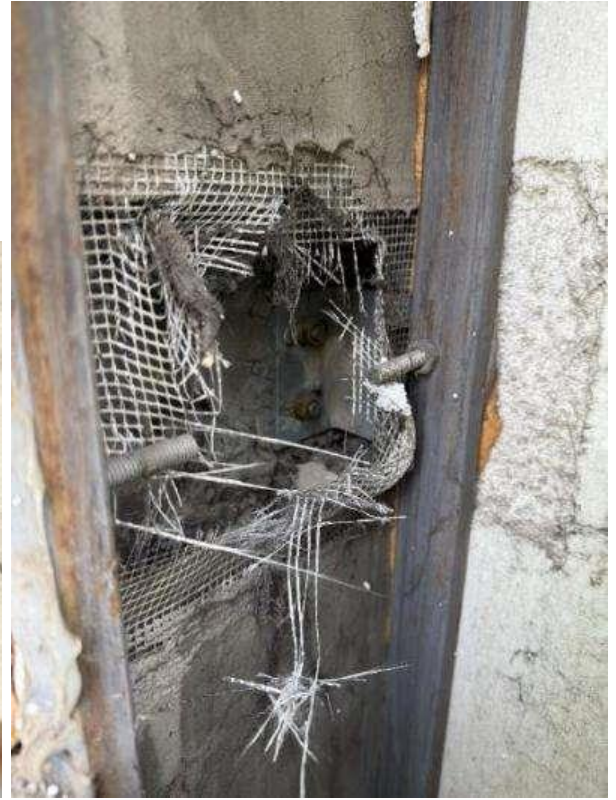
Figure 5.1.48. Fastening of the building impost frame to the wall

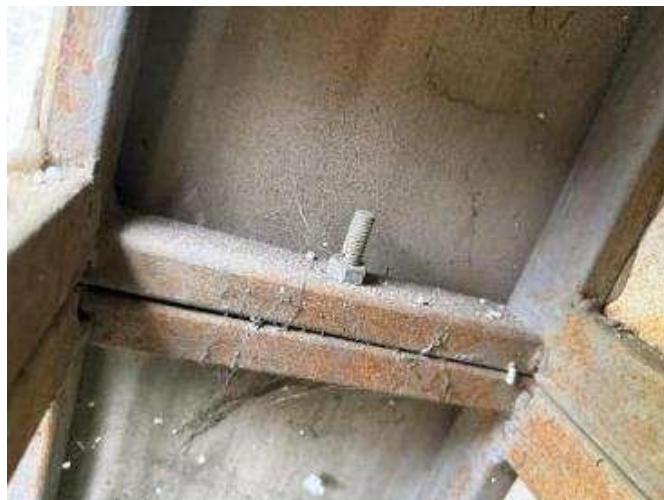
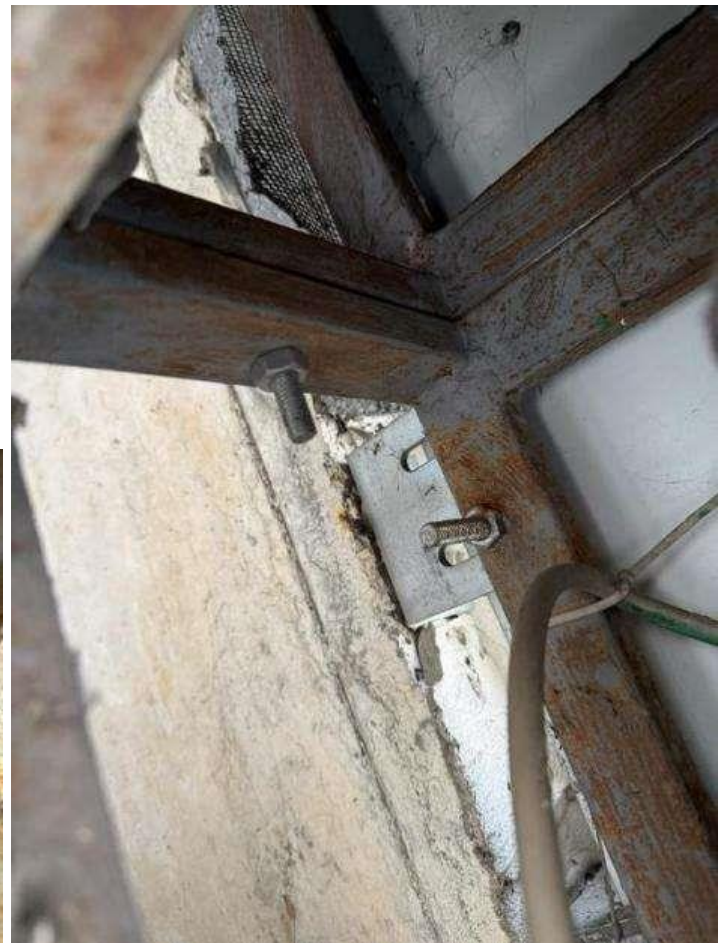
Figure 5.1.49. Fastening the frame of the building impost to the wall. Connecting the frame elements to each other
