Inspection of the technical condition of the Tbilisi Mall facade
Contract No. 01/12-2025 dated 02.12.2025

01/12-2025-TR		
		Sheet	No. doc	Signed	Date			
Director		Savchenko			01.2026	Inspection of the technical condition of the Tbilisi Mall facade		
Engineer		Shuranov			01.2026			
							Stage	Page
								Pages
								2 75

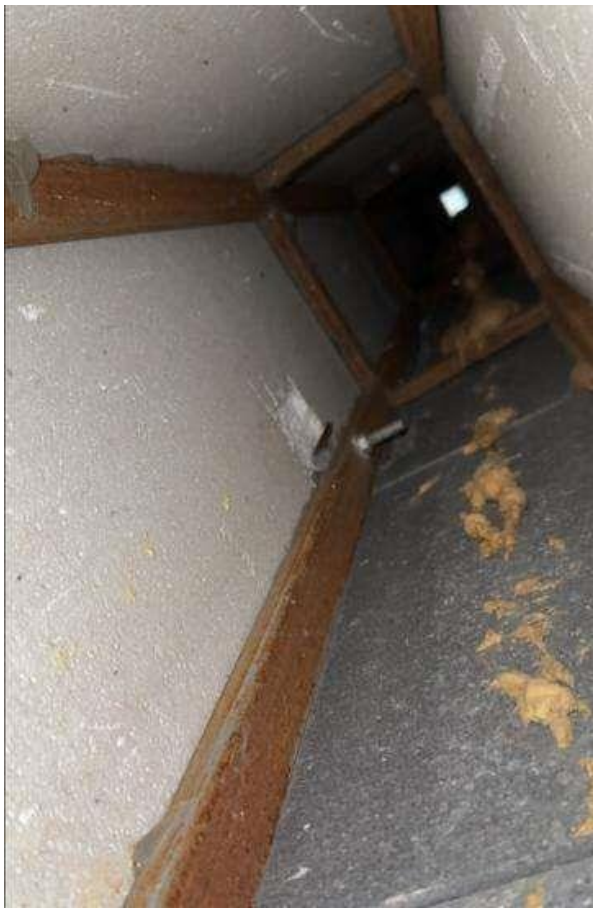
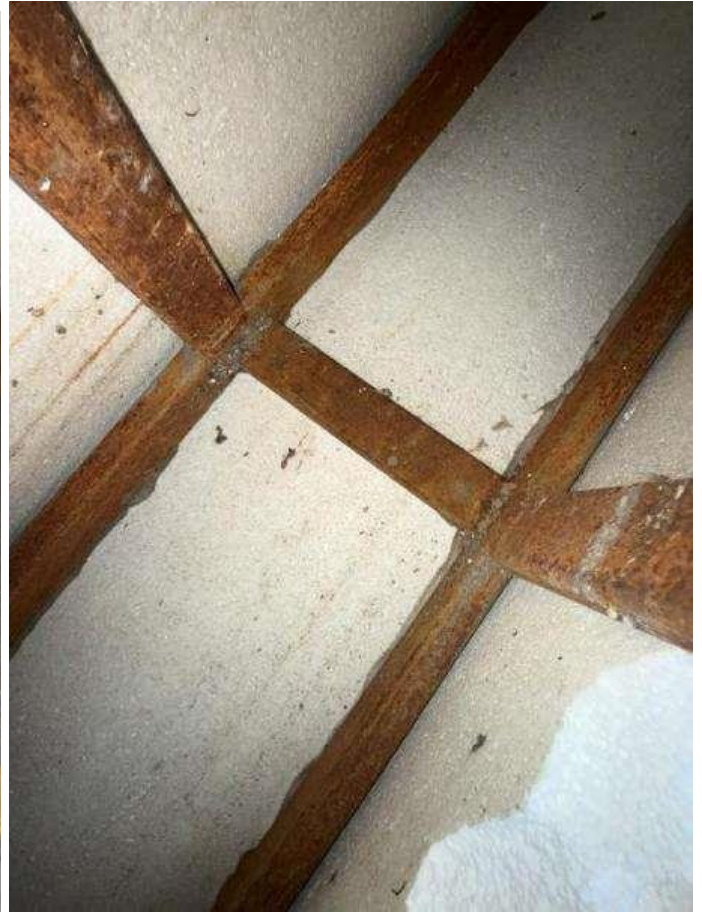
Figure 5.1.50. Fastening the building impost frame to the wall

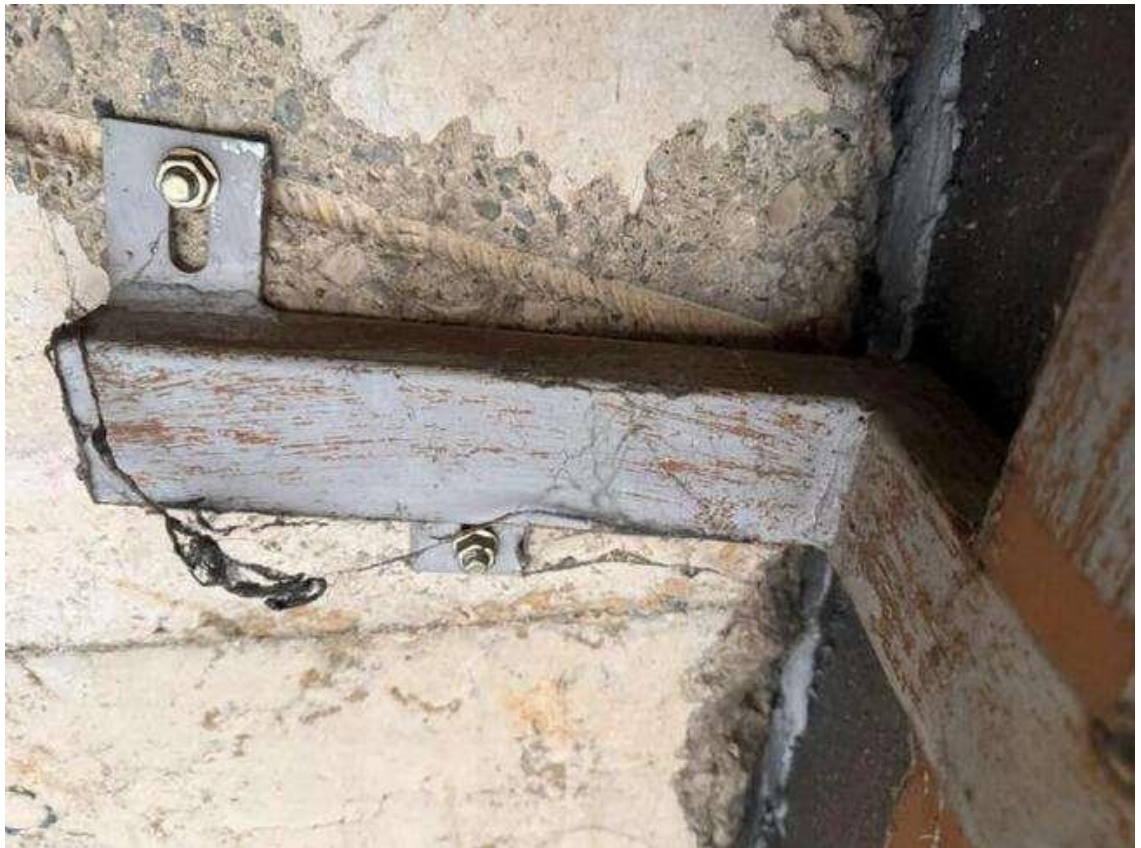
Figure 5.1.51. Fastening the building impost frame to the slab at elevation +6.000

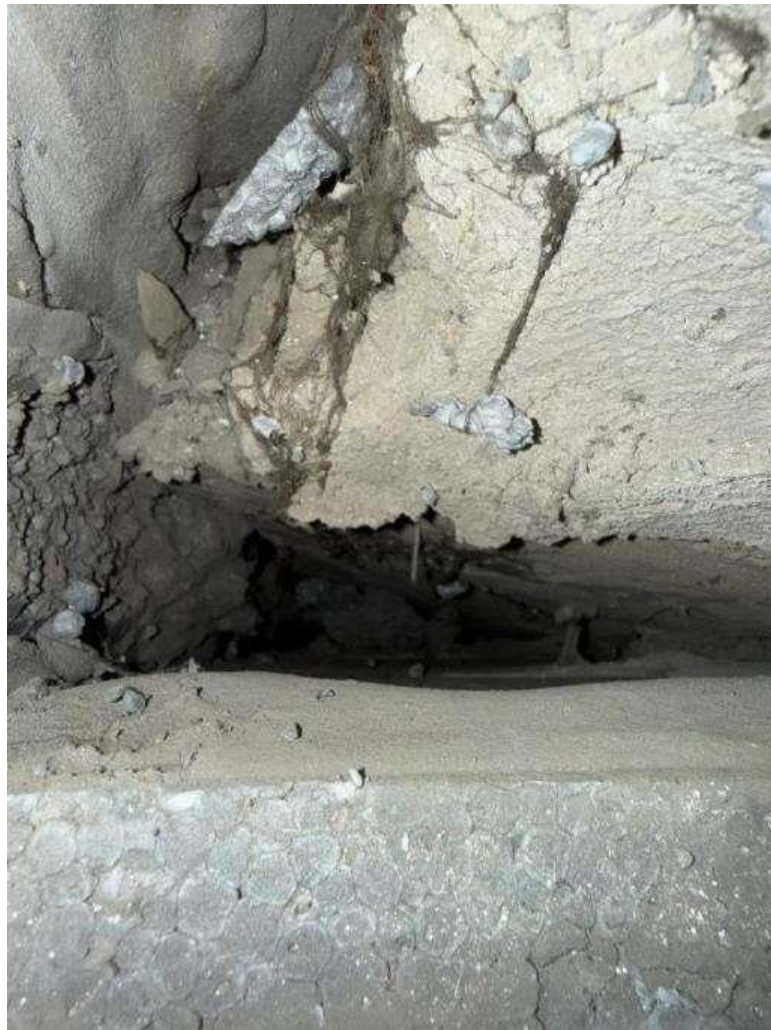
- isolated (up to 10%) significant defects in the form of detachment of the insulating layer from the wall and the formation of stress cracks; this defect is located in A-B/1 and 5-6/A. This defect arose due to the unevenness of the bonding base (exceeding Table 1) and insufficient mechanical fastening.

Figure 5.1.55. Gap up to 50 mm between the insulation and the wall

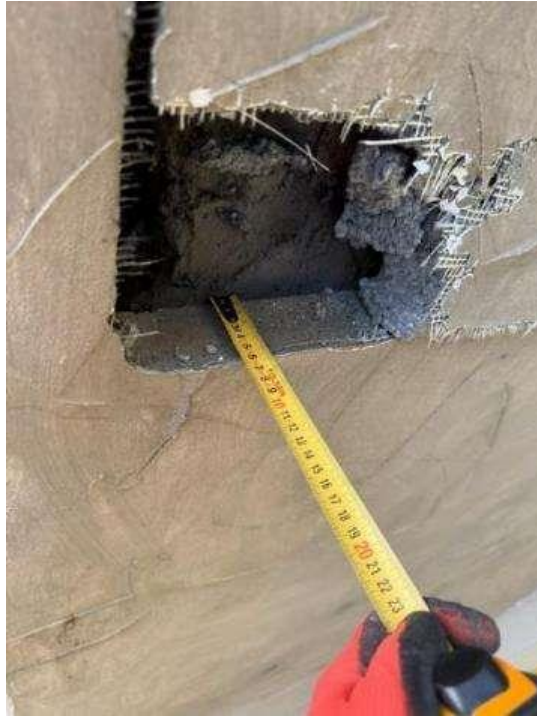
Figure 5.1.55. Opening of insulation

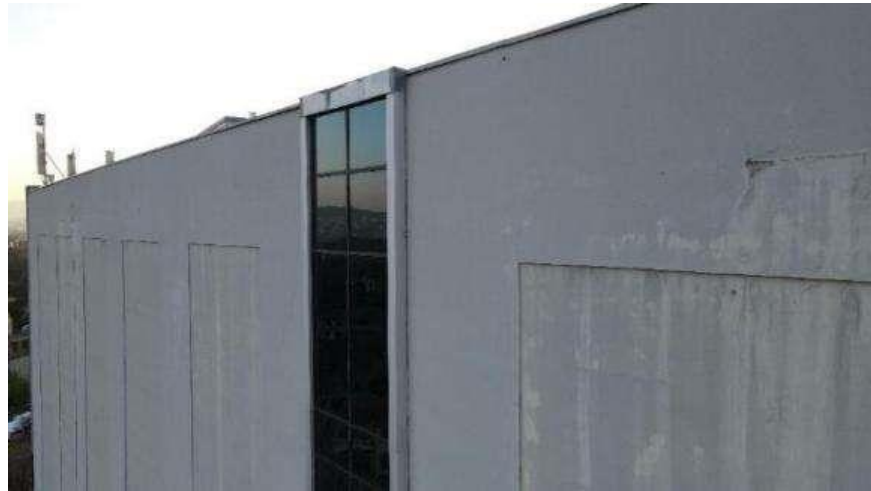
Figure 5.1.59. Peeling of the finishing layer. Cracks in the plaster layer of the facade in axes 1-6/C

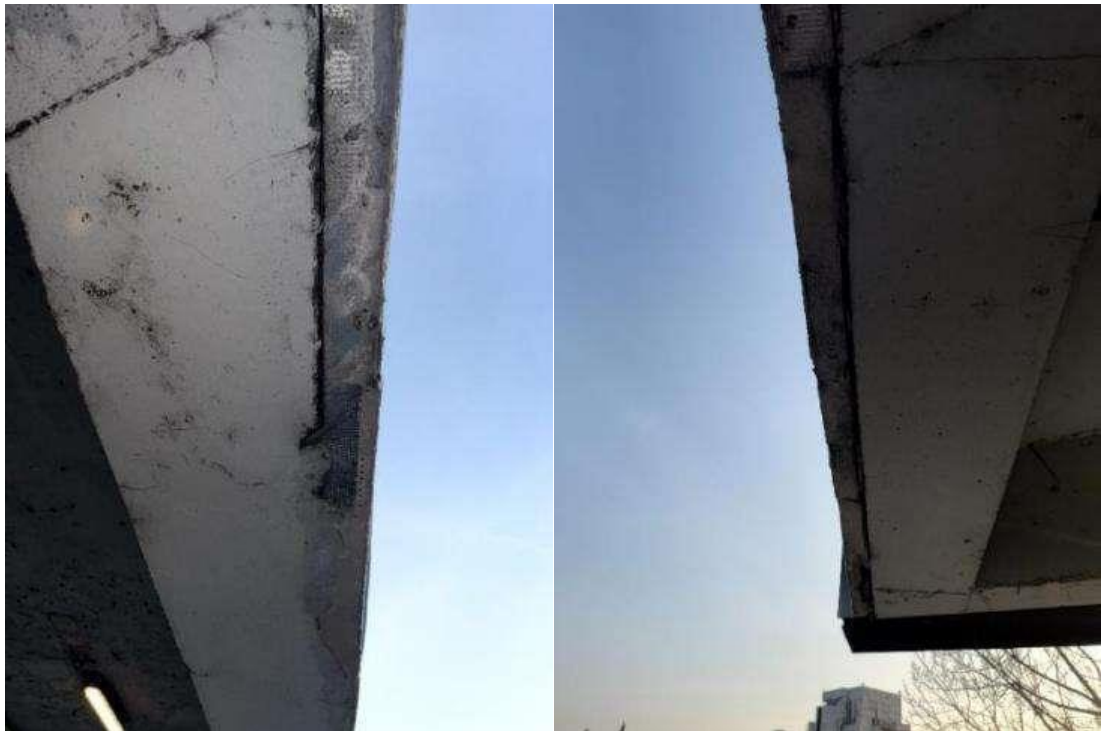
Figure 5.1.60. Wall insulation in axes 1-6/C

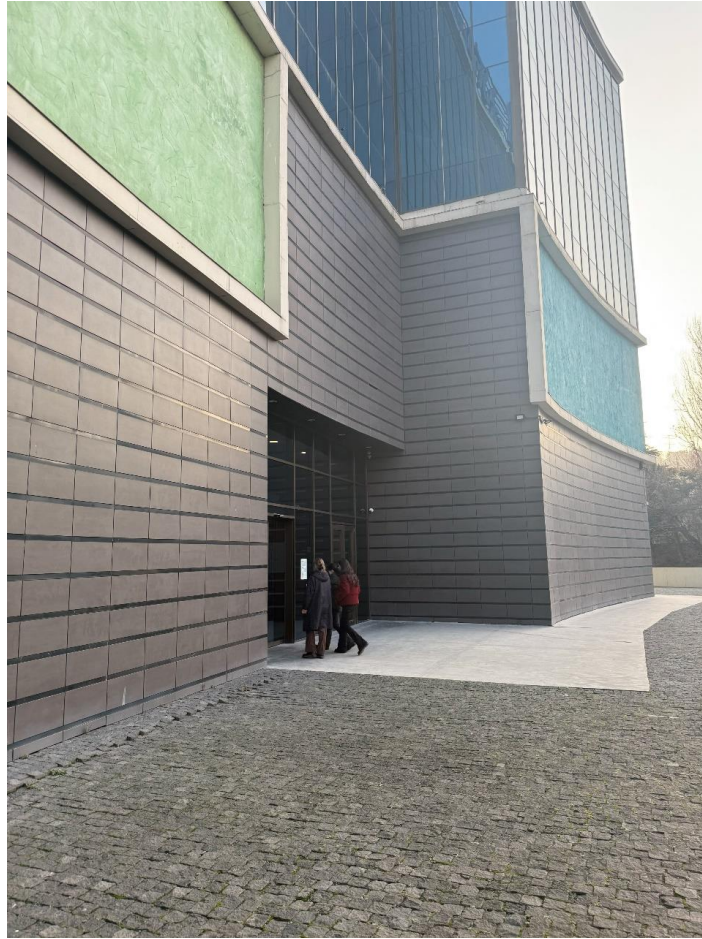
Figure 5.2.1. General view of the curtain wall in axes 6/A-B

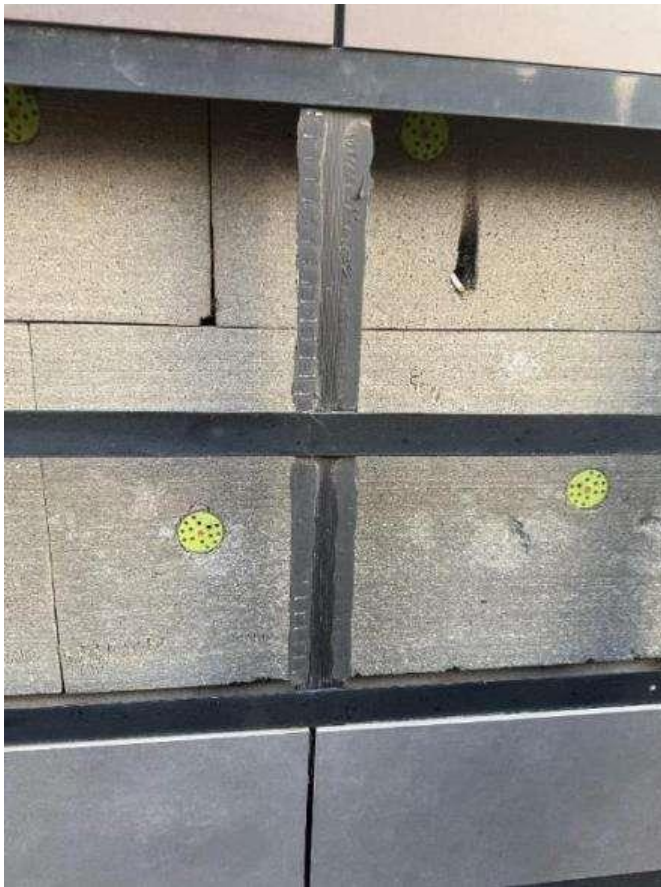
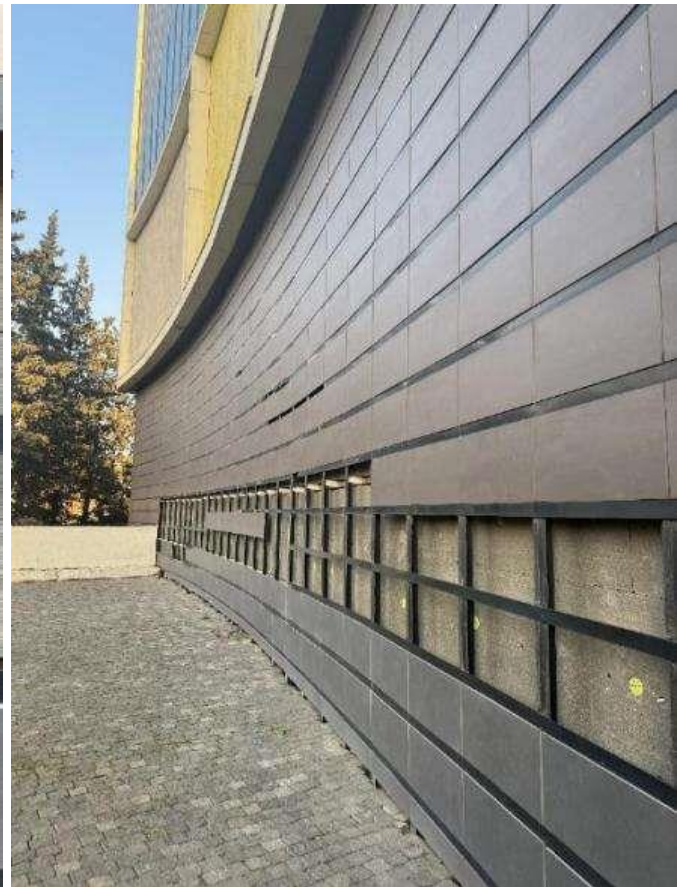
- widespread (more than 40%) minor defects in the form of an insufficient number of disc dowels for fastening the insulation. This defect was formed during installation.

- numerous (covering an area of more than 10% to 40%) minor defects in the form of gaps (more than 2 mm) between insulation elements. This defect was caused during the installation of the facade and the absence of joint filling of more than 2 mm;

Figure 5.2.2. Fastenings of the insulation layer (insufficient). Increased gaps between slabs. Adhesive layer on the vertical fastening element of the ventilated facade

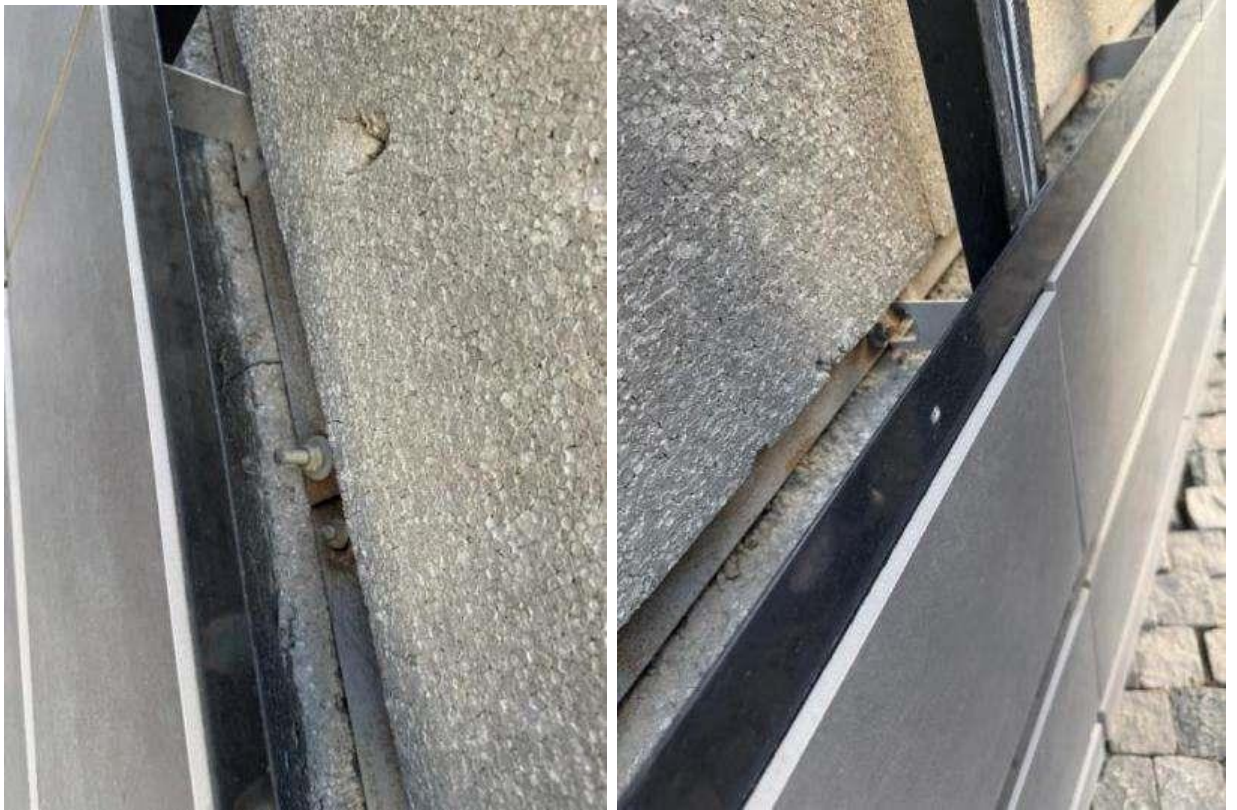
Figure 5.2.3. Fastening of the facade frame to the wall

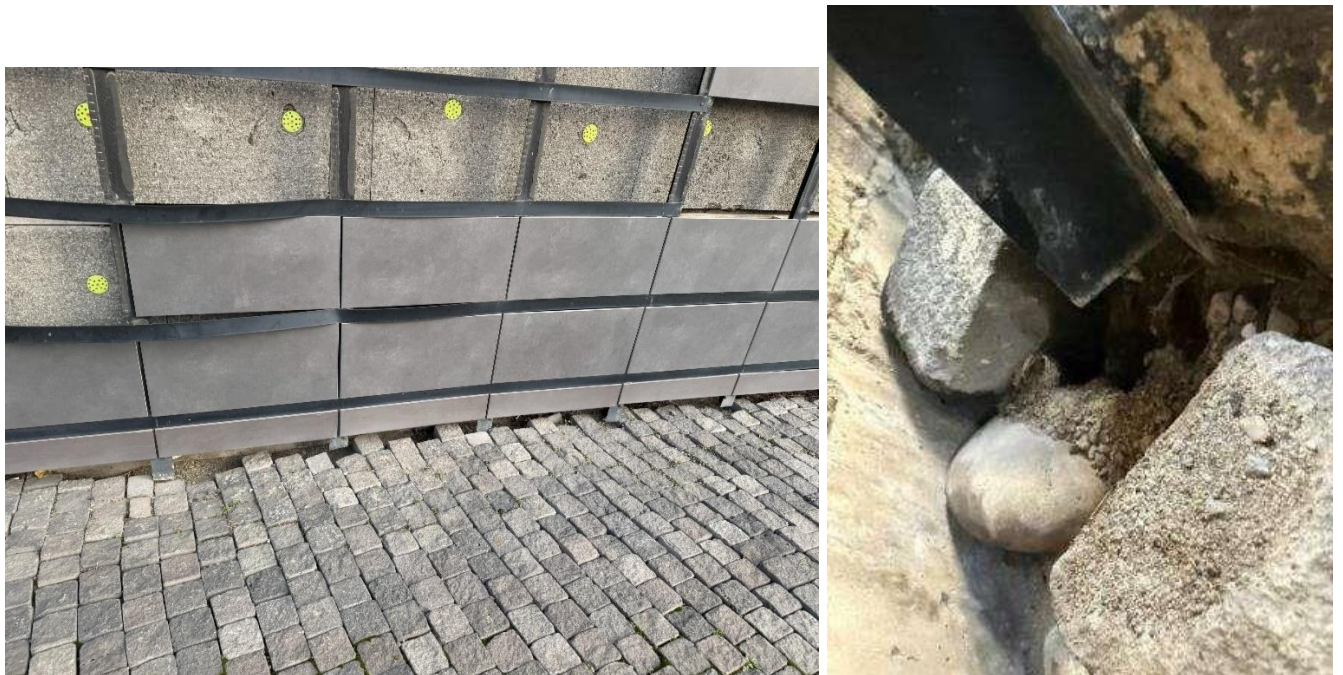
- numerous (covering more than 10% to 40%) minor defects in the form of delamination of slats and panels from the frame posts. This defect is due to physical wear of the adhesive composition;

Figure 5.2.4. Delamination of slats and panels from the frame uprights

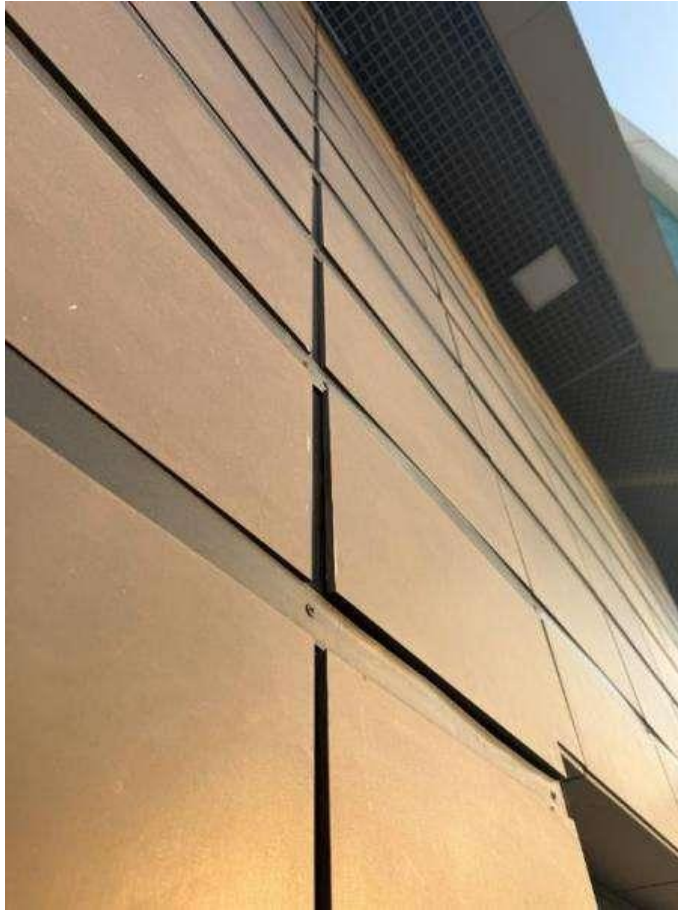
Figure 5.2.7. Detachment of panels from frame studs. In this section, the slats are additionally fastened to the stud with self-tapping screws

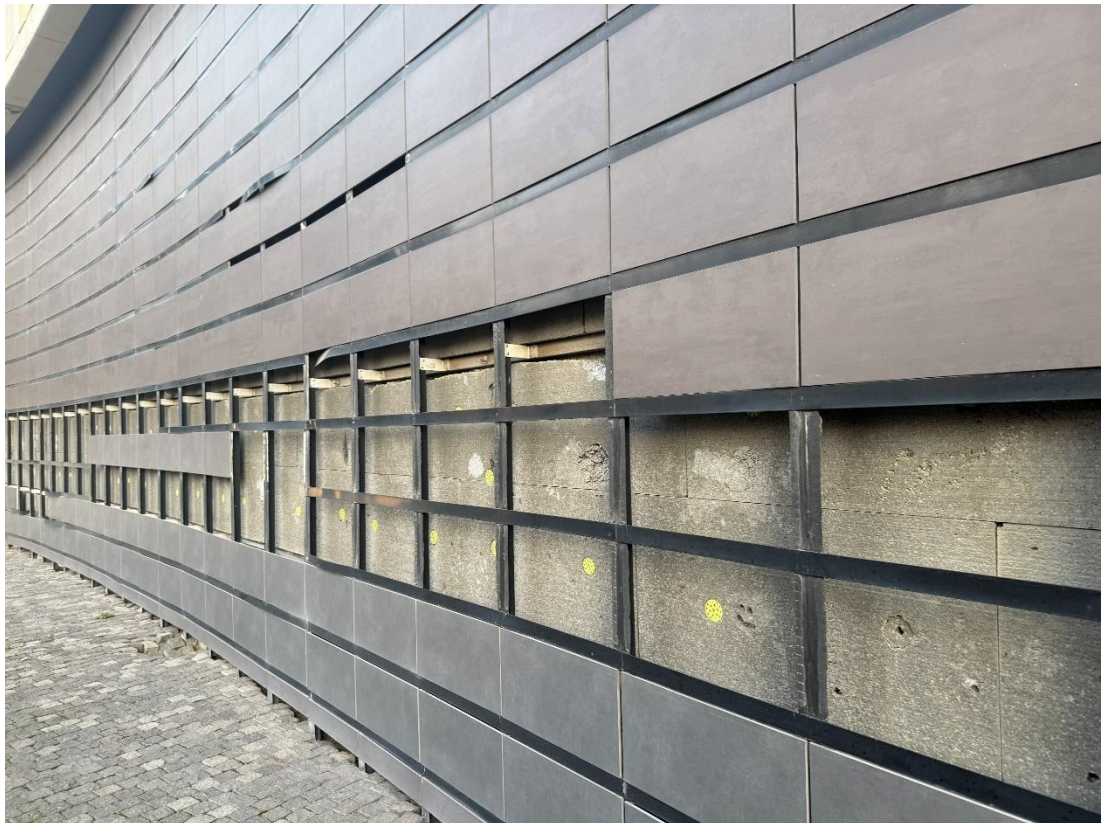
Figure 5.2.8. Detachment of slats and panels from frame posts. Enlarged joints between slabs

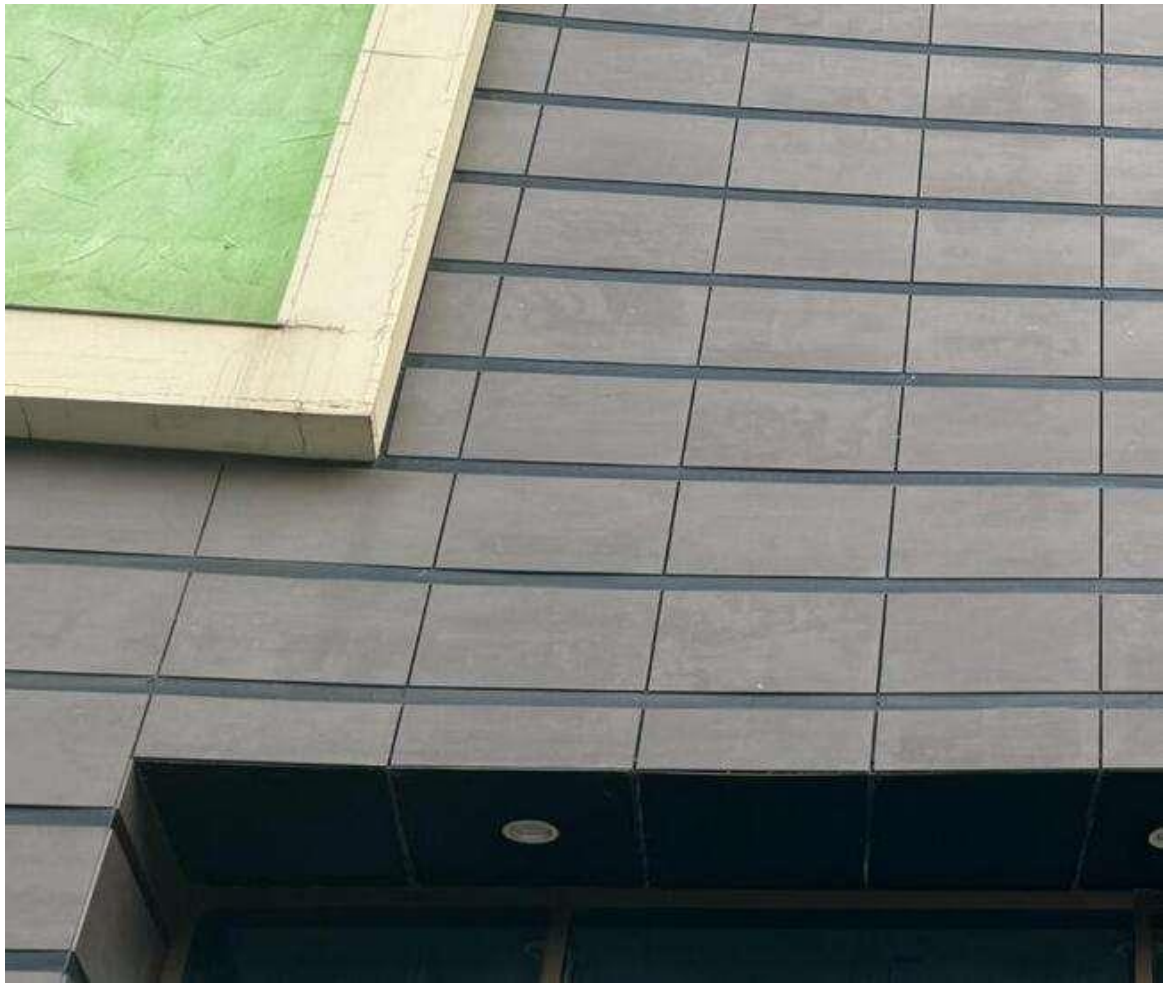
Figure 5.2.9. Delamination of slats and panels from frame posts

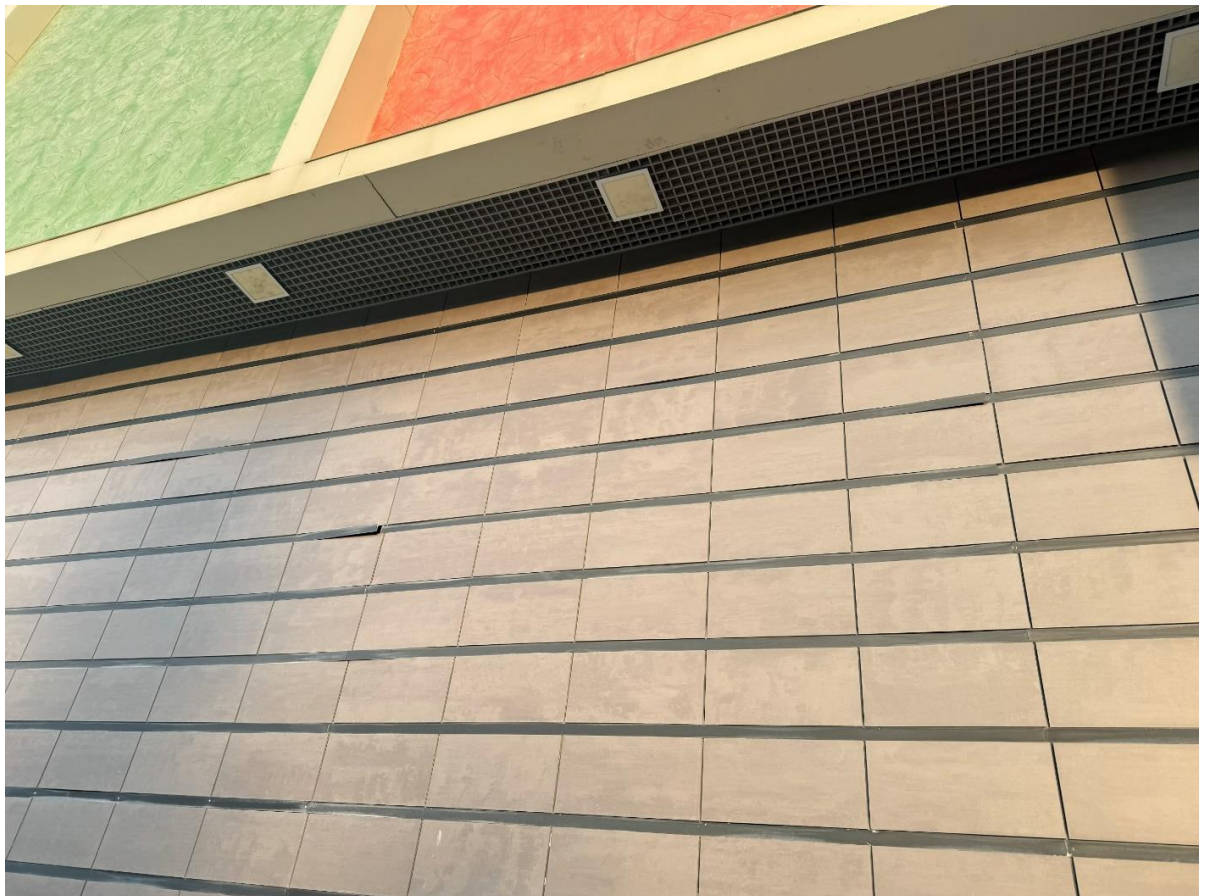
Figure 5.2.10. Delamination of lamellas and panels from frame posts

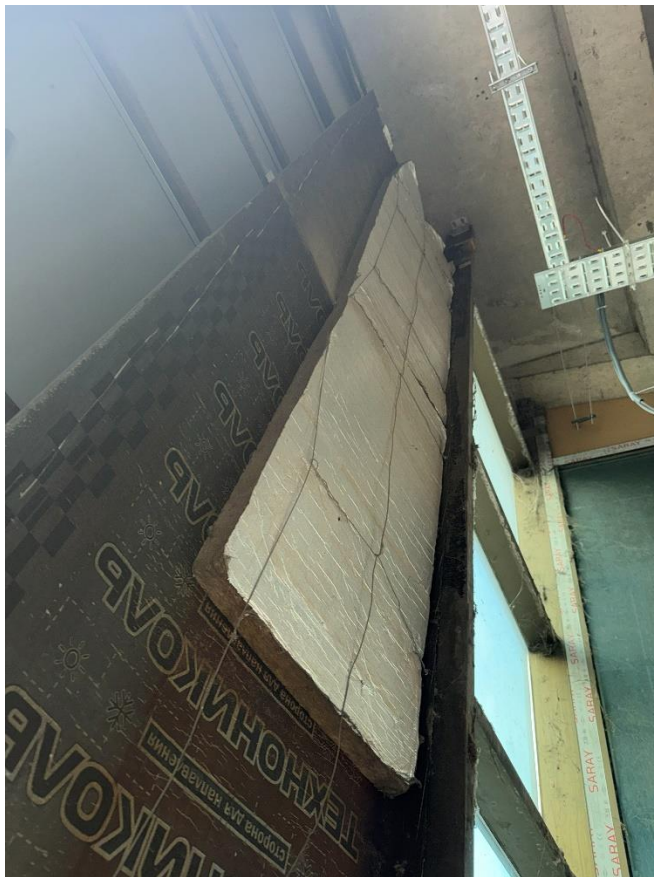
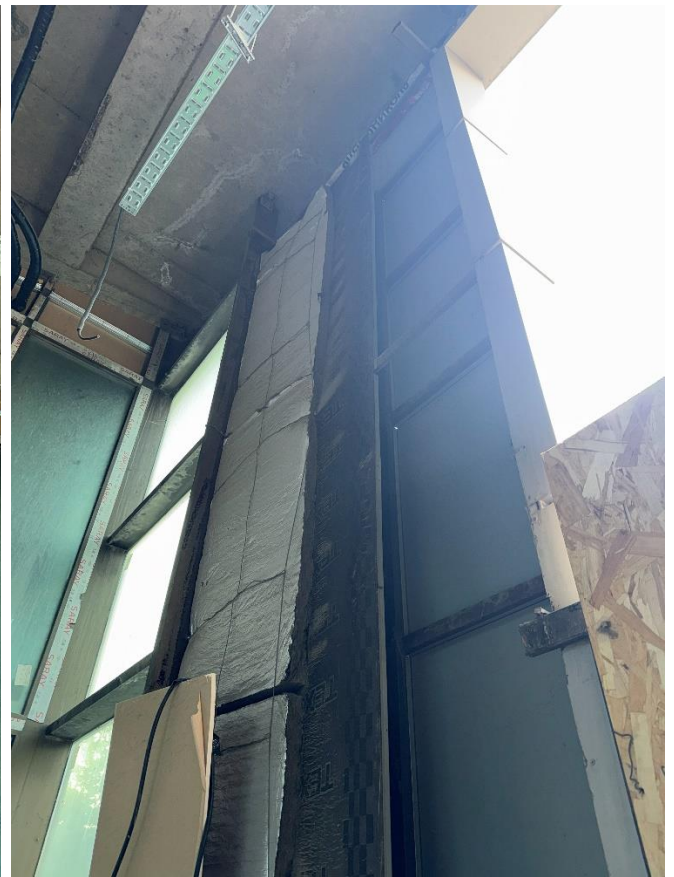
Figure 5.2.18. Insulation structure of this part of the facade

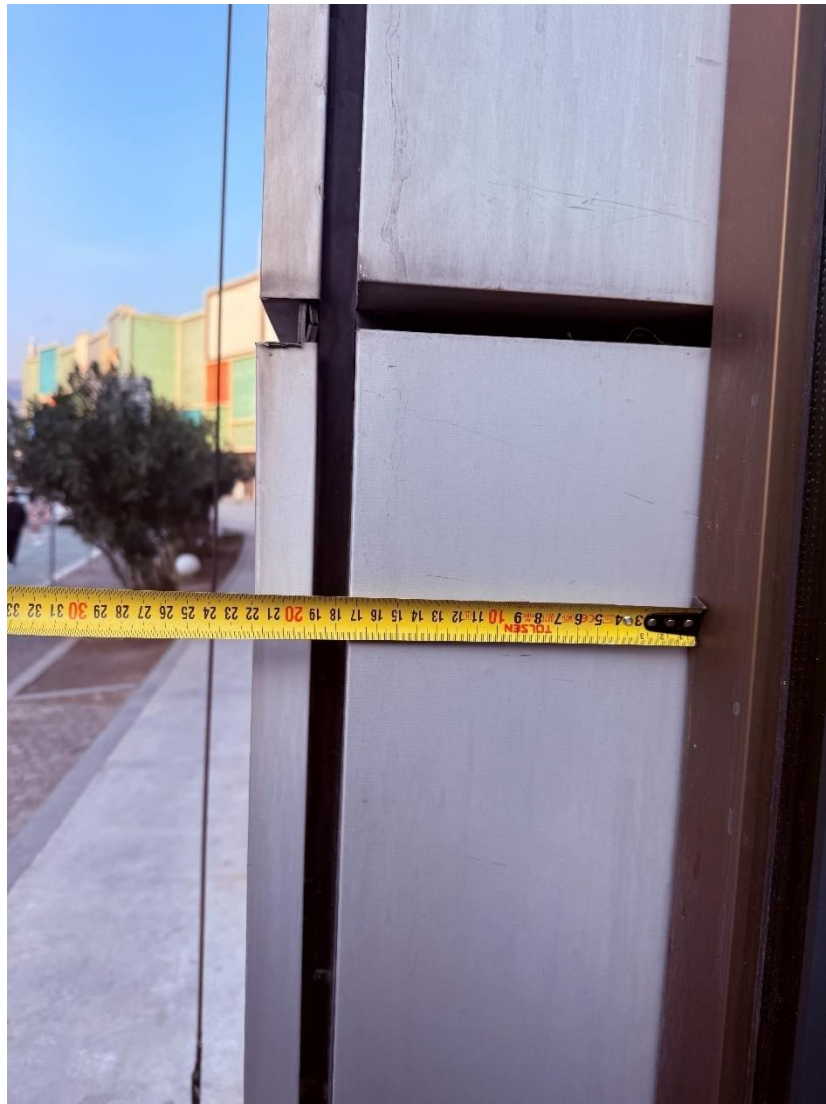
Figure 5.2.19. Seams of the facade with aluminum panels

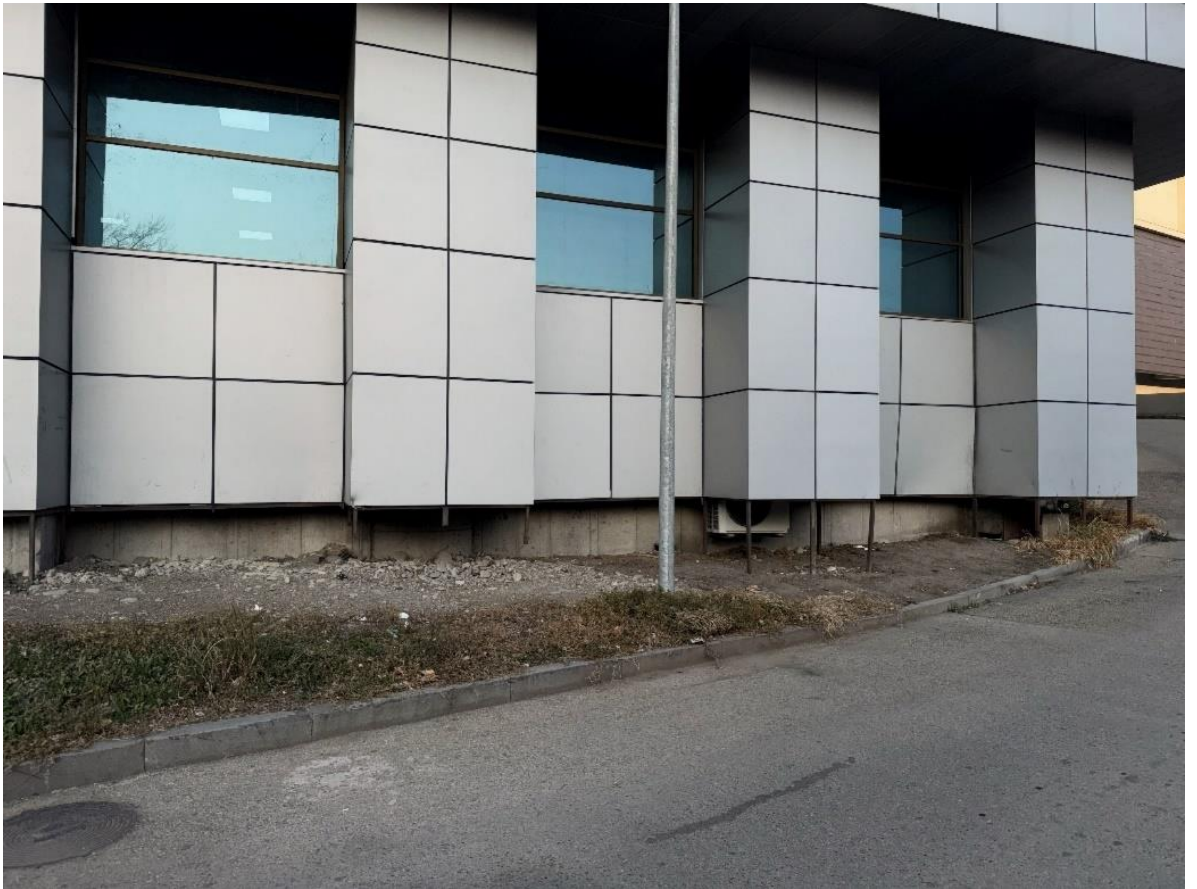
Figure 5.2.22. Facade construction made of suspended aluminum panels

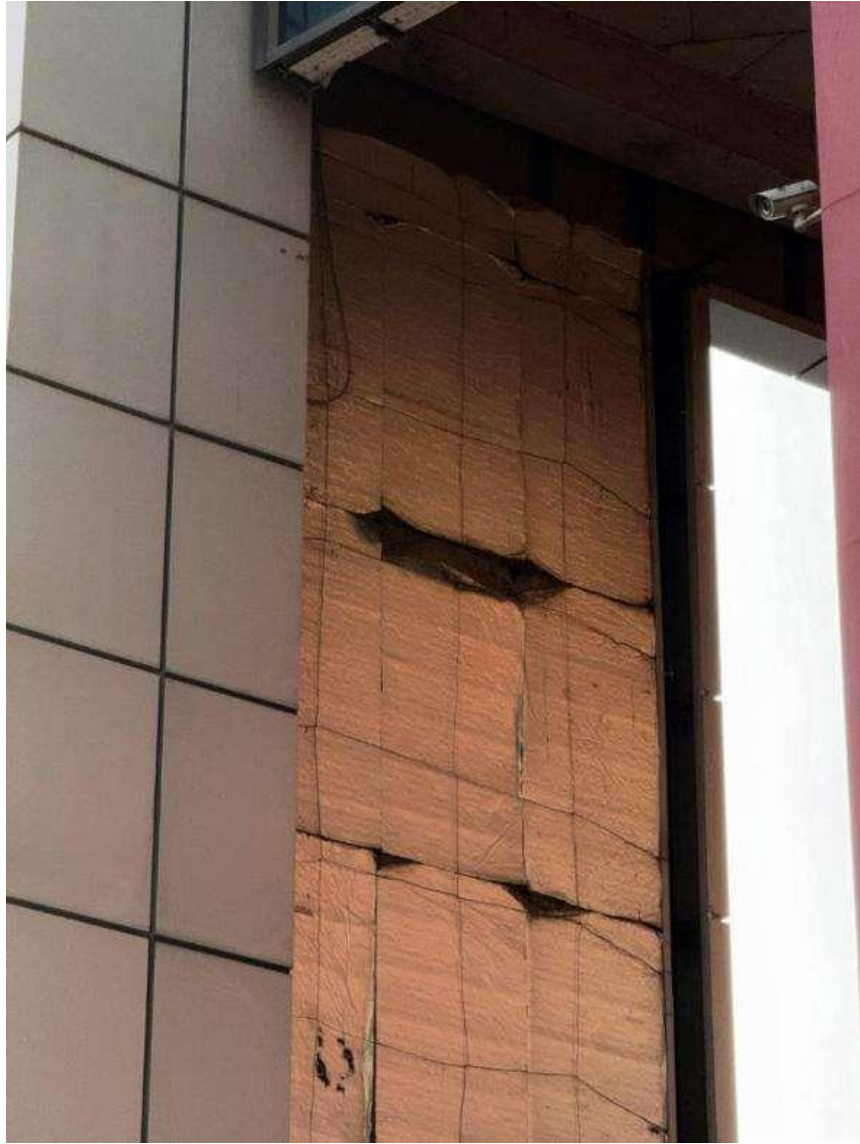
Figure 5.2.23. Insulation structure of this part of the facade

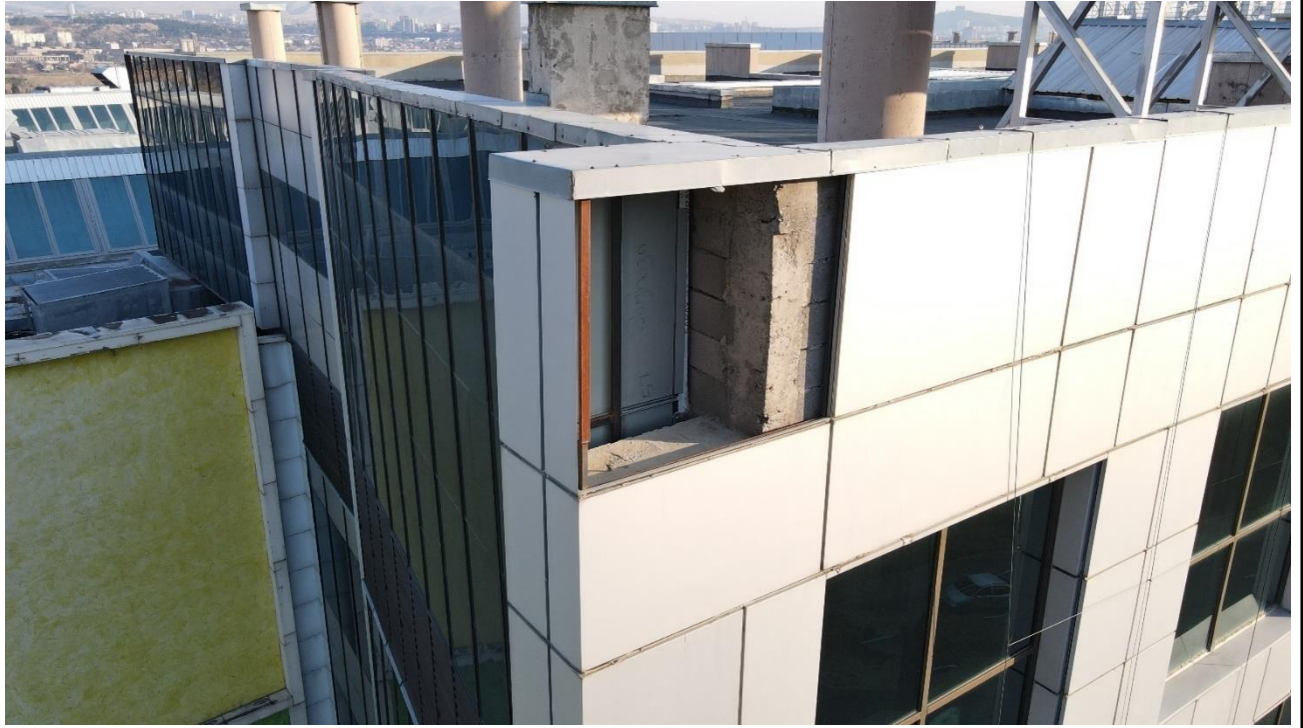
Figure 5.2.25. Absence of aluminum panels on the facade

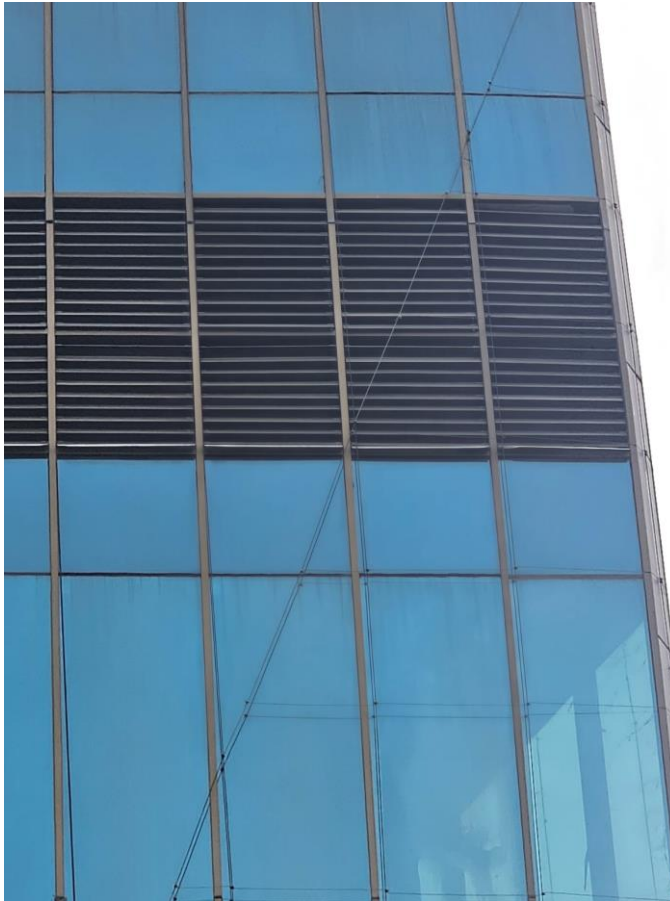
Figure 5.2.26. Ventilation grilles on the curtain wall in axes 1-3/A-C

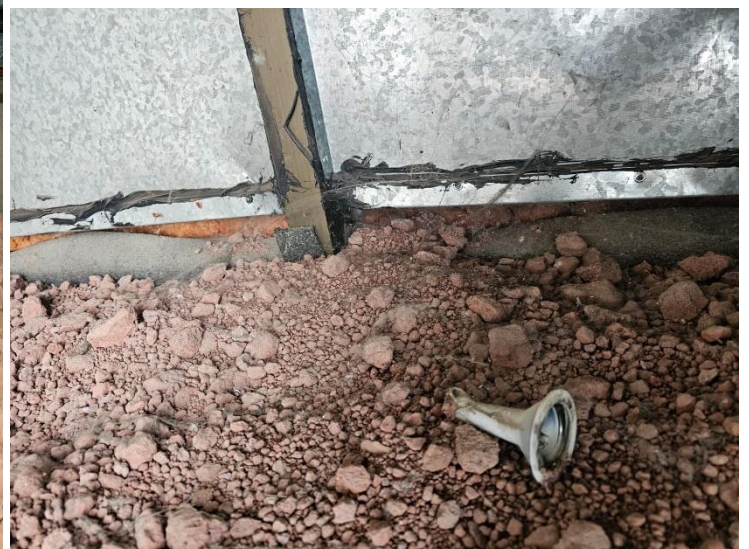
- massive (more than 40%) minor indirect defects in the form of leaks in facades made of aluminum panels due to leaks in ventilation grilles.

Figure 5.2.28. The ventilation grilles are currently not functional. These grilles are subject to leaks from precipitation (indirect defects). The inside is sealed with steel sheets and polyurethane sealant

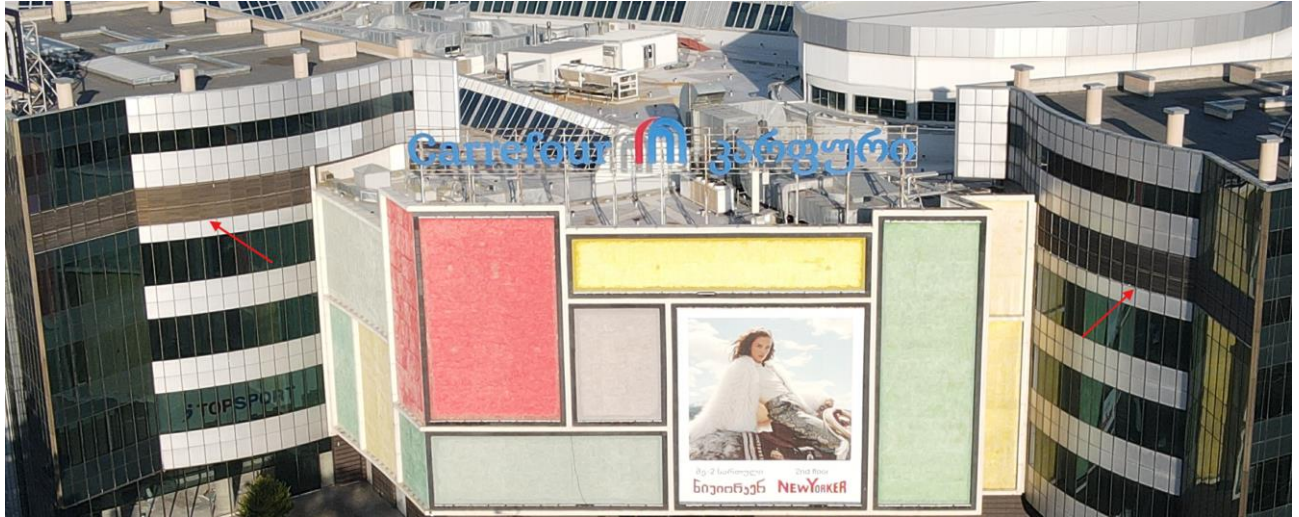
Figure 7.4. Ventilation grilles on the building facade
